## FIELD REPORT

TITLE Stone Harbor Maintenance Dredging  
DATE 20 January 2016  
TO Jill Gougher  
COPY MADN  
FROM BEWI  
PROJECT NO A06772

**Purpose of Visit:** Observation of work in progress

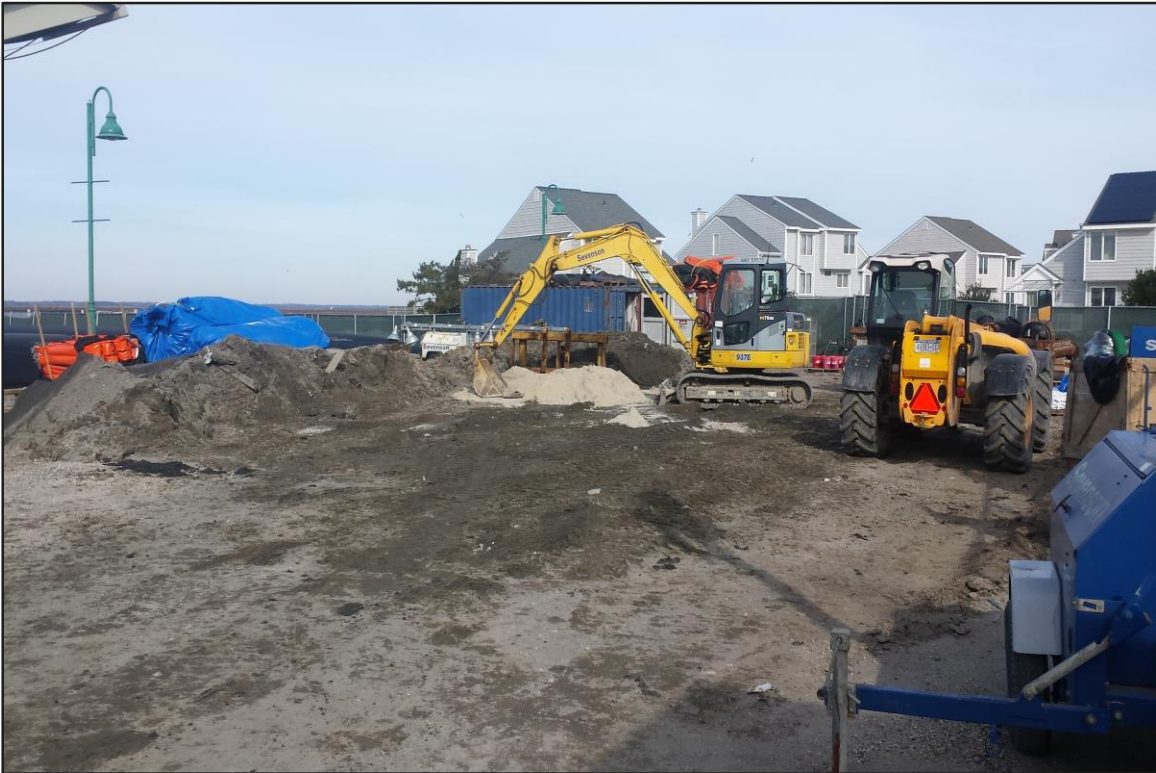
Photograph 1: De-watering area – Equipment loading sand into bags to block boat ramp. (Looking northwest)

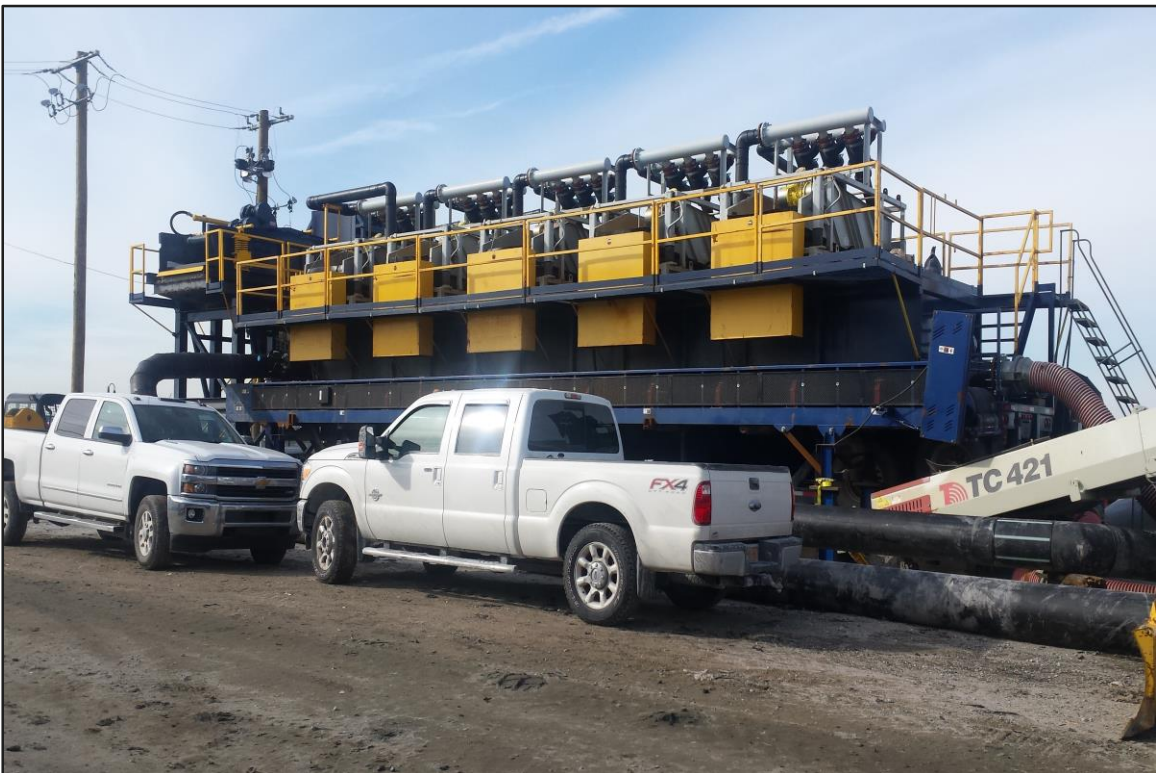
Photograph 2: De-watering area – De-sanding plant on standby. (Looking west)

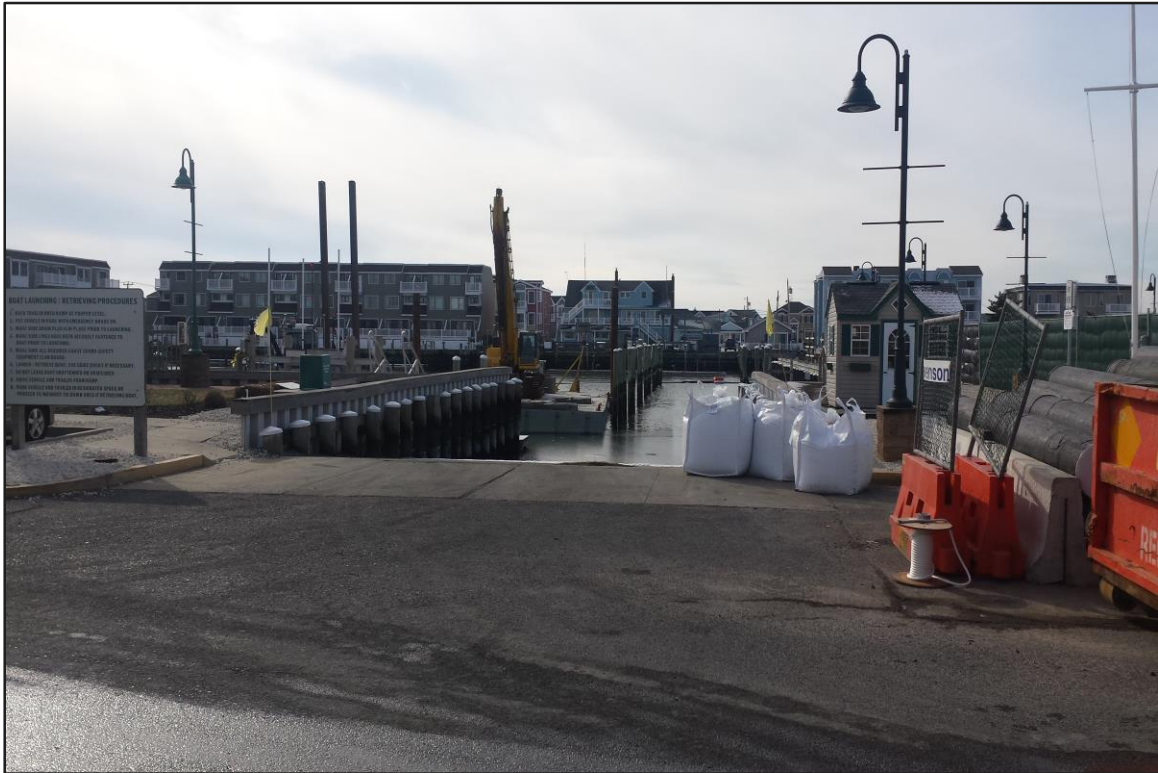
*Photograph 3: De-watering area – Sand bags to block storm surge. (Looking south)*

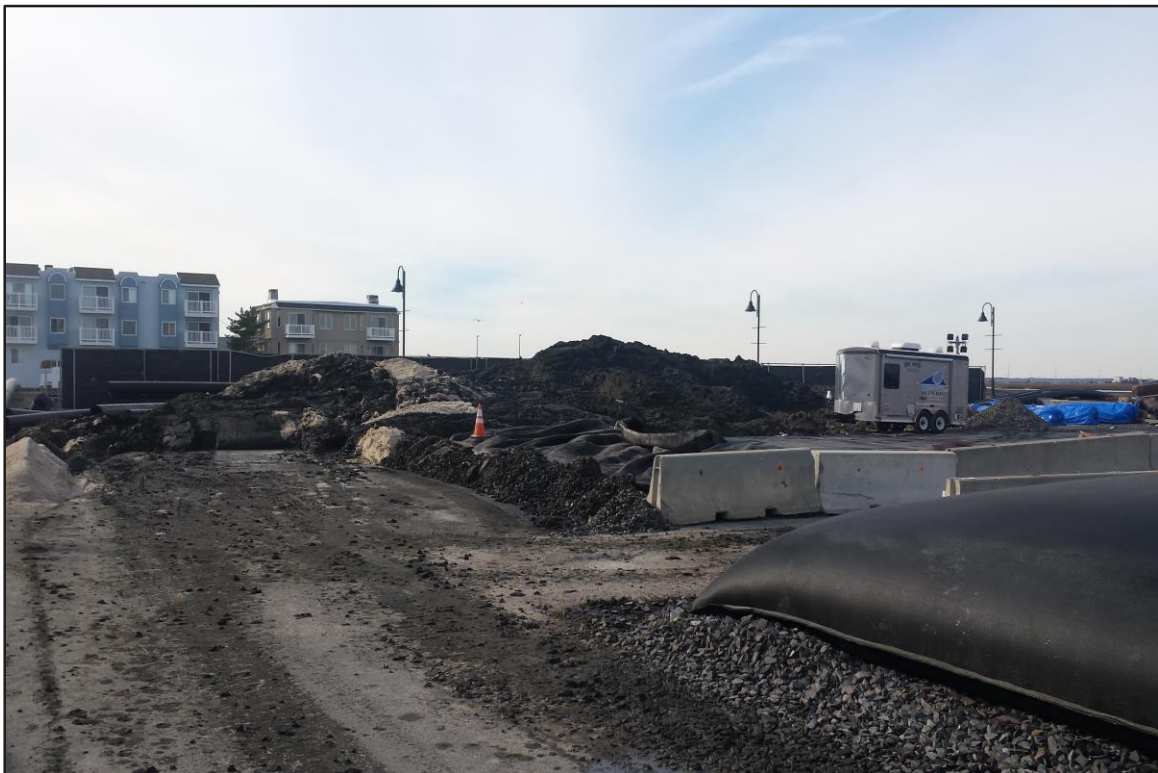
*Photograph 4: De-watering area – Blended material staged for removal. (Looking southwest)*

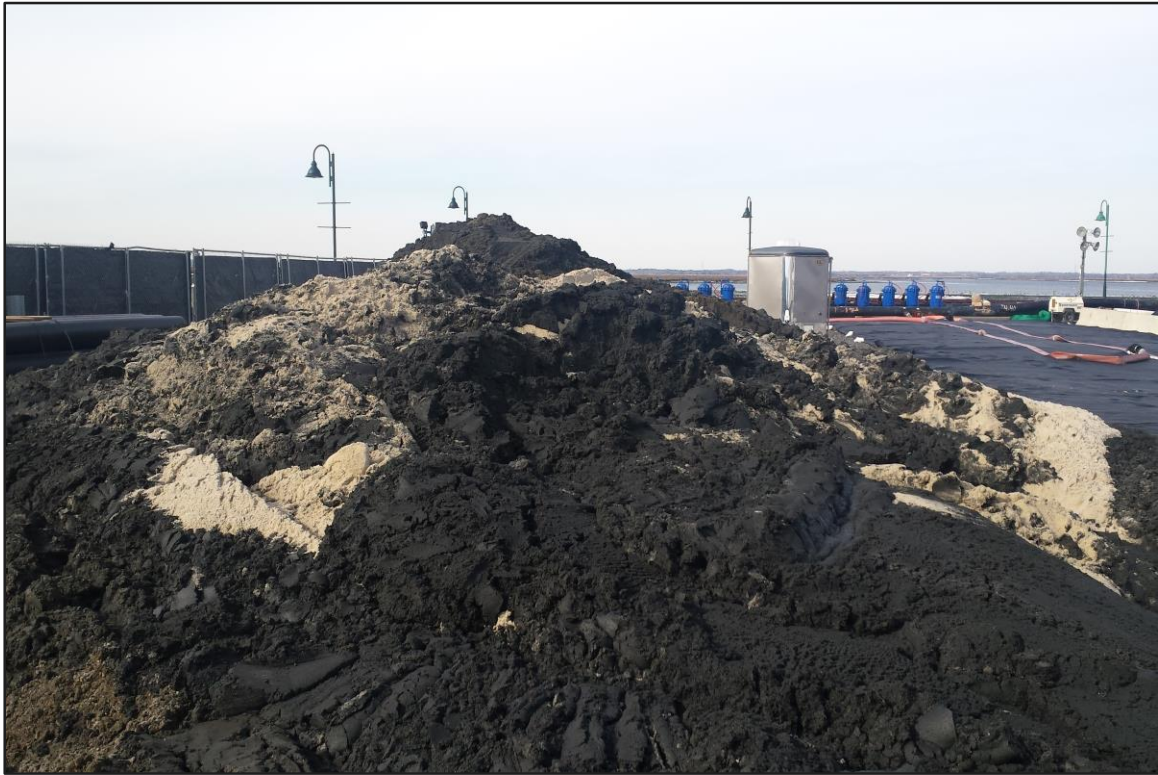
*Photograph 5: De-watering area – Blended material staged for removal. (Looking west)*

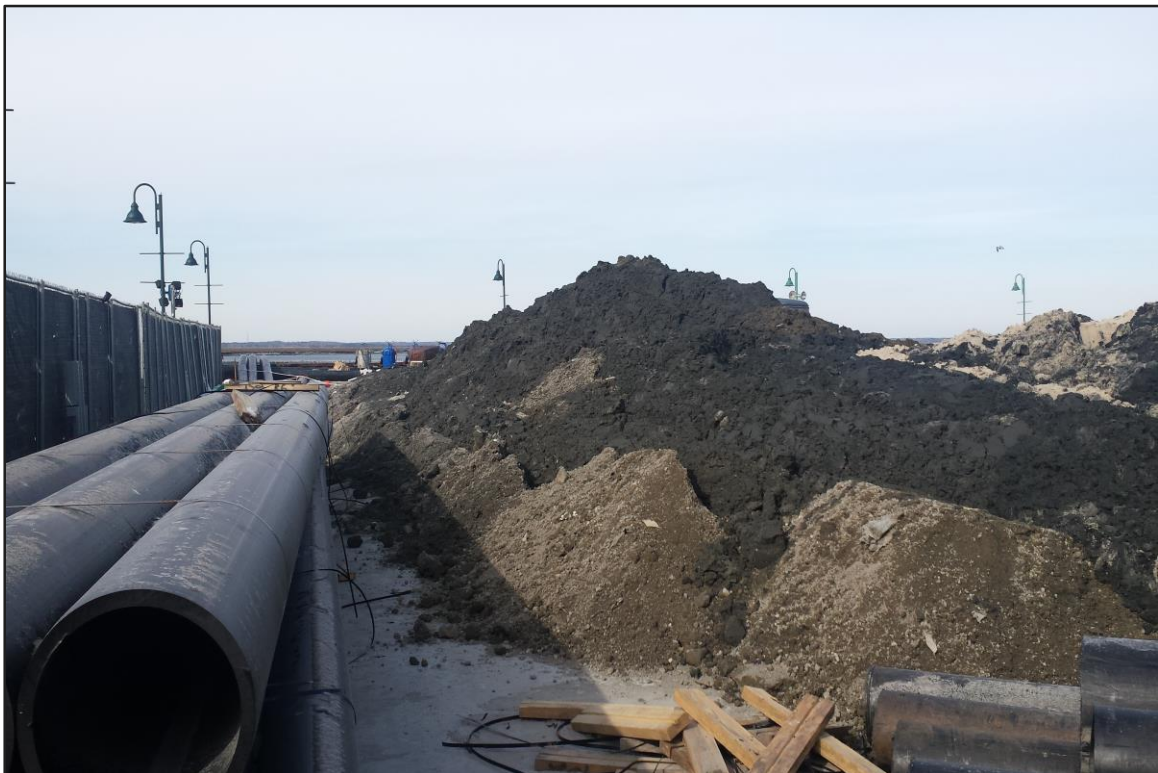
*Photograph 6: De-watering area – Blended material staged for removal. (Looking west)*

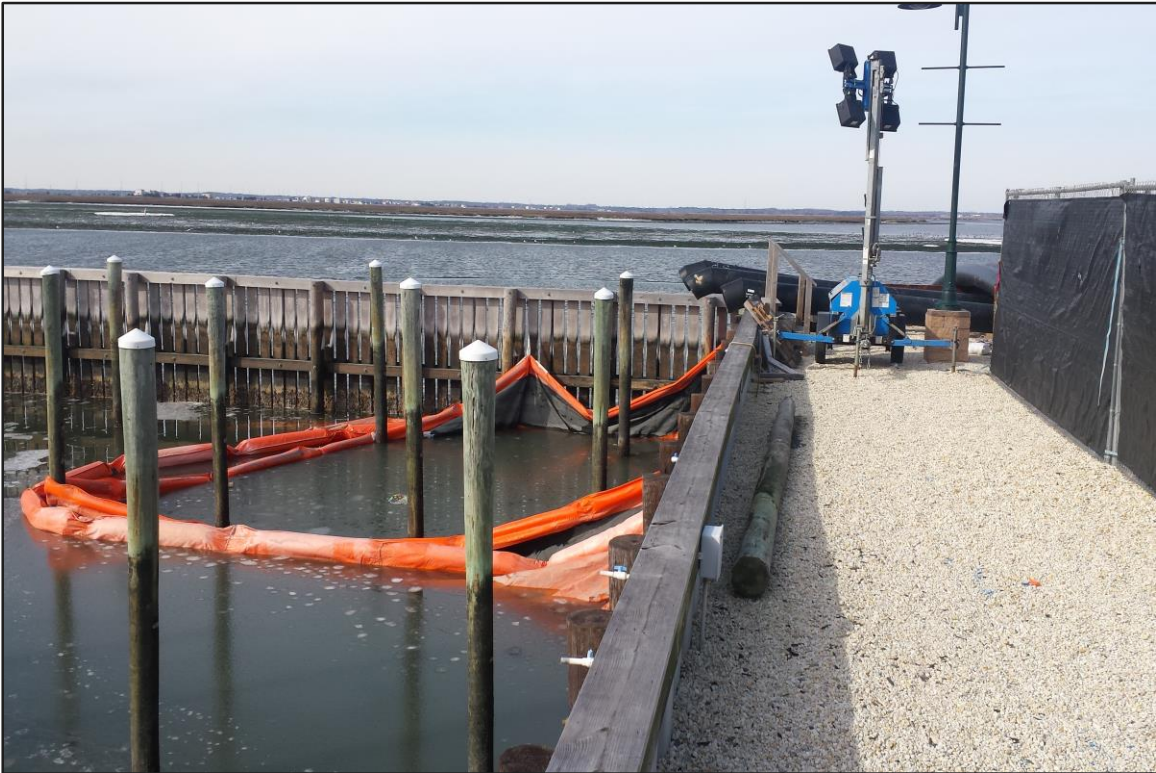
Photograph 7: De-watering area – Discharge pipes on standby. (Looking west)

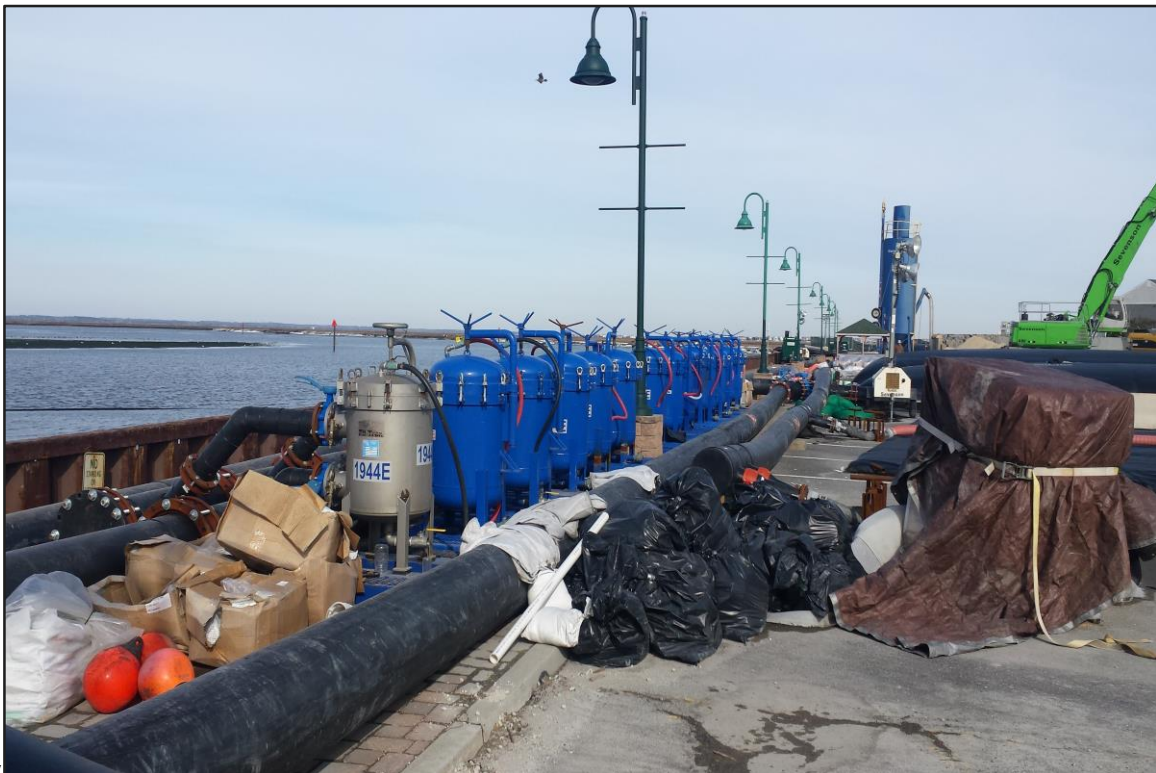
Photograph 8: De-watering area – Filtration system on standby. (Looking northwest)

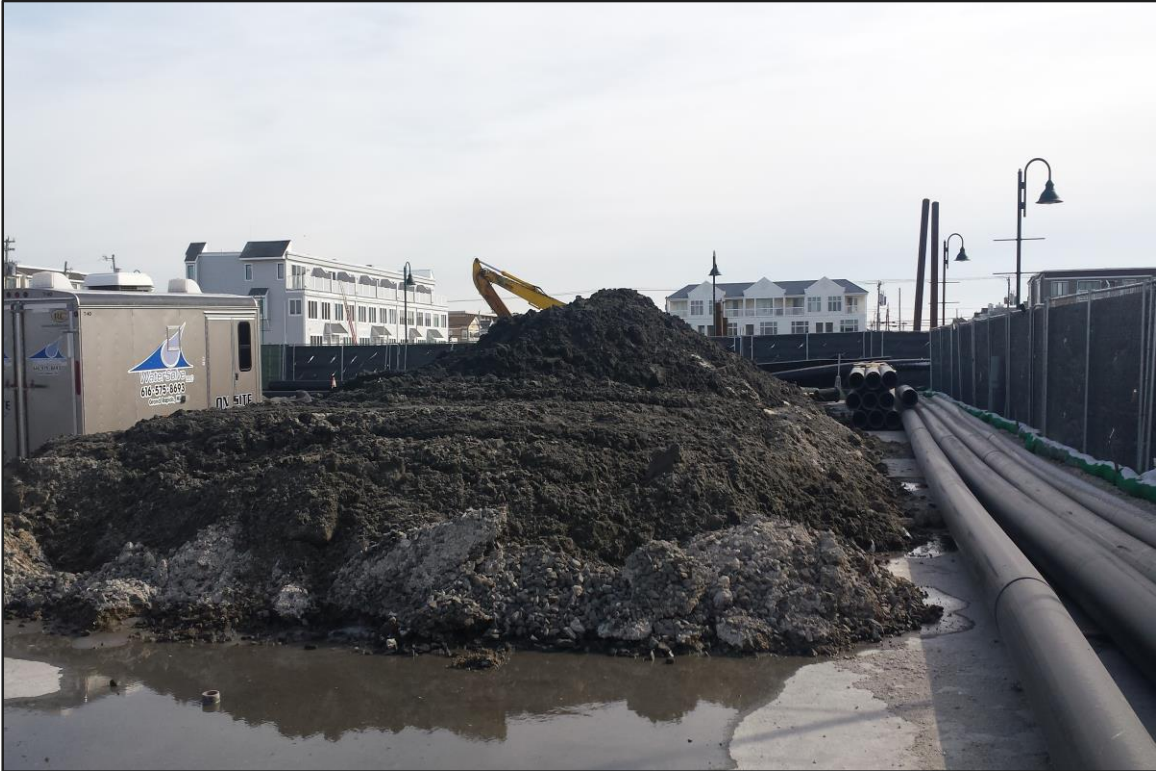
*Photograph 9: De-watering area – Blended material staged for removal. (Looking east)*

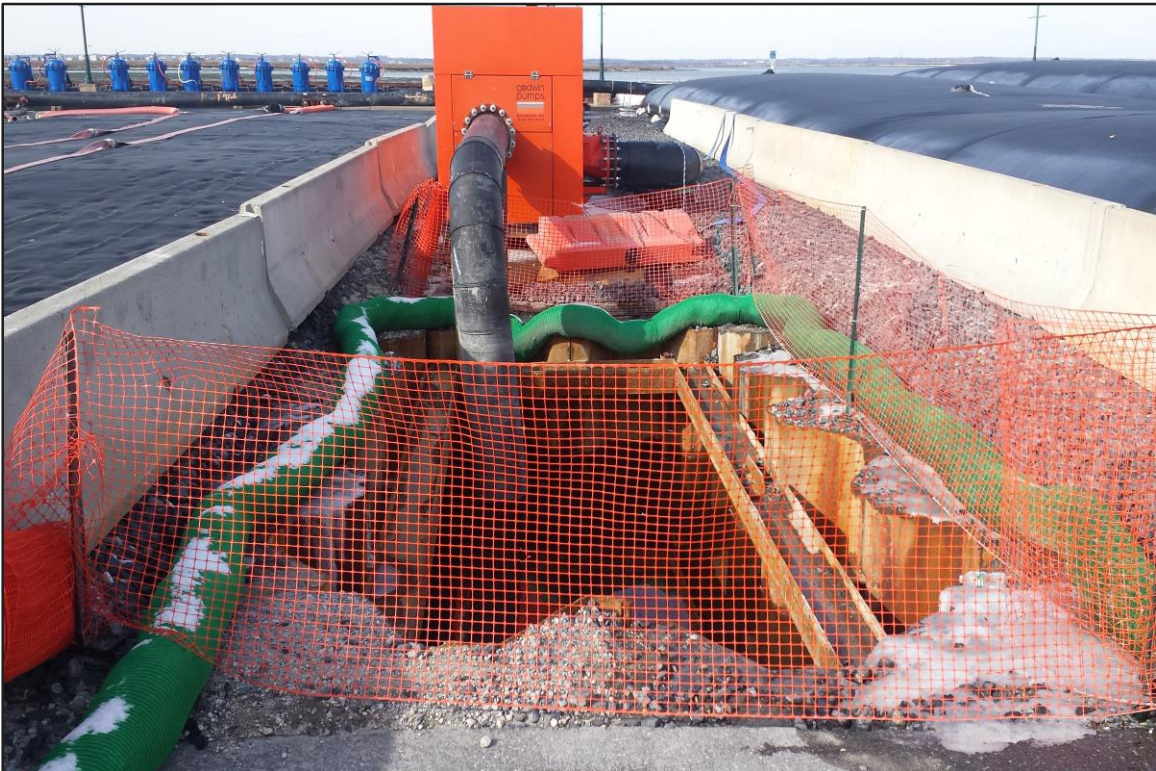
*Photograph 10: De-watering area – Sump pump on standby. (Looking west)*

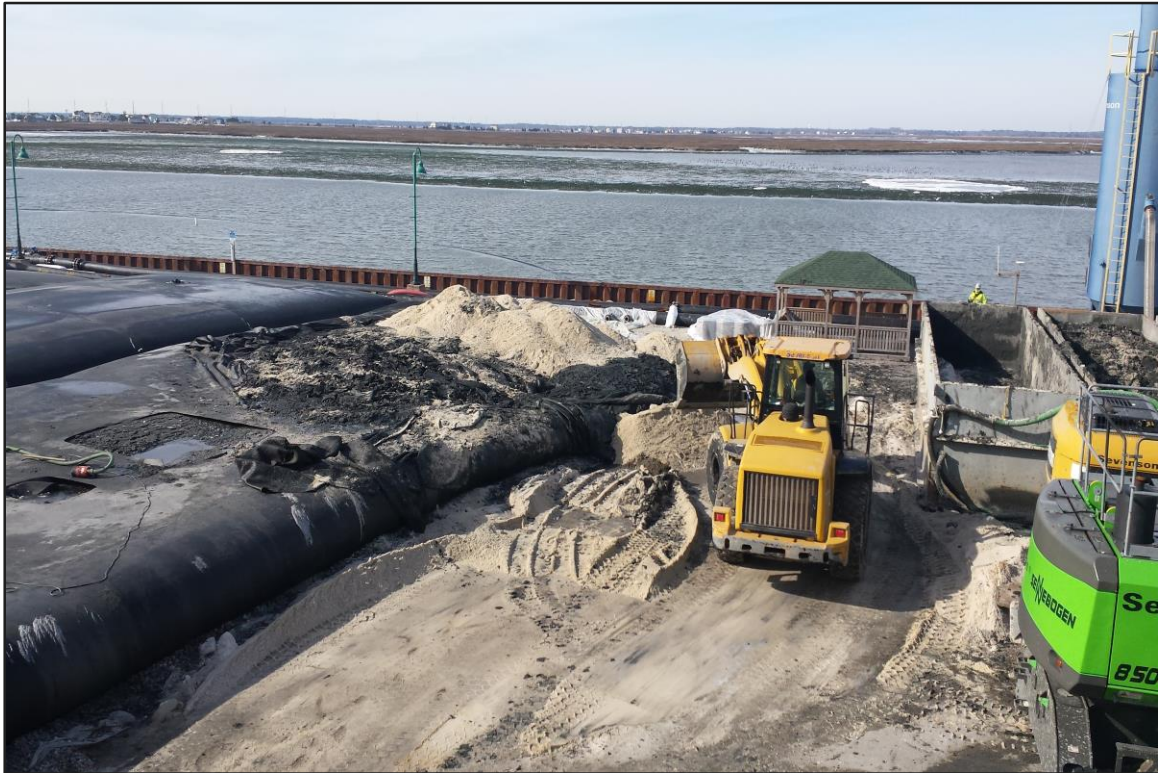
*Photograph 11: De-watering area – Sand-blending operations in progress. (Looking west)*

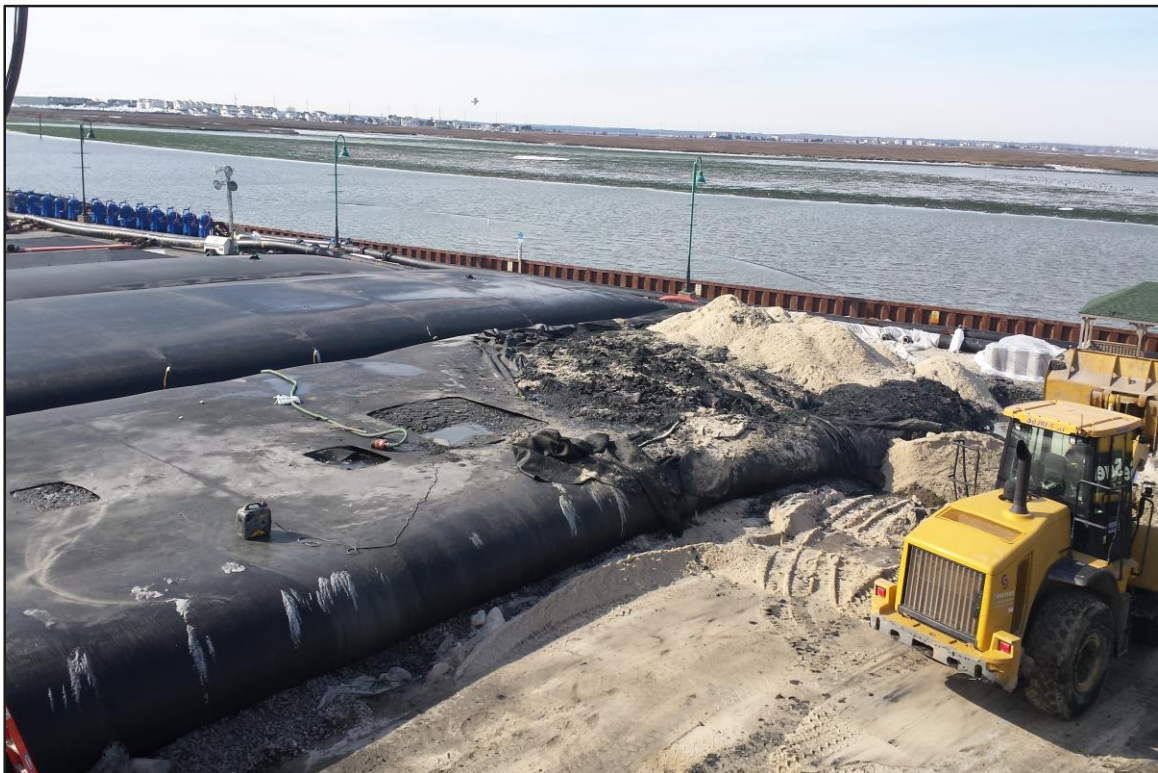
*Photograph 12: De-watering area – Sand-blending operations in progress. (Looking southwest)*

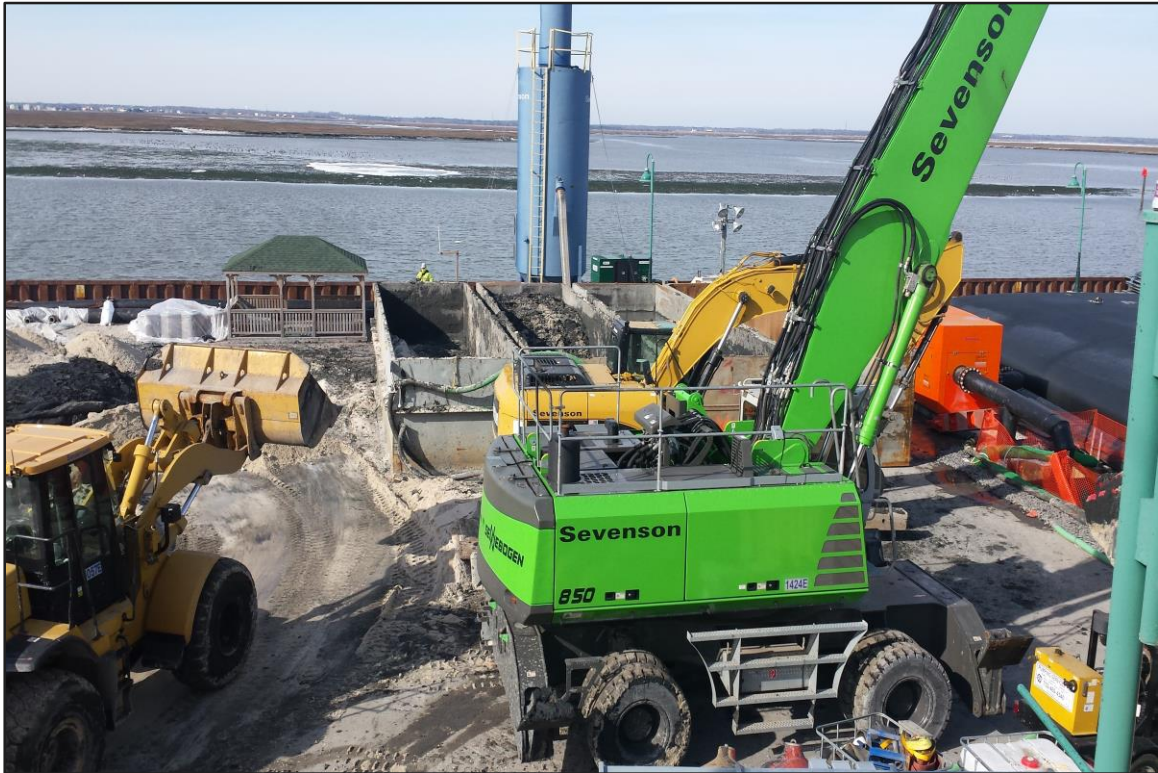
*Photograph 13: De-watering area – Sand-blending operations in progress. (Looking west)*

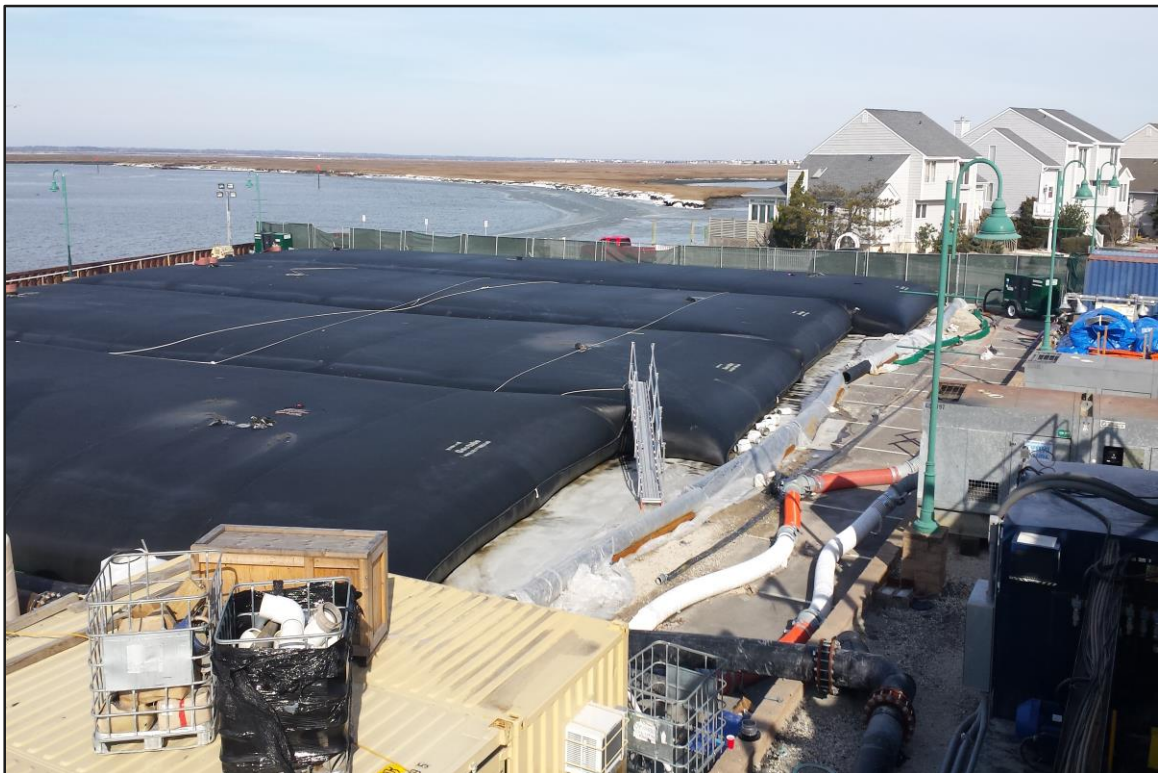
*Photograph 14: De-watering area – Geobags on standby. (Looking northwest)*

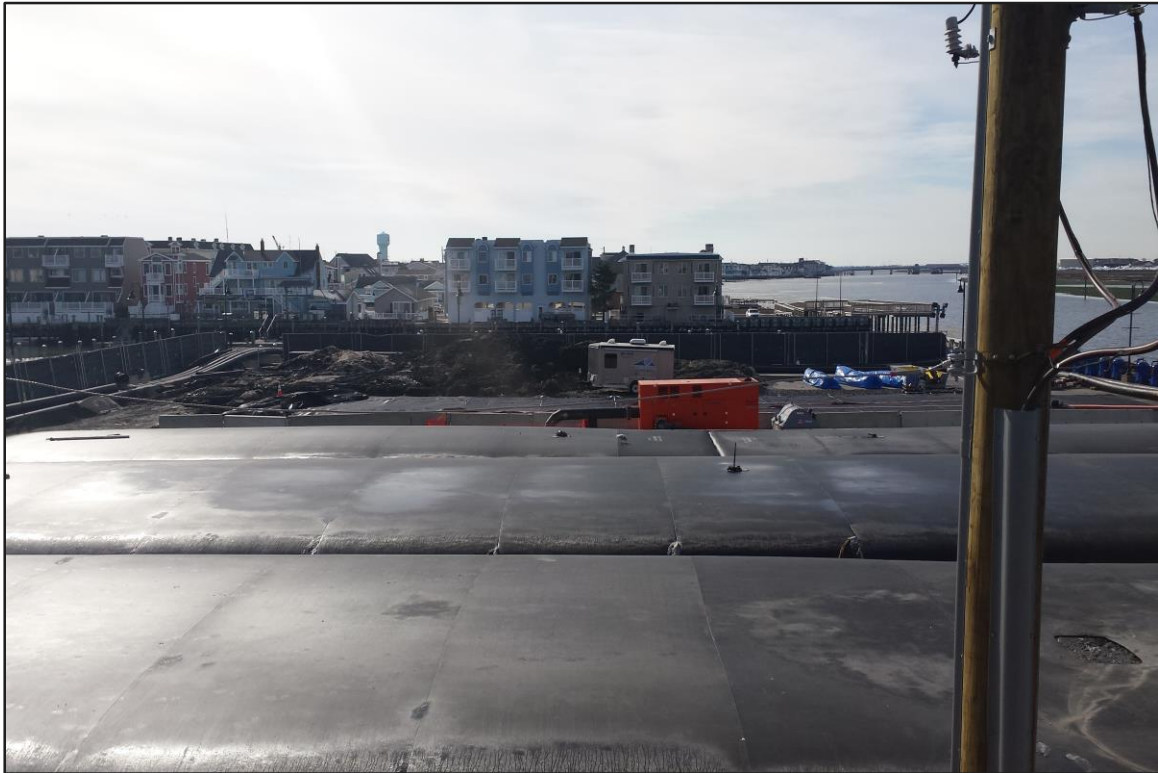
*Photograph 15: De-watering area – Blended material staged for removal. (Background, Looking south)*

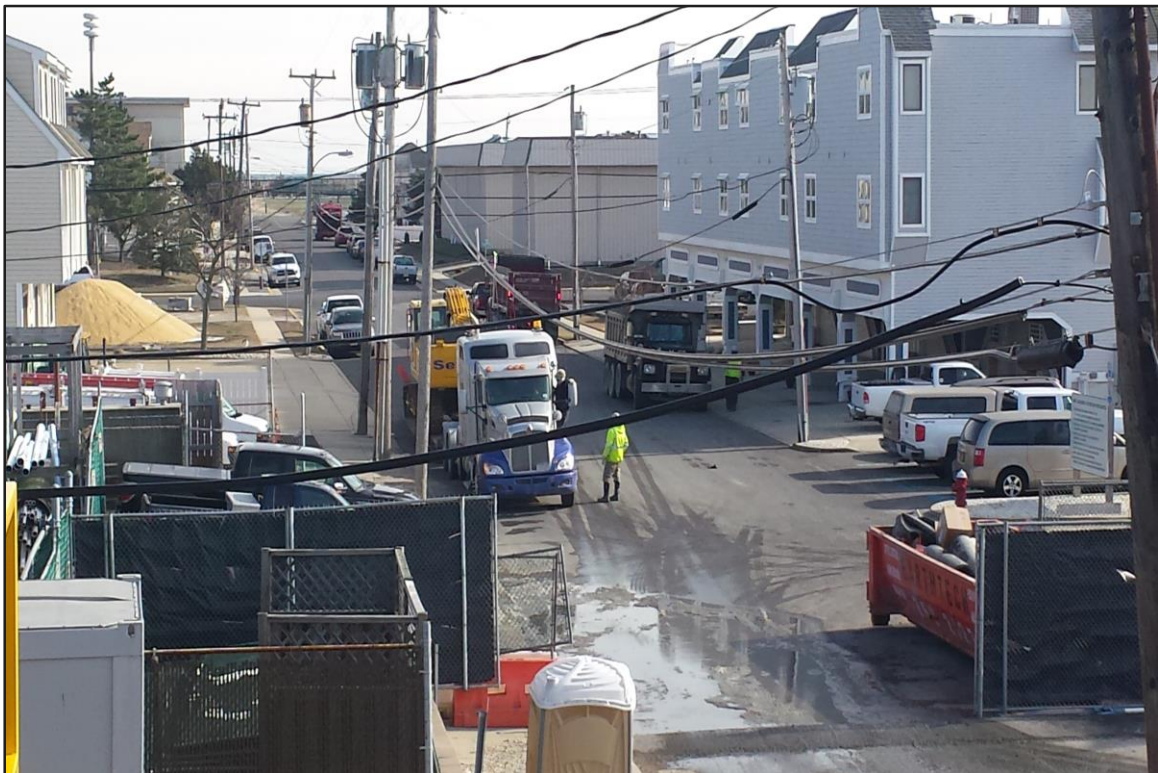
*Photograph 16: Site entrance – Sand delivery trucks queue and an additional excavator is delivered. (Looking east)*

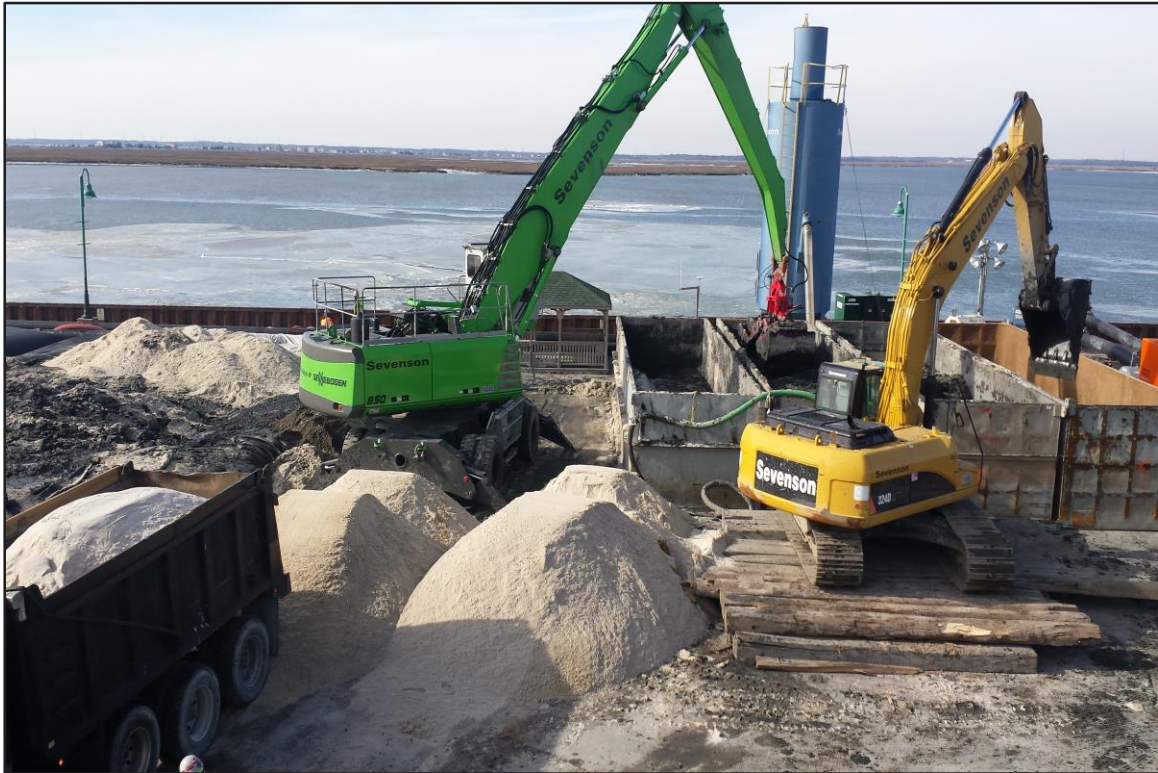
*Photograph 17: De-watering area – Sand-blending operations in progress. (Looking west)*
