FIELD REPORT

TITLE Stone Harbor Maintenance Dredging
DATE 13 January 2016
TO Jill Gougher
COPY MADN
FROM BEWI
PROJECT NO A06772

Project Information

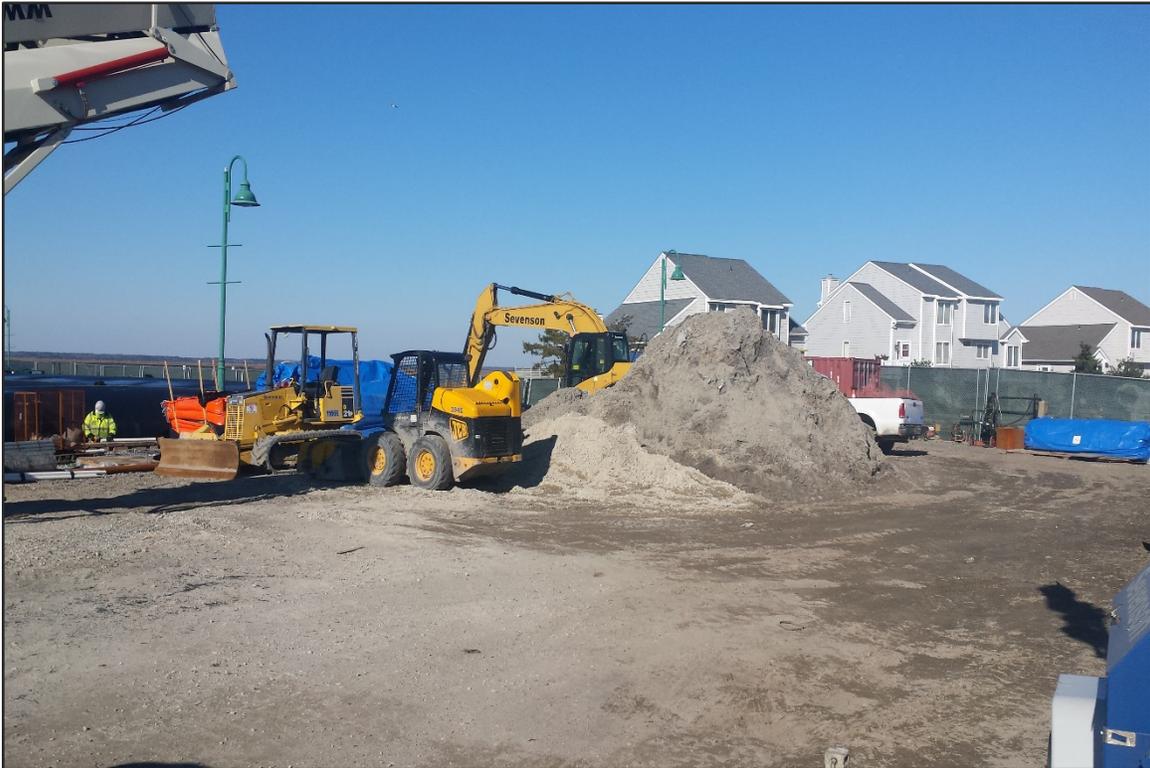
Photograph 1: De-watering Area – Equipment on standby (Looking northwest)

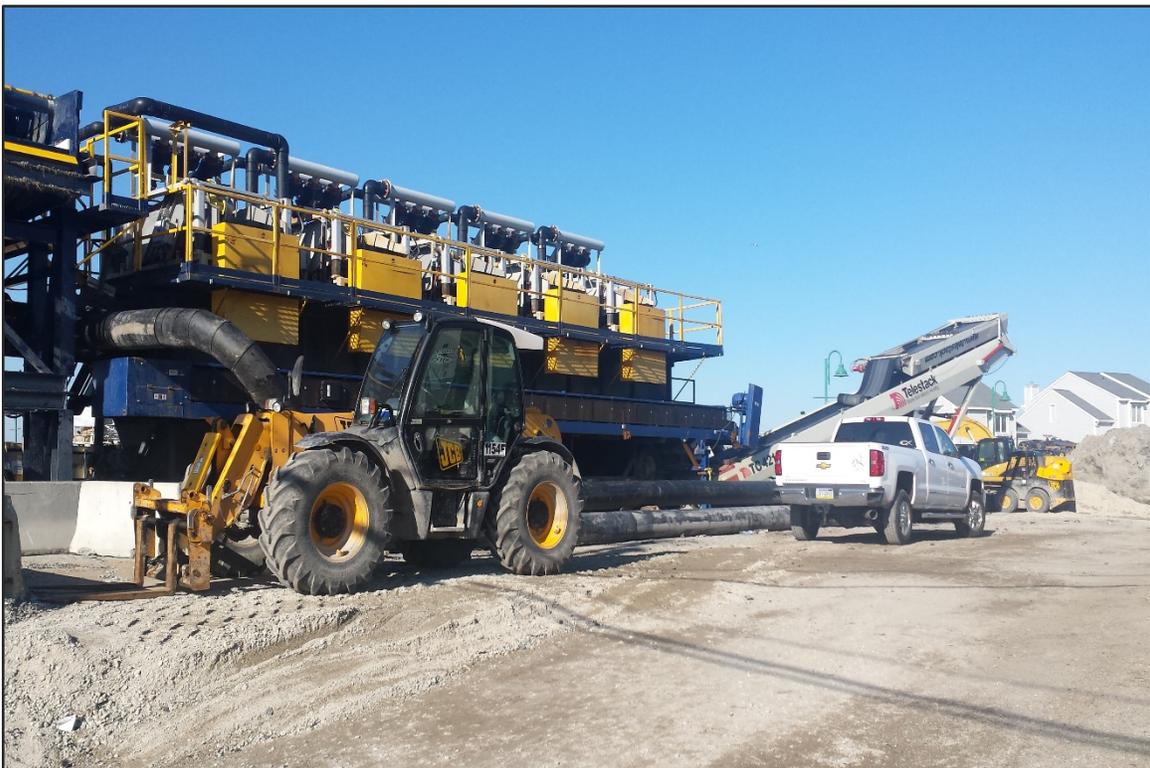
Photograph 2: De-watering Area – De-sanding plant on standby (Looking northwest)

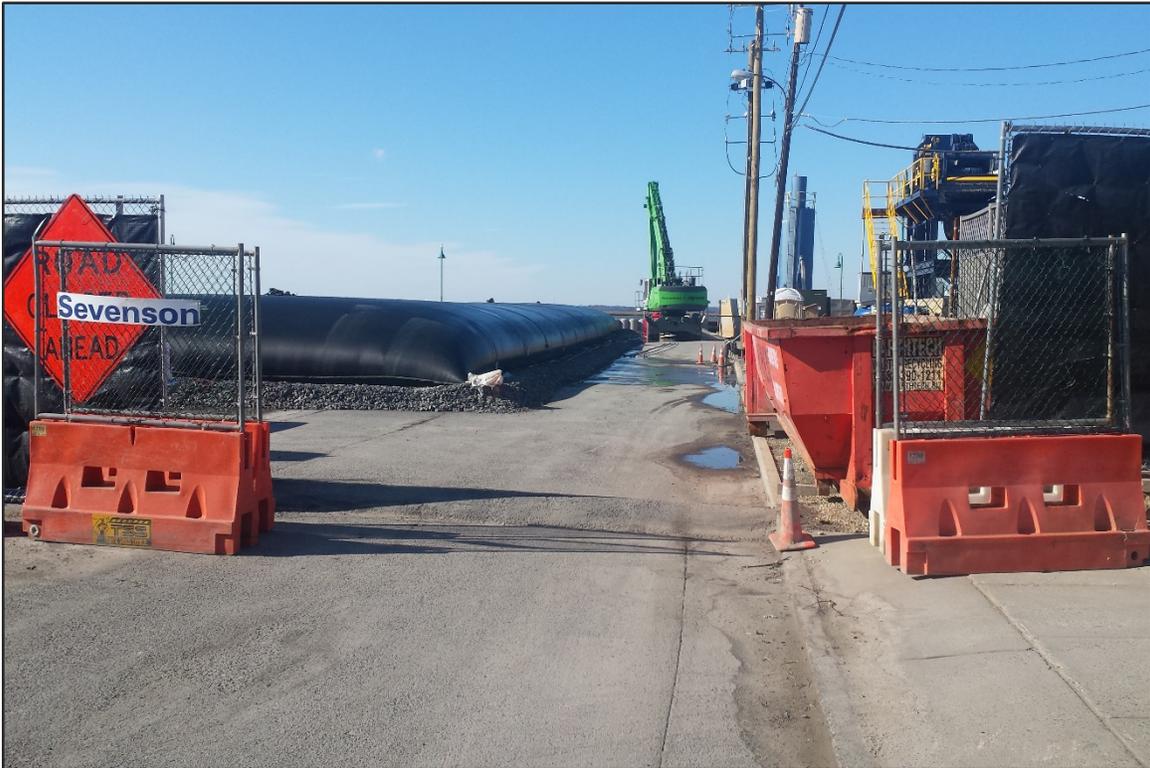
Photograph 3: De-watering area – Site entrance (Looking west)

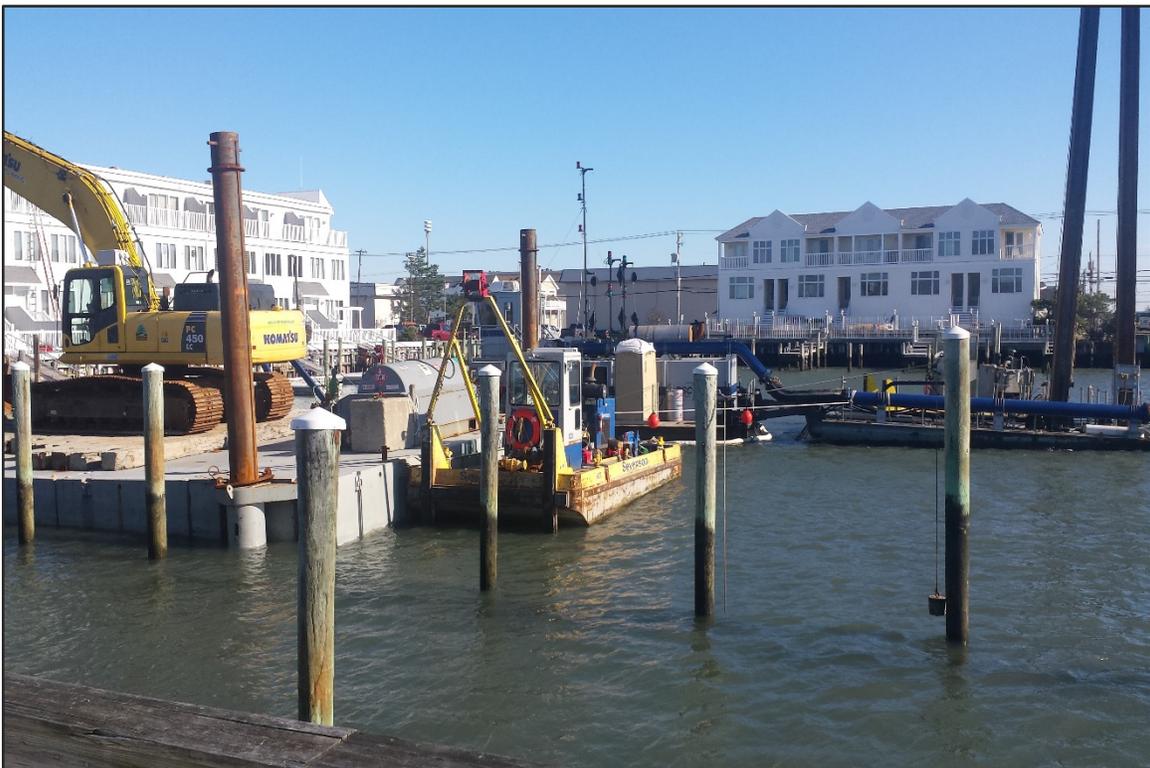
Photograph 4: North Basin - Hydraulic and mechanical dredge on standby (Looking east)

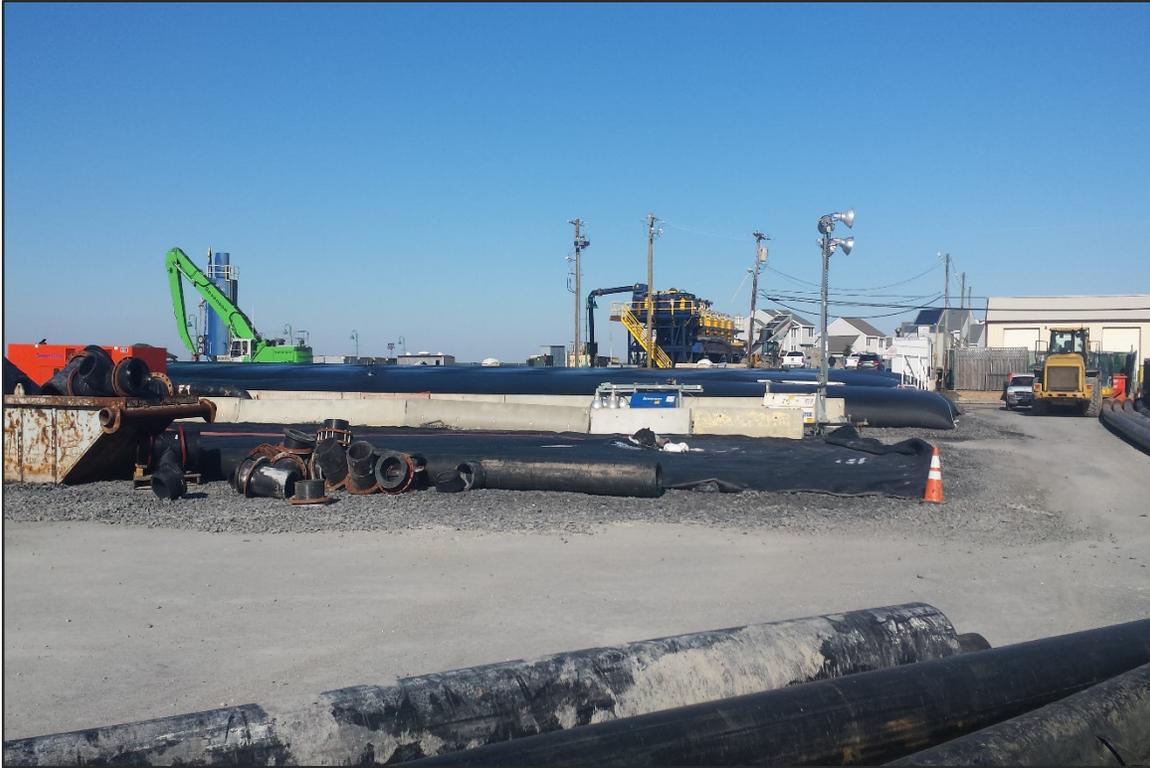
Photograph 5: De-watering area – Geotubes (x3) (Looking north)

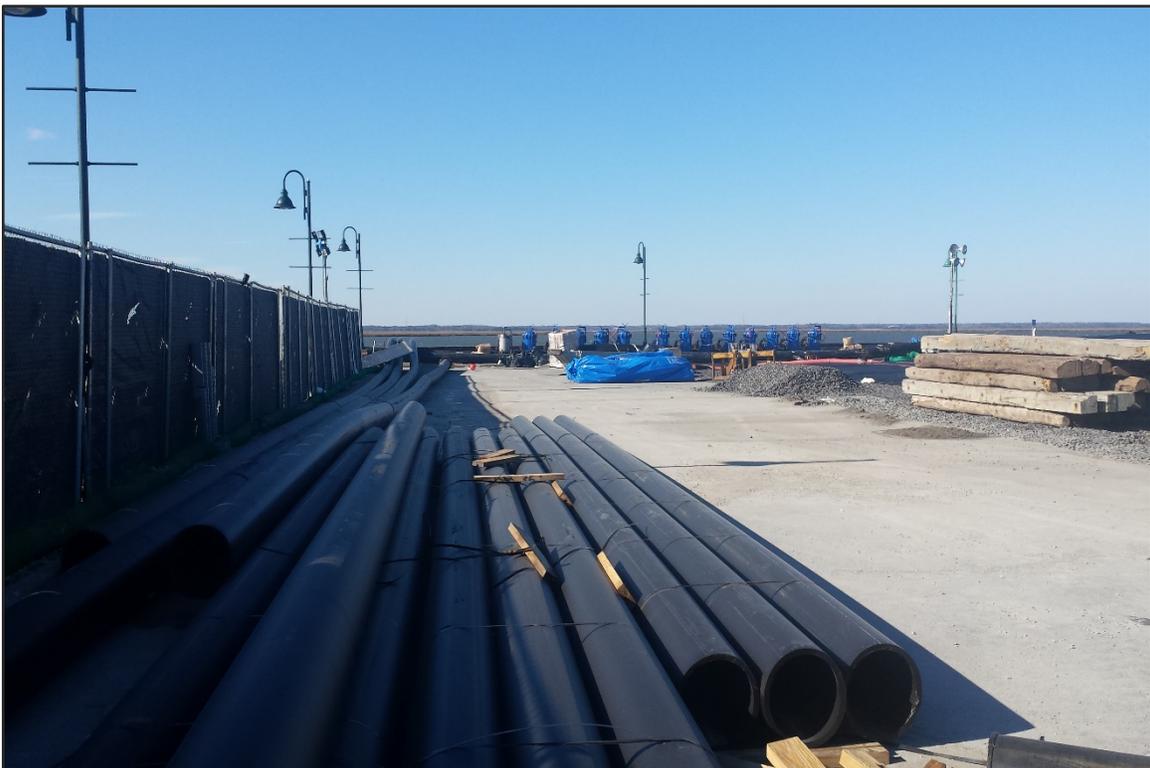
Photograph 6: De-watering area – Equipment on standby (Looking west)

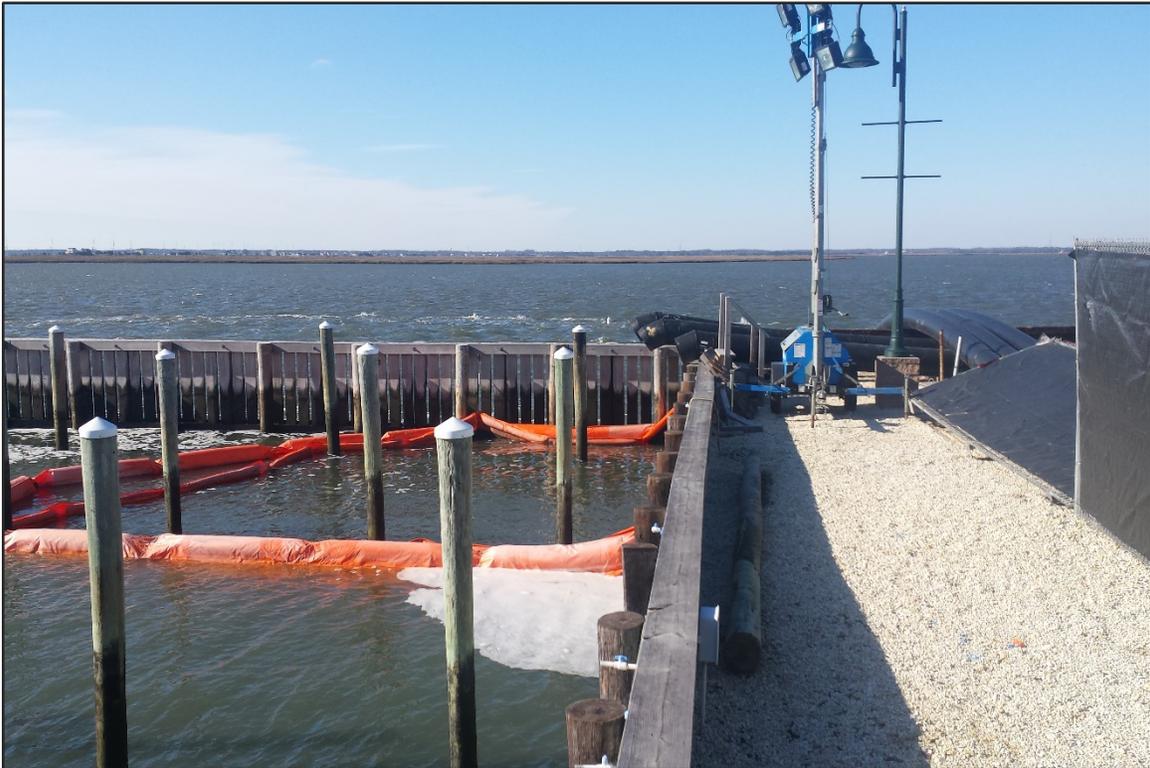
Photograph 7: De-watering area/North Basin – Discharge pipes (Looking west)

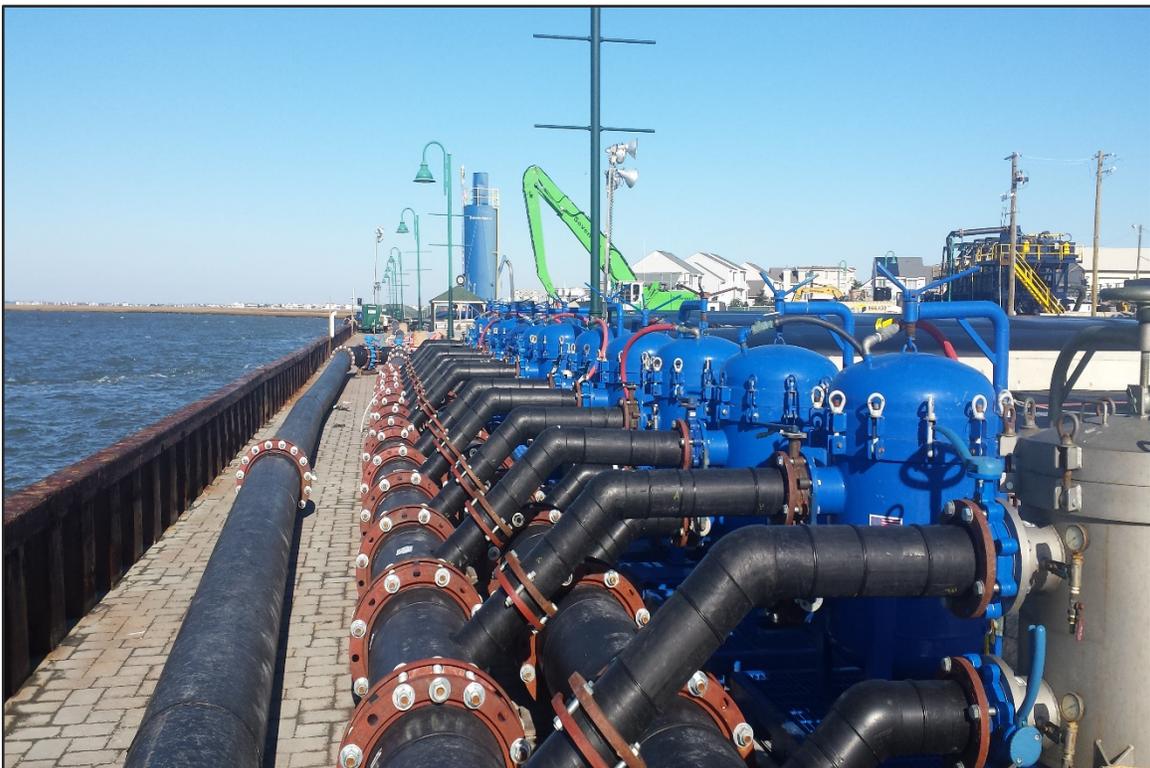
Photograph 8: De-watering area – Filtration system on standby (Looking north)

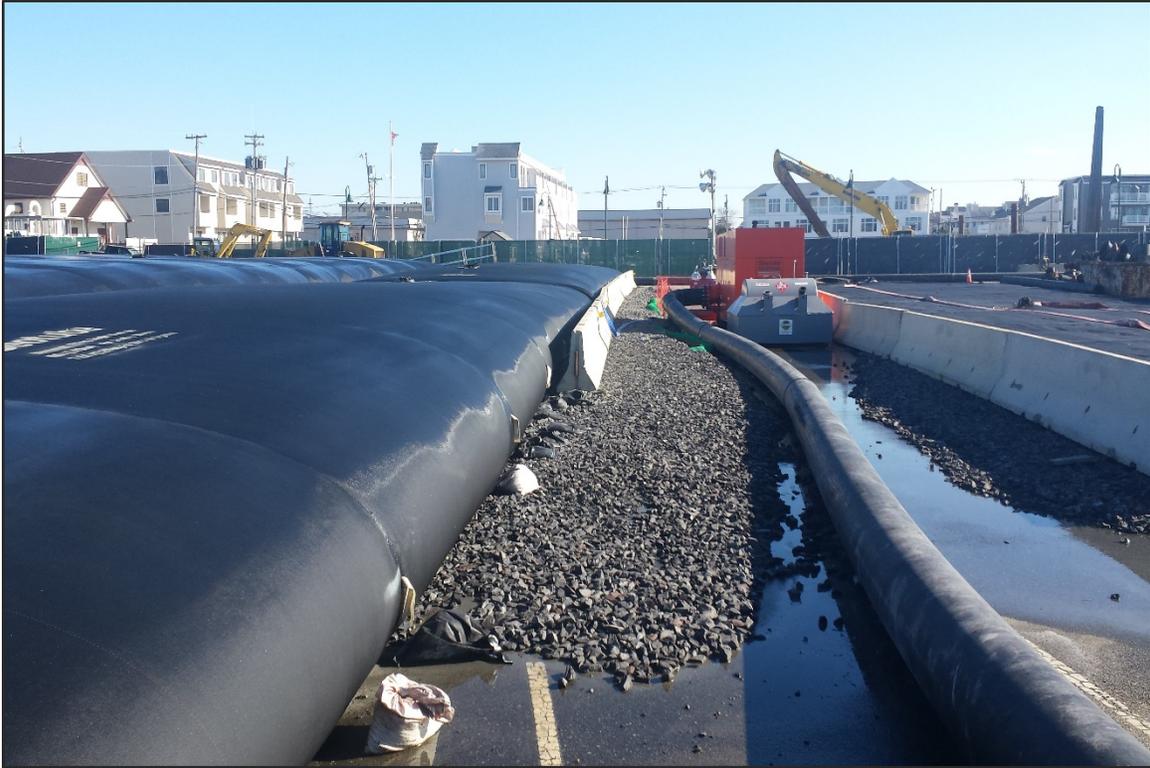
Photograph 9: De-watering area – Geotube and sump pump on standby (Looking east)

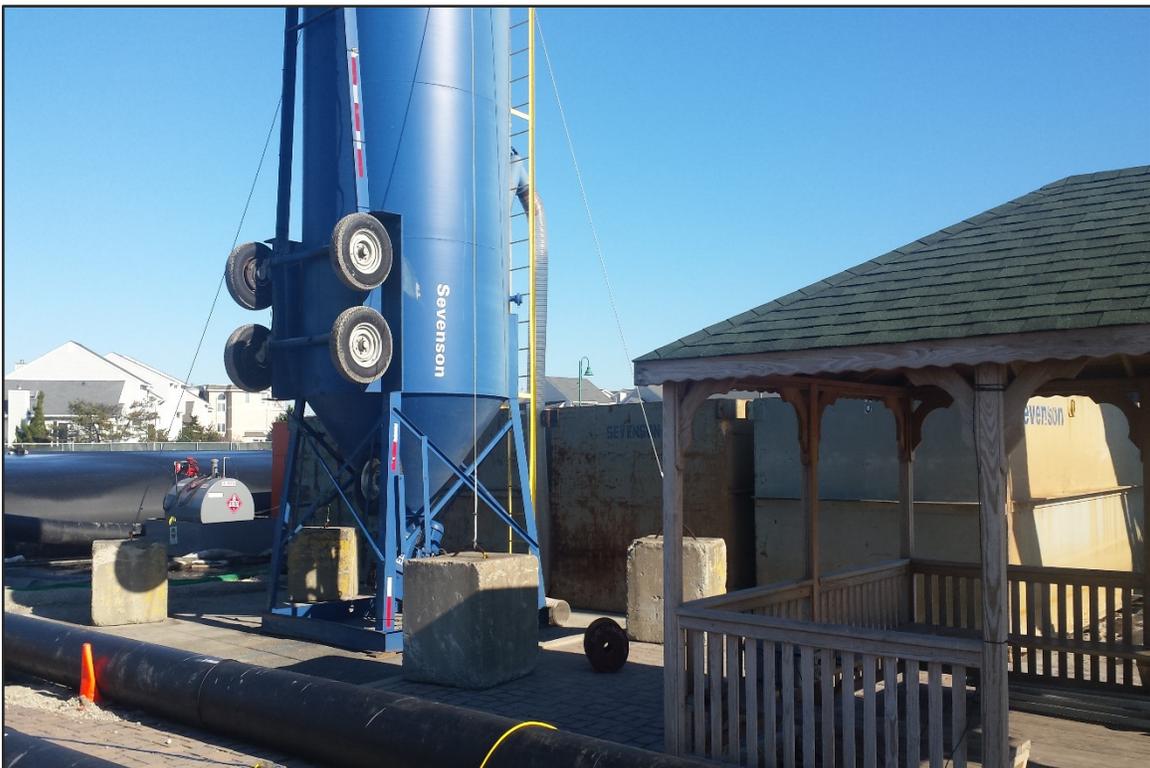
Photograph 10: De-watering area – Cement silo on standby (Looking northeast)

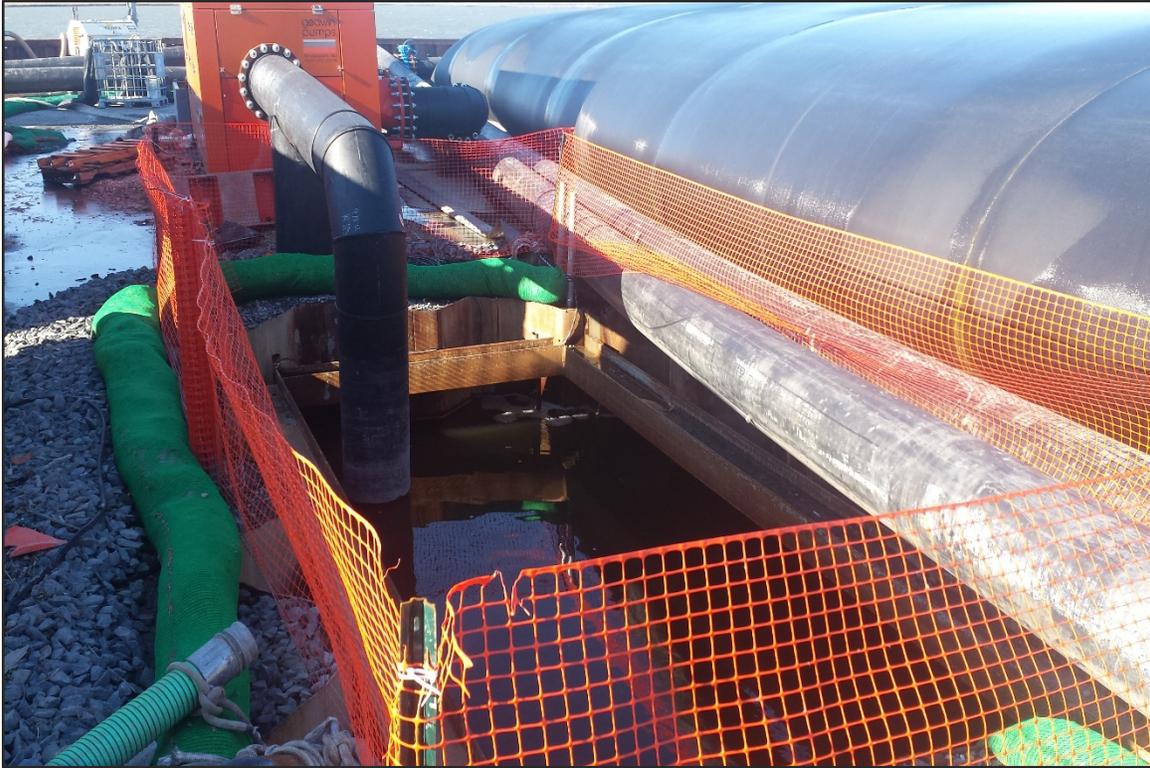
Photograph 11: De-watering area – Sump pump on standby (Looking northwest)

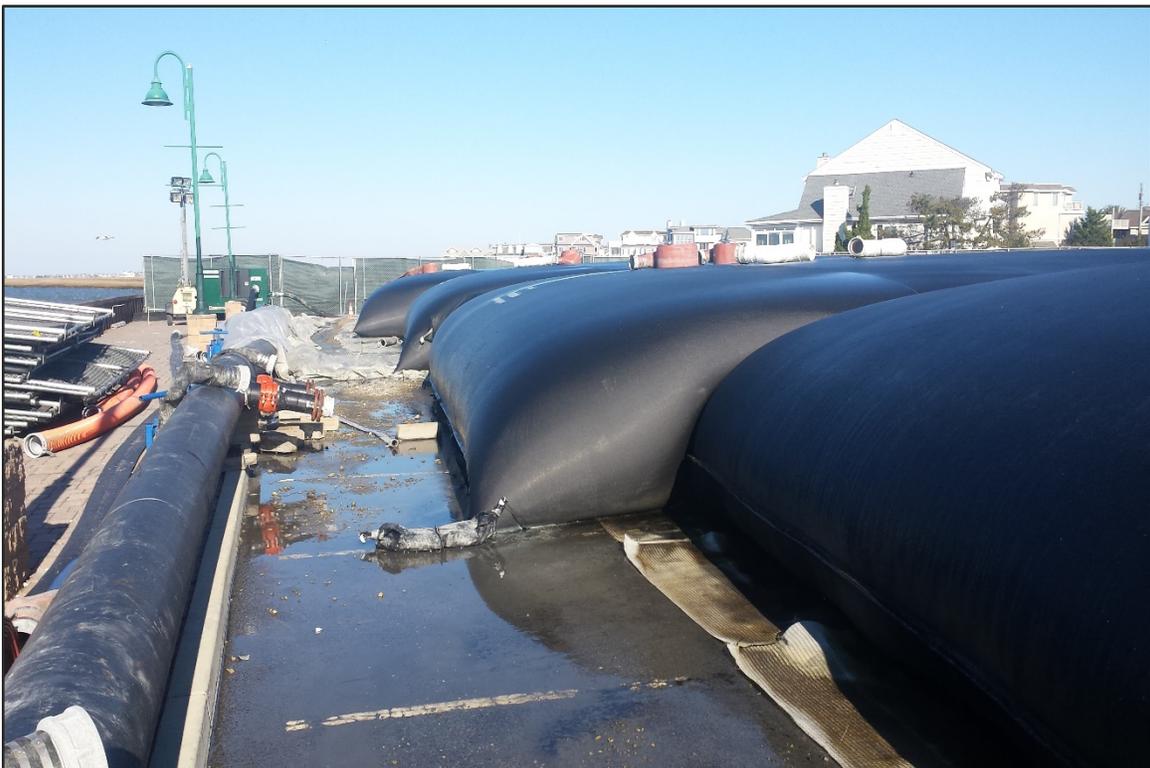
Photograph 12: De-watering area – Geotubes (X4) (Looking north)
