FIELD REPORT

Stone Harbor Maintenance Dredging

1 February 1, 2016

PROJECT NO A06772 PAGE 1/9

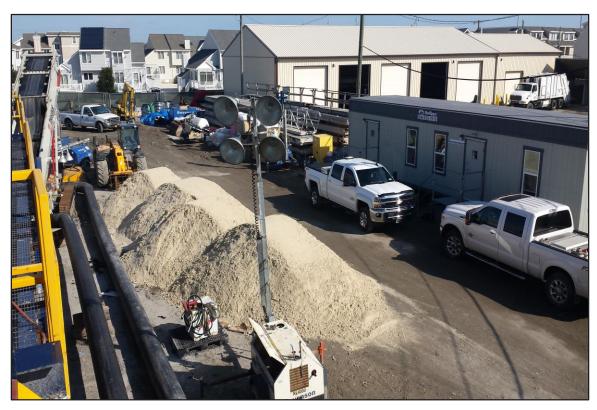
Photograph 1: De-watering area – Elevated parking area, equipment on standby. (Looking north)

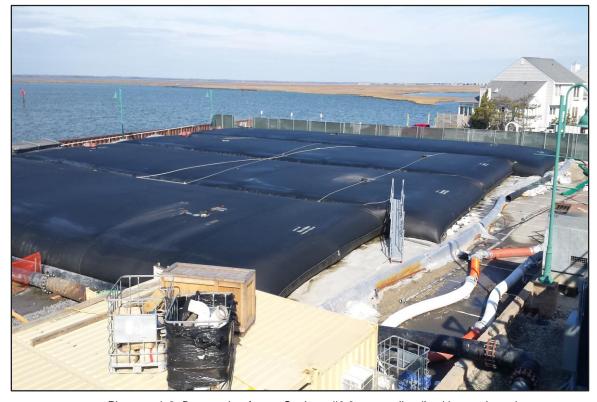
Photograph 2: De-watering Area – Geobags #6-9 on standby. (Looking northwest)

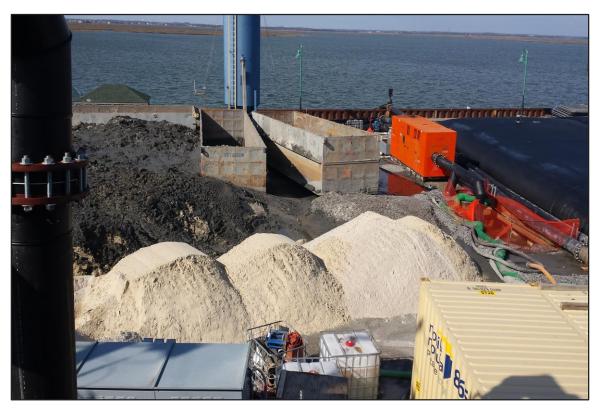
Photograph 3: De-watering Area – Sand for blending, mixing boxes, sump pump on standby. (Looking west)

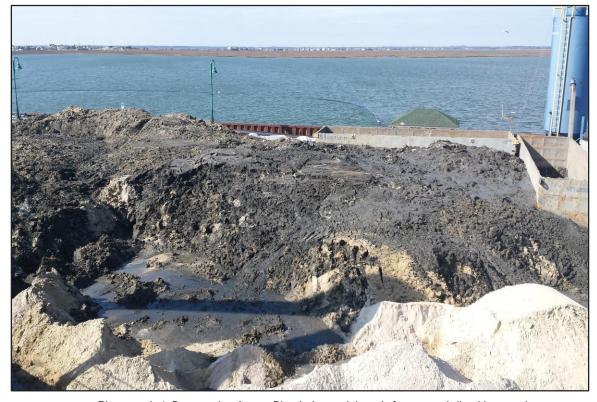
Photograph 4: De-watering Area – Blended material ready for removal. (Looking west)

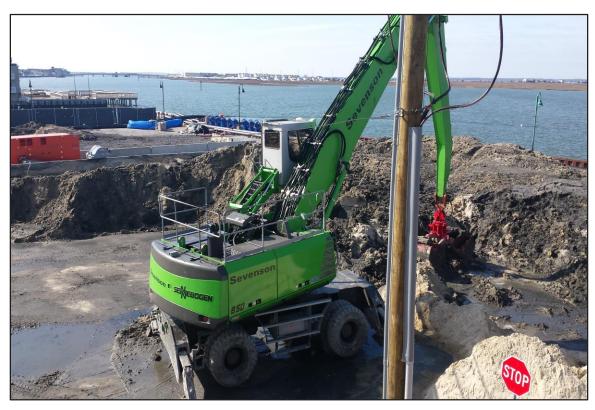
Photograph 5: De-watering Area – Sand blending and removal operations. (Looking southwest)

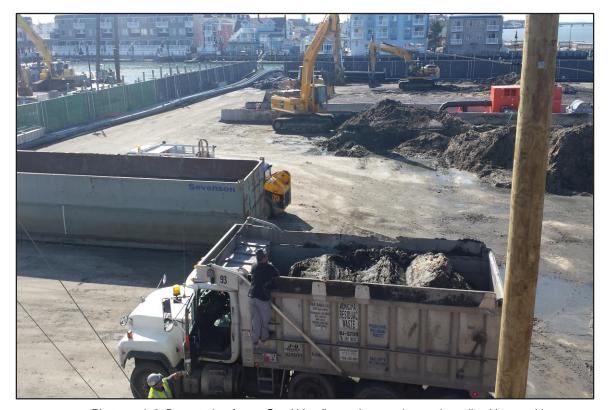
Photograph 6: De-watering Area – Sand blending and removal operations. (Looking south)

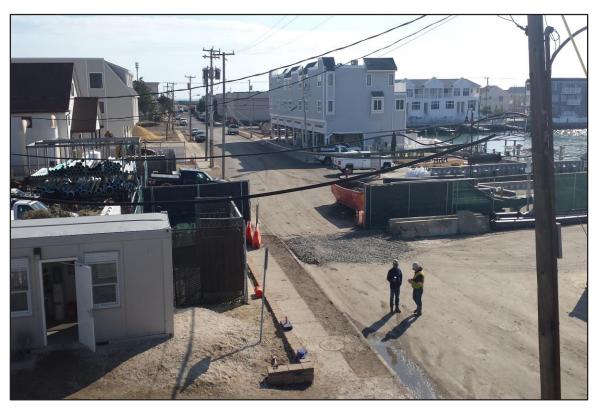
Photograph 7: Site Entrance. (Looking east)

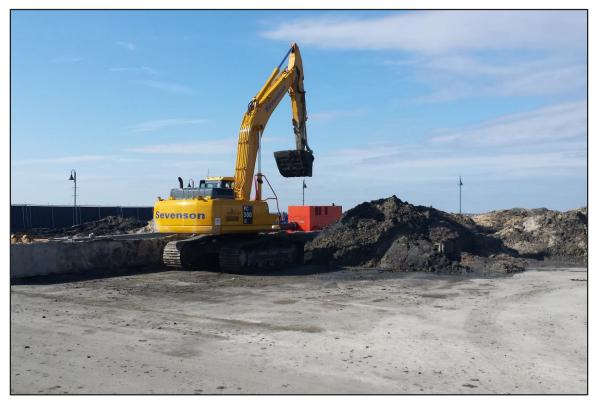
Photograph 8: De-watering Area – Sand blending operations. (Looking southwest)

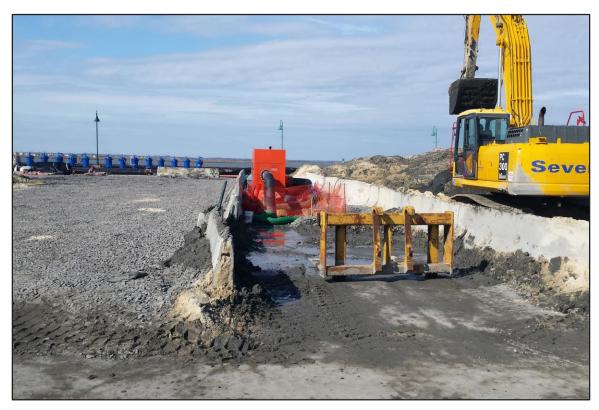
Photograph 9: De-watering Area – Sump pump on standby. (Looking west)

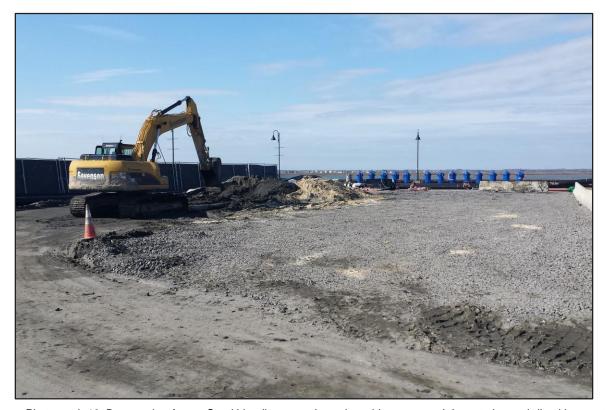
Photograph 10: De-watering Area – Sand blending operations alongside a prepared de-watering pad. (Looking west)

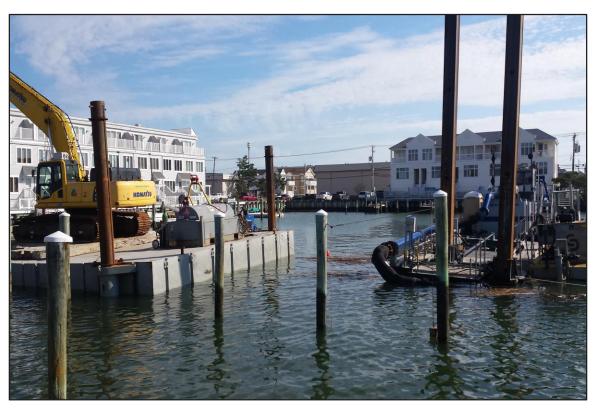
Photograph 11: North Basin - Dredges on standby. (Looking east)

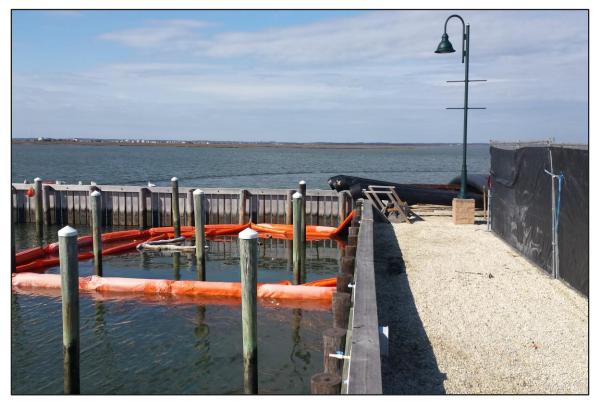
Photograph 12: De-watering Area – Discharge pipes on standby. (Looking west)

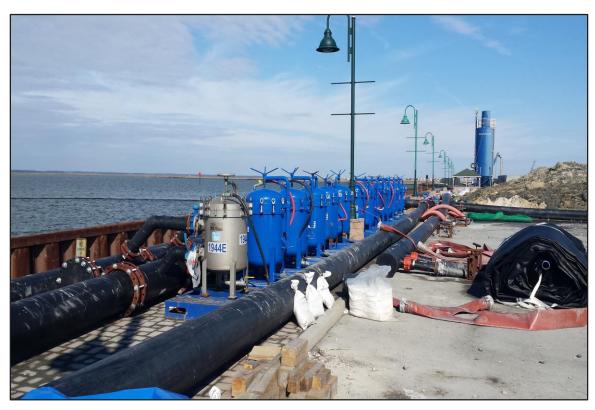
Photograph 13: De-watering Area – Filtration system on standby. (Looking north)

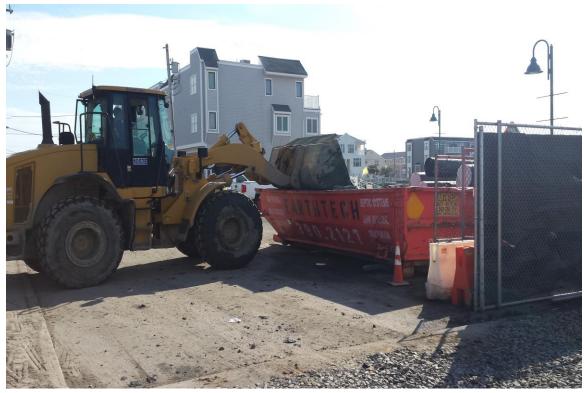
Photograph 14: Site Entrance – Material loaded into dumpster. (Looking east)
