## FIELD REPORT

TITLE Stone Harbor Maintenance Dredging  
DATE February 3, 2016  
TO Jill Gougher  
COPY MADN  
FROM BEWI  
PROJECT NO A06772

### Project Information

**Owner:** The Borough of Stone Harbor  
**Contractor:** Severson Environmental Services, Inc.

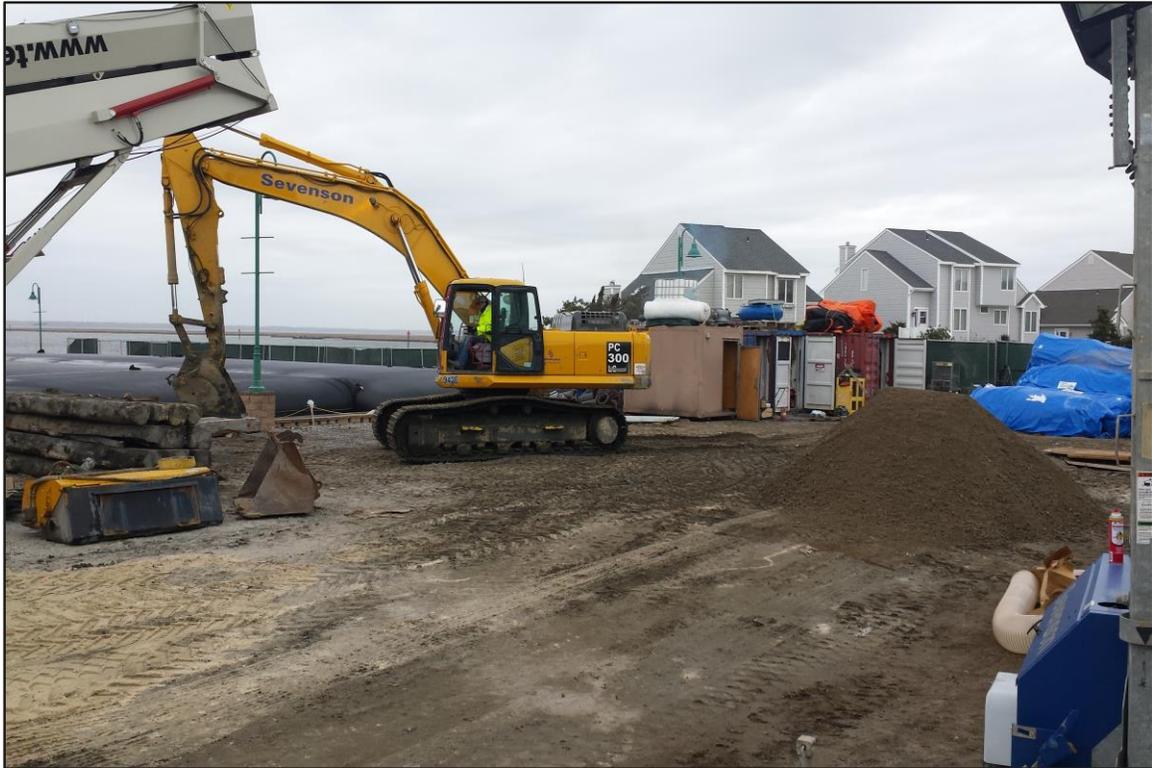
*Photograph 1: De-watering Area – Excavator preparing for sand blending. (Looking northwest)*

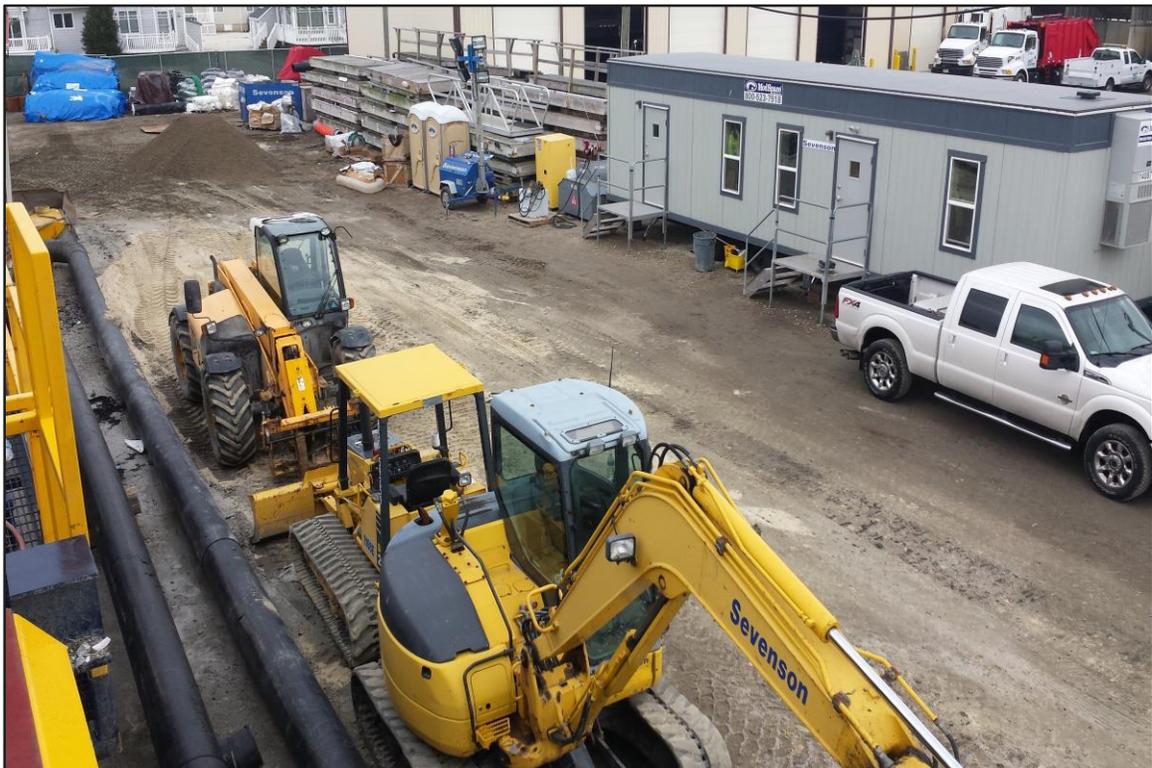
*Photograph 2: De-watering Area – Equipment on standby. (Looking northeast)*

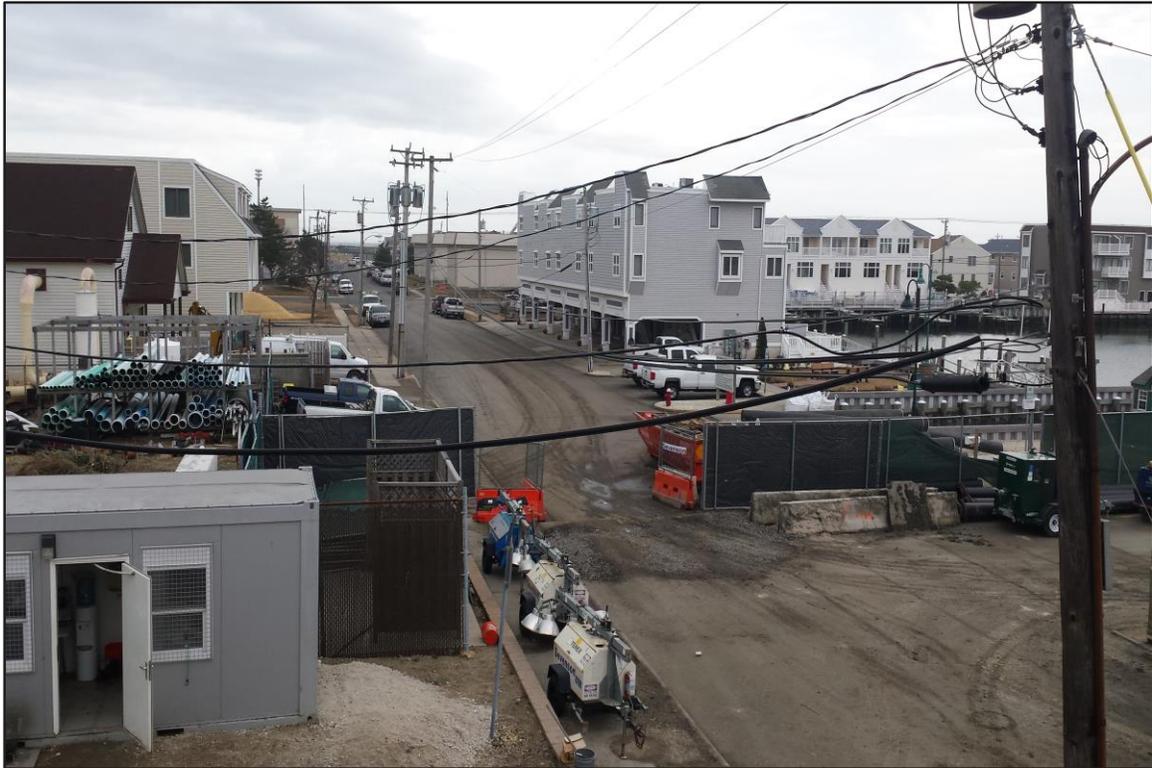
Photograph 3: Site Entrance. (Looking east)

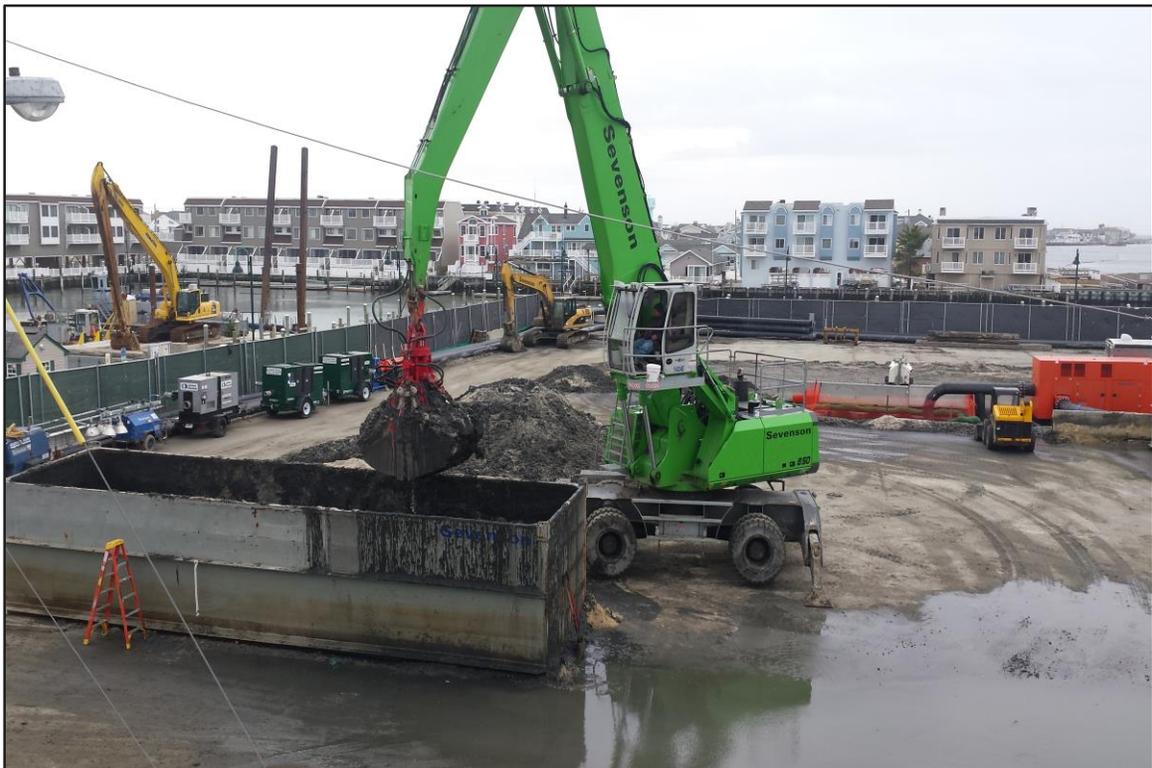
Photograph 4: De-watering Area – Sand blending operations. (Looking south)

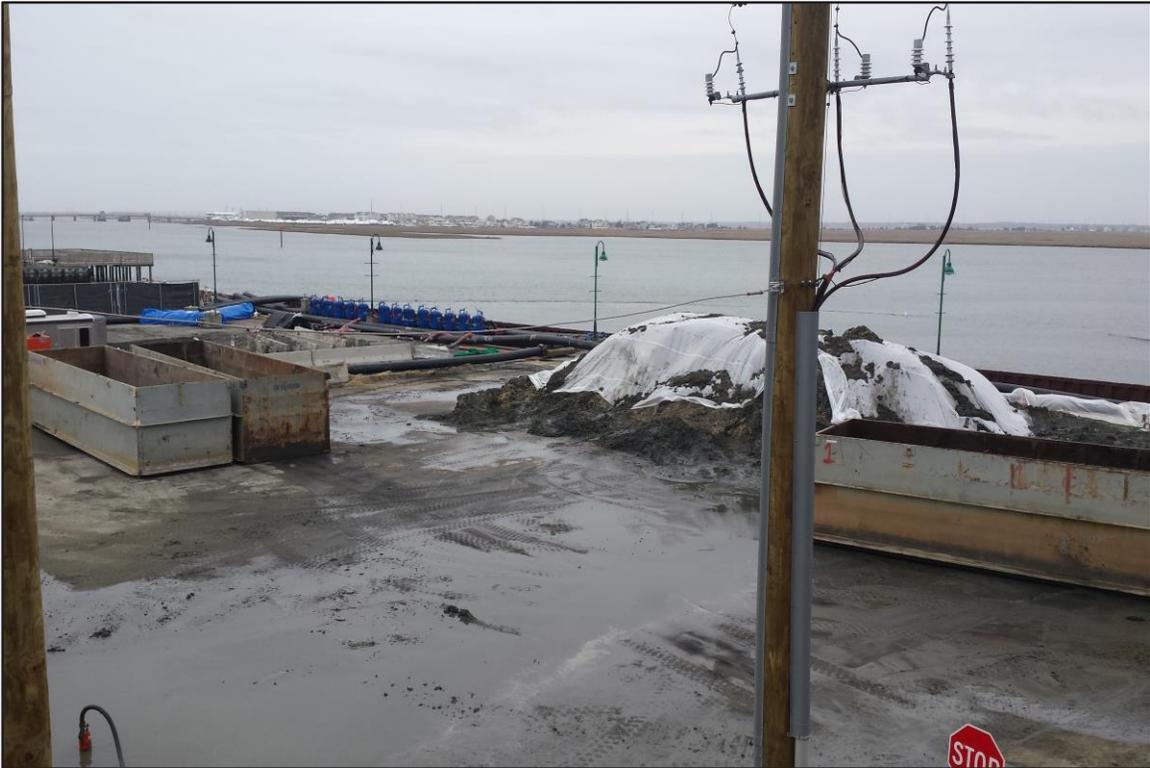
*Photograph 5: De-watering Area – Mixing boxes undergo cleaning, blended material on standby. (Looking southwest)*

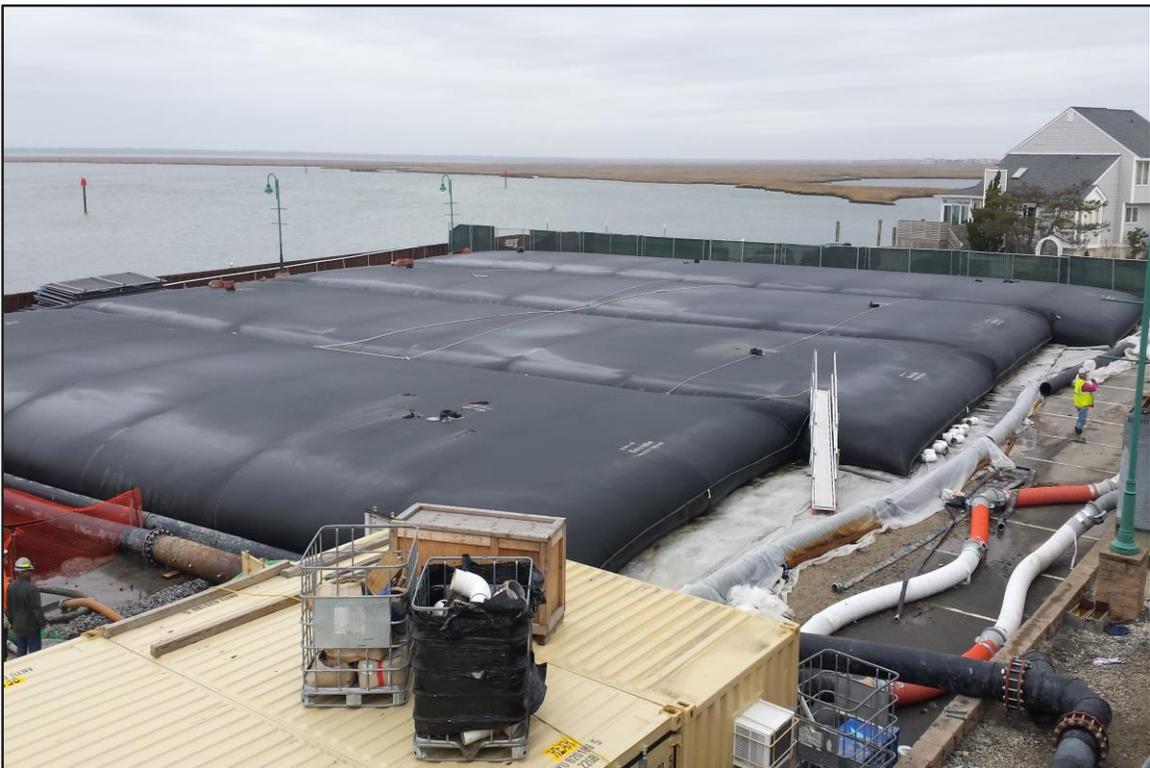
*Photograph 6: De-watering Area – Goebags #6-9 on standby. (Looking northwest)*

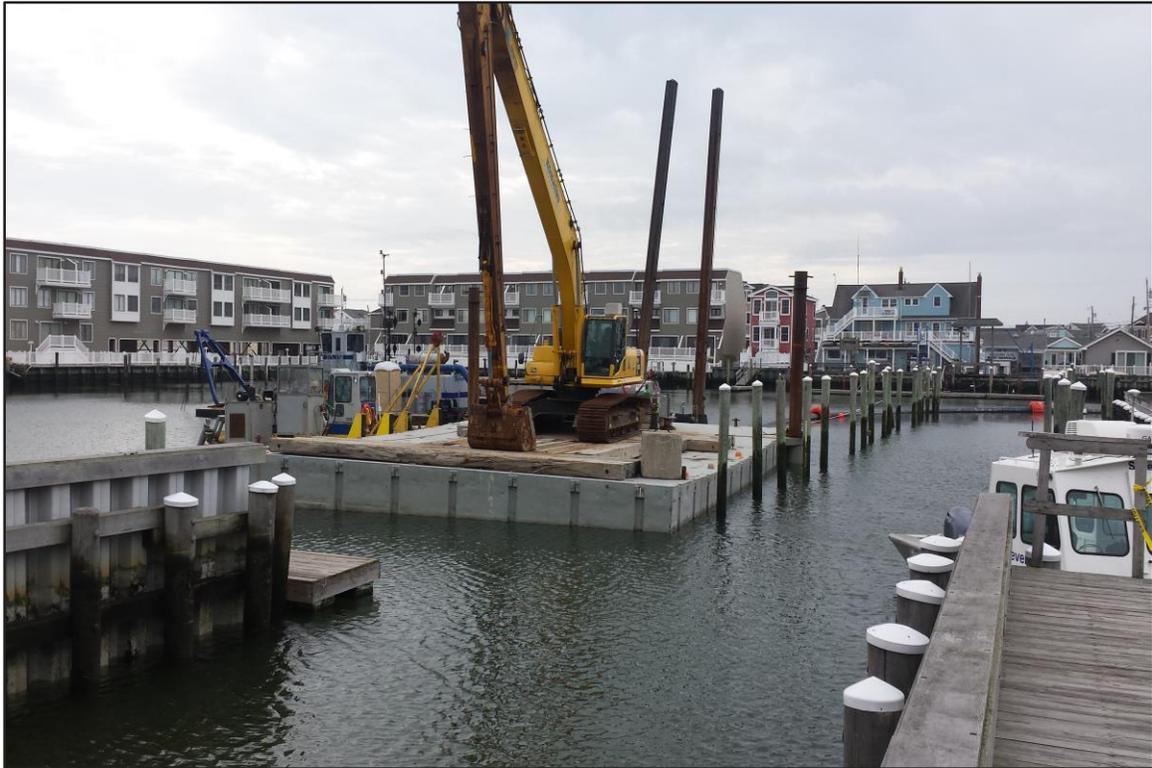
*Photograph 7: North Basin – Dredges and boats on standby. (Looking southeast)*

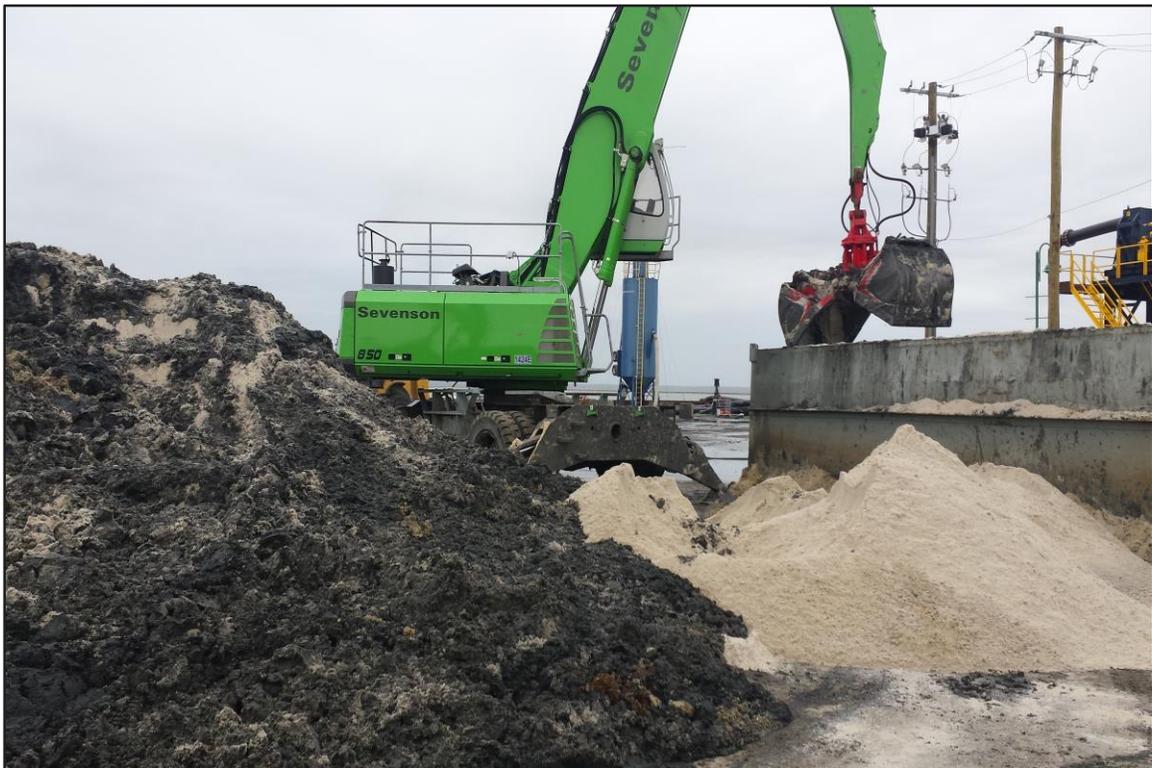
*Photograph 8: De-watering Area – Sand blending operations. (Looking west)*

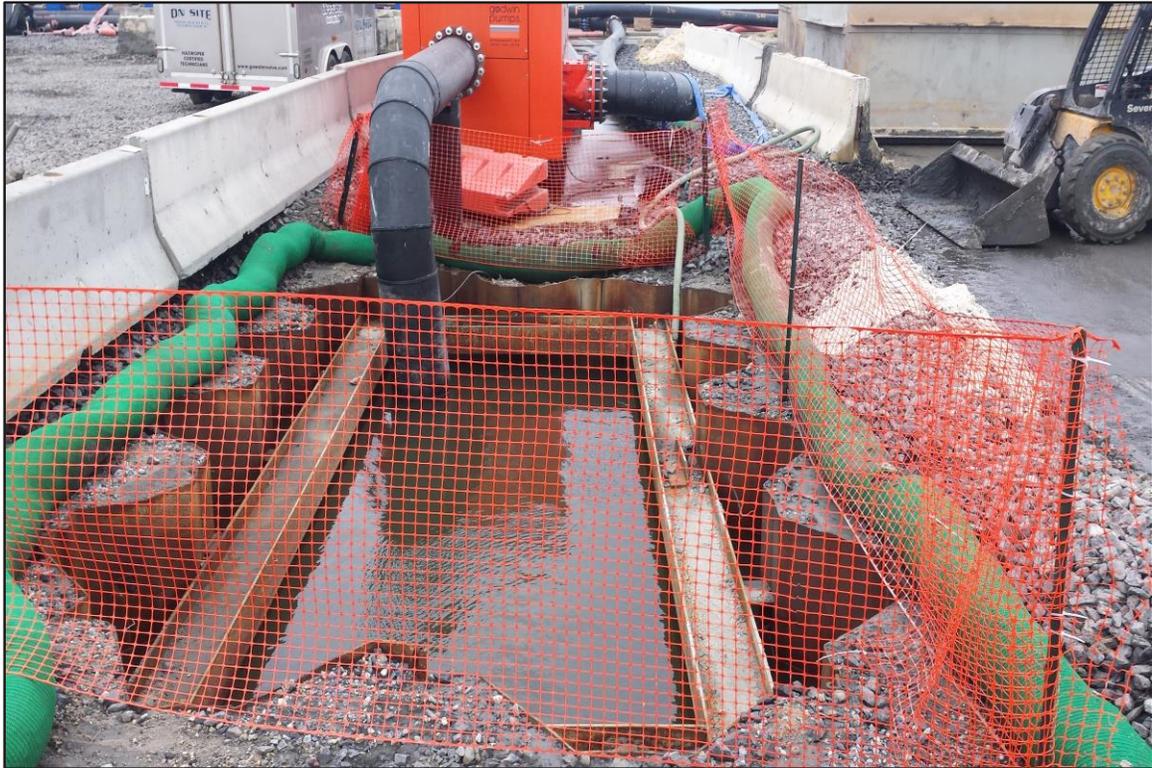
*Photograph 9: De-watering Area – Sump pump on standby. (Looking west)*

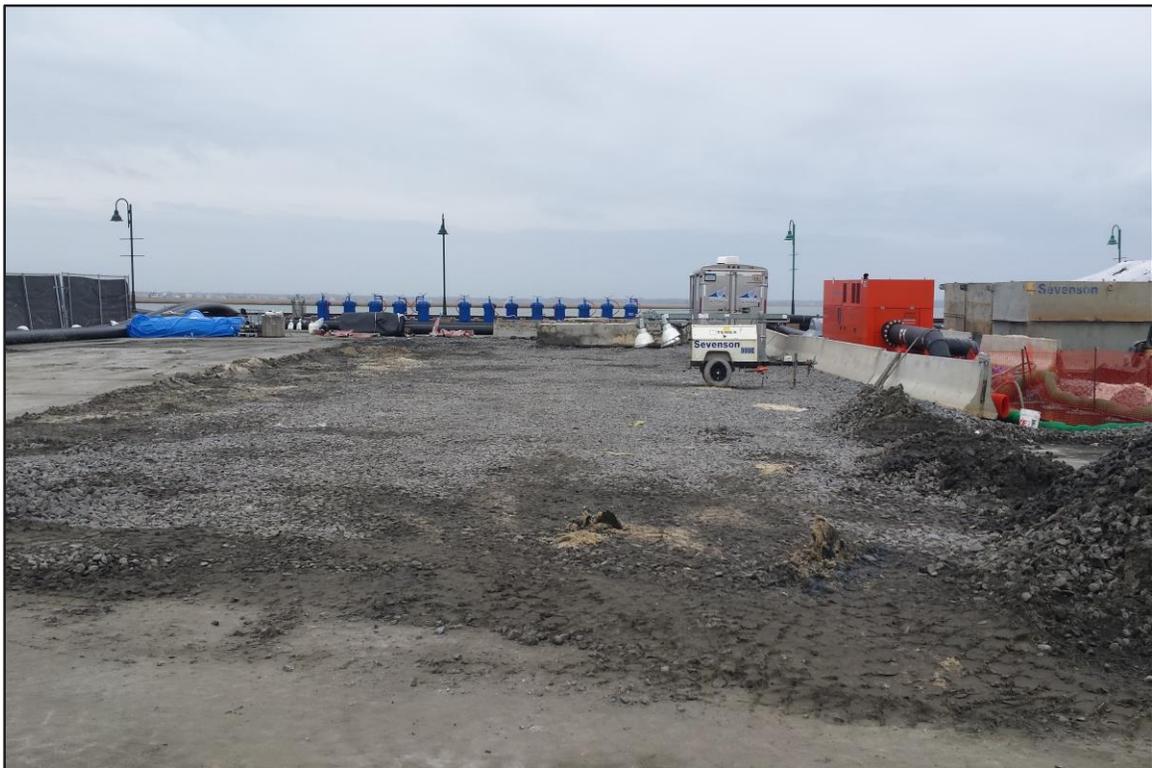
*Photograph 10: De-watering Area – Prepared pad for new geobag. (Looking west)*

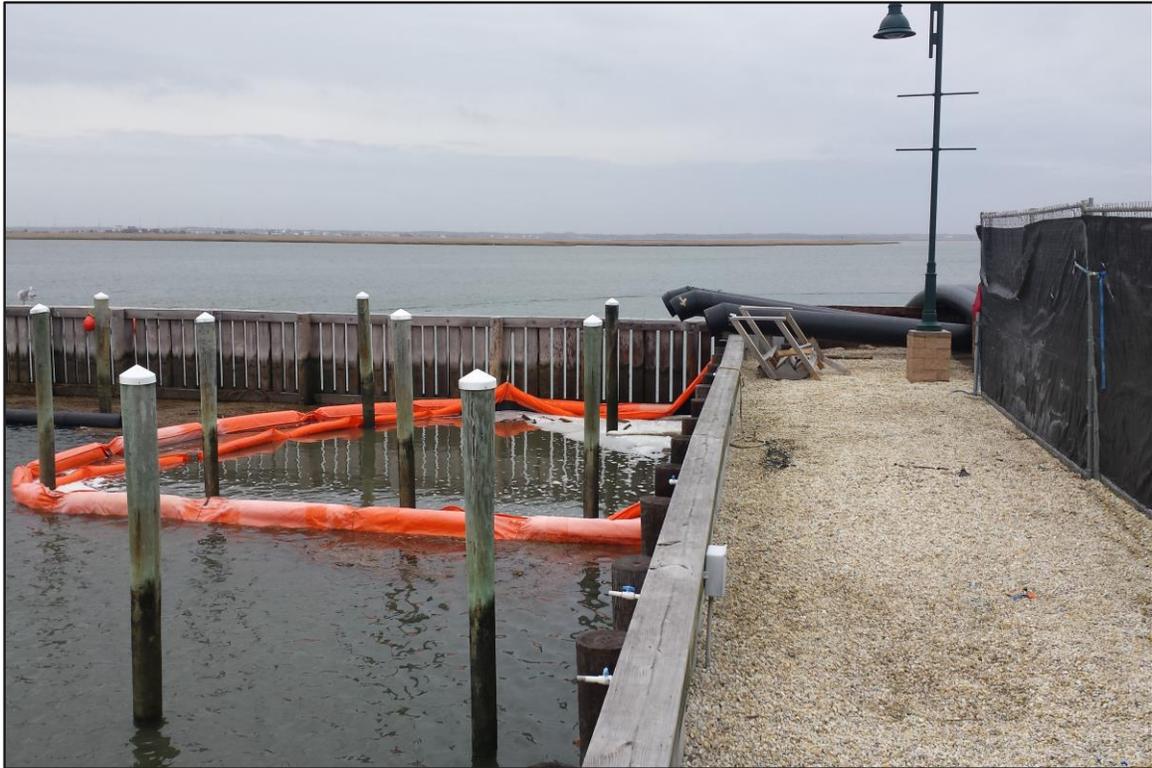
*Photograph 11: De-watering Area/North Basin – Discharge pipes on standby. (Looking west)*

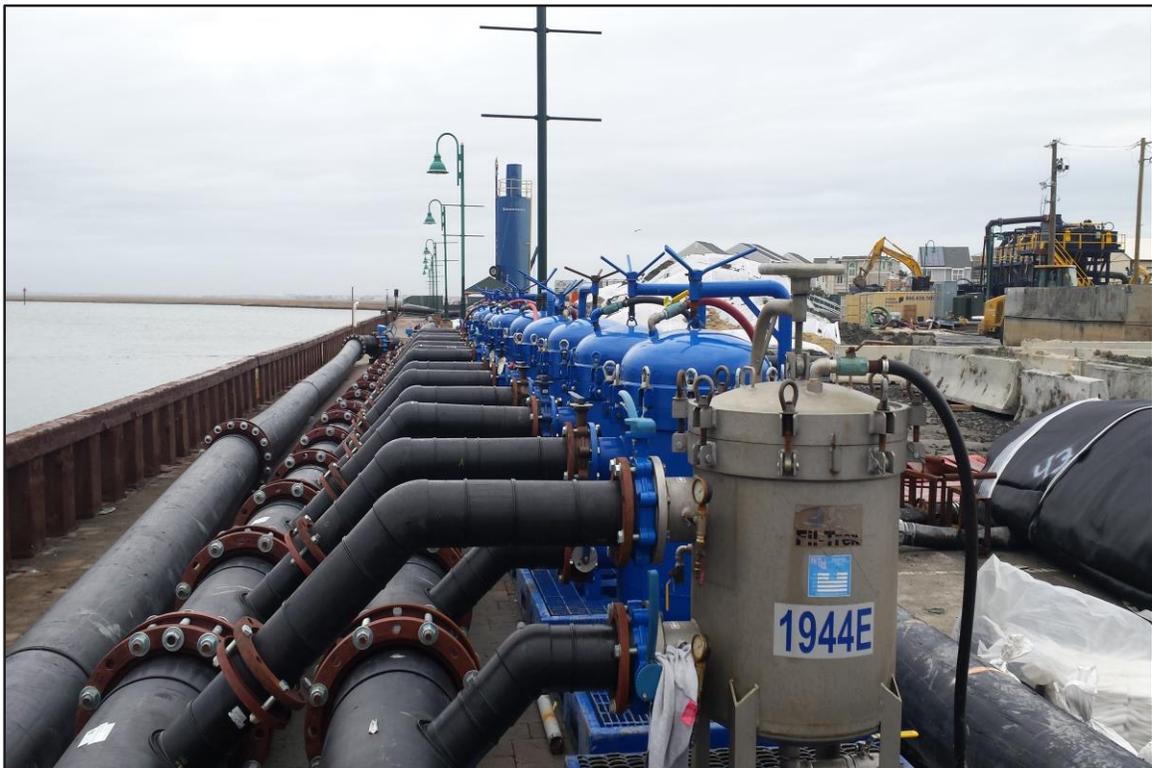
*Photograph 12: De-watering Area – Filtration system on standby. (Looking north)*

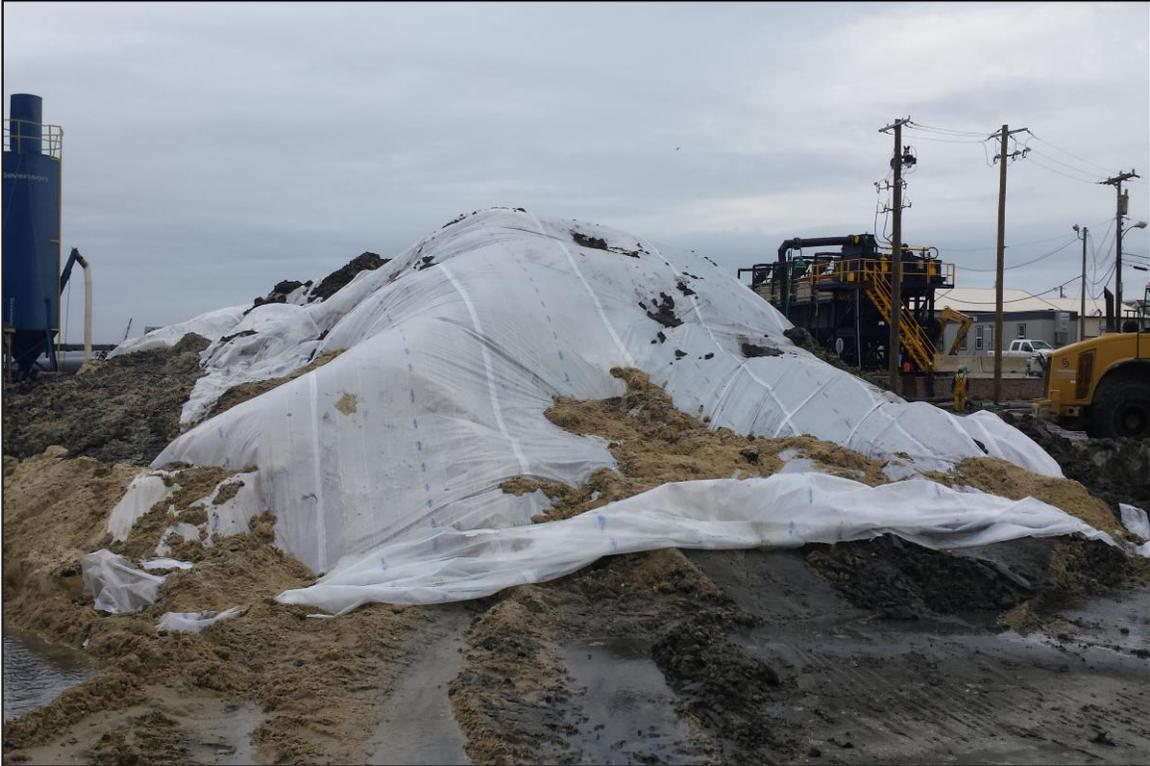
*Photograph 13: De-watering Area – Blended material covered in anticipation of rain. (Looking north)*

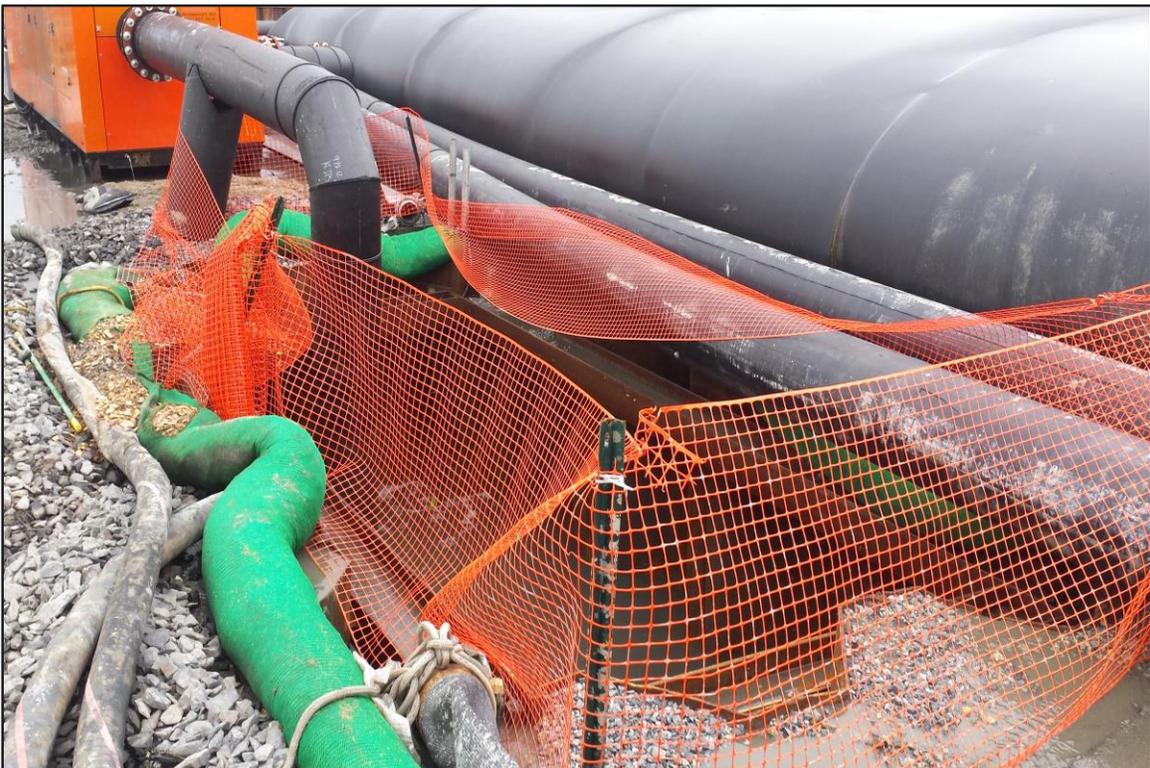
*Photograph 14: De-watering Area – Sump pump on standby. (Looking northwest)*
