FIELD REPORT

TITLE Stone Harbor Maintenance Dredging
DATE February 5, 2016
TO Jill Gougher
COPY MADN
FROM BEWI
PROJECT NO A06772

Project Information

Purpose of Visit: Observation of work in progress

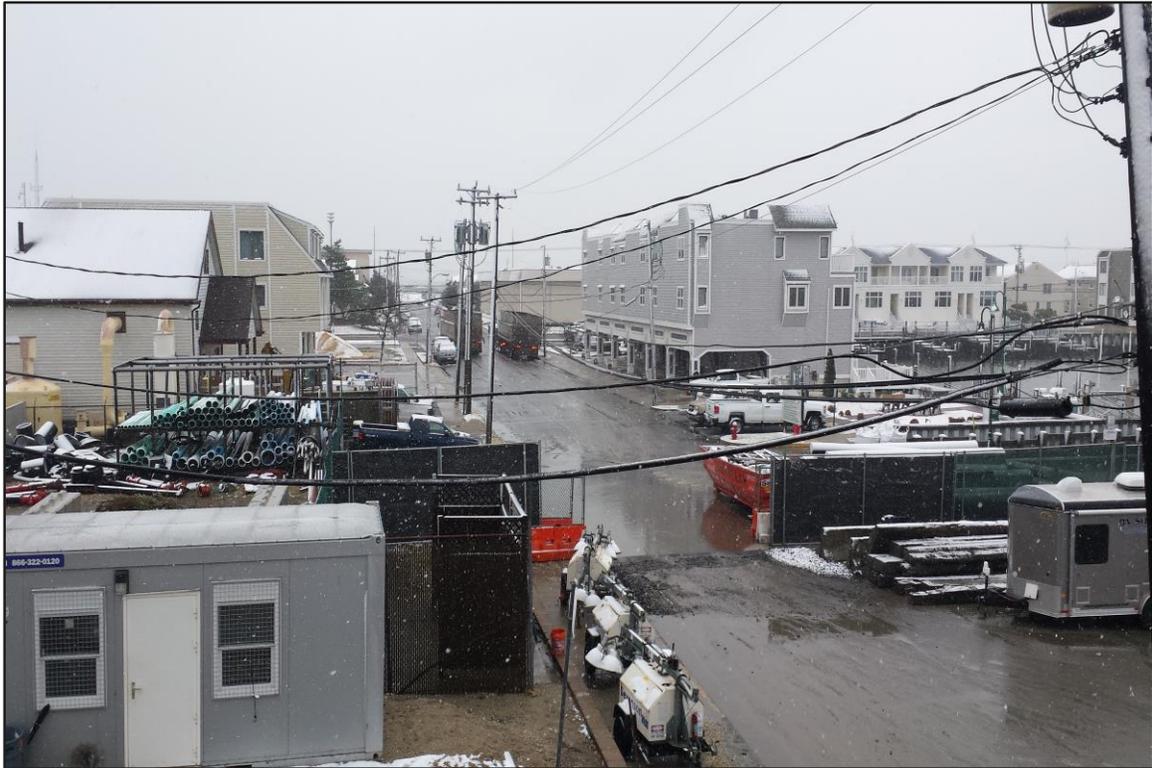
Photograph 1: Site Entrance. (Looking east)

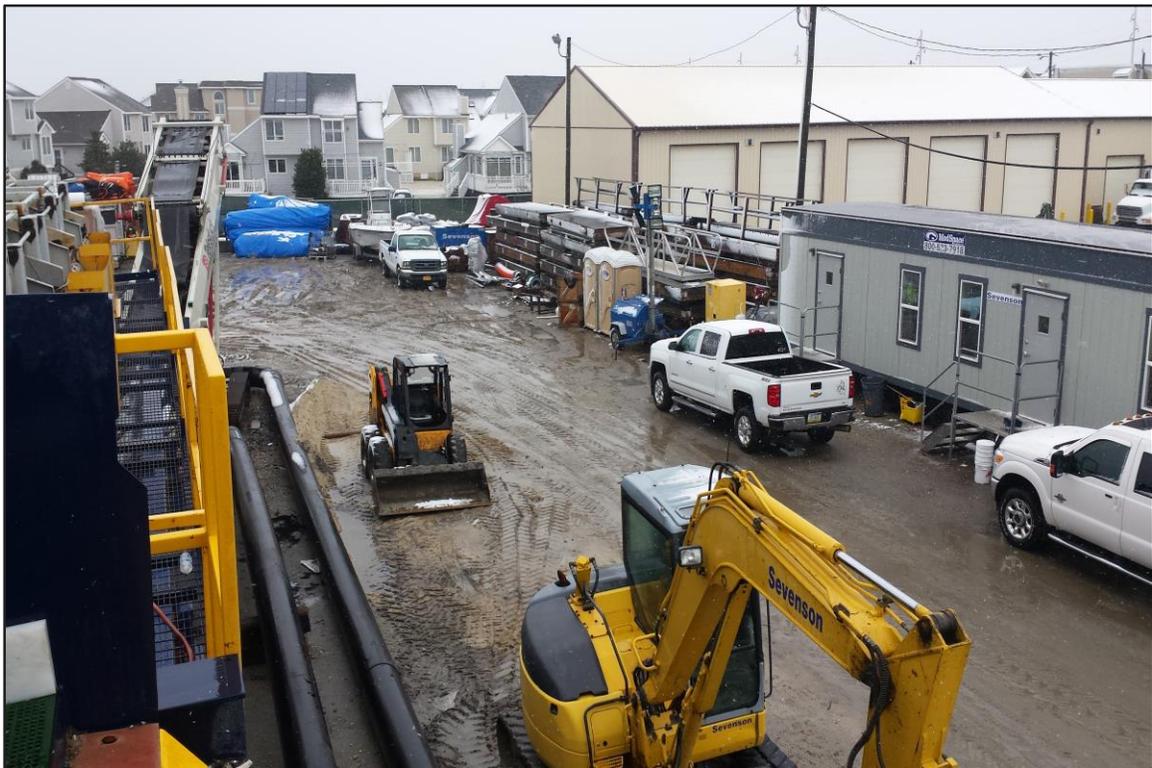
Photograph 2: De-watering Area – Equipment on standby. (Looking northeast)

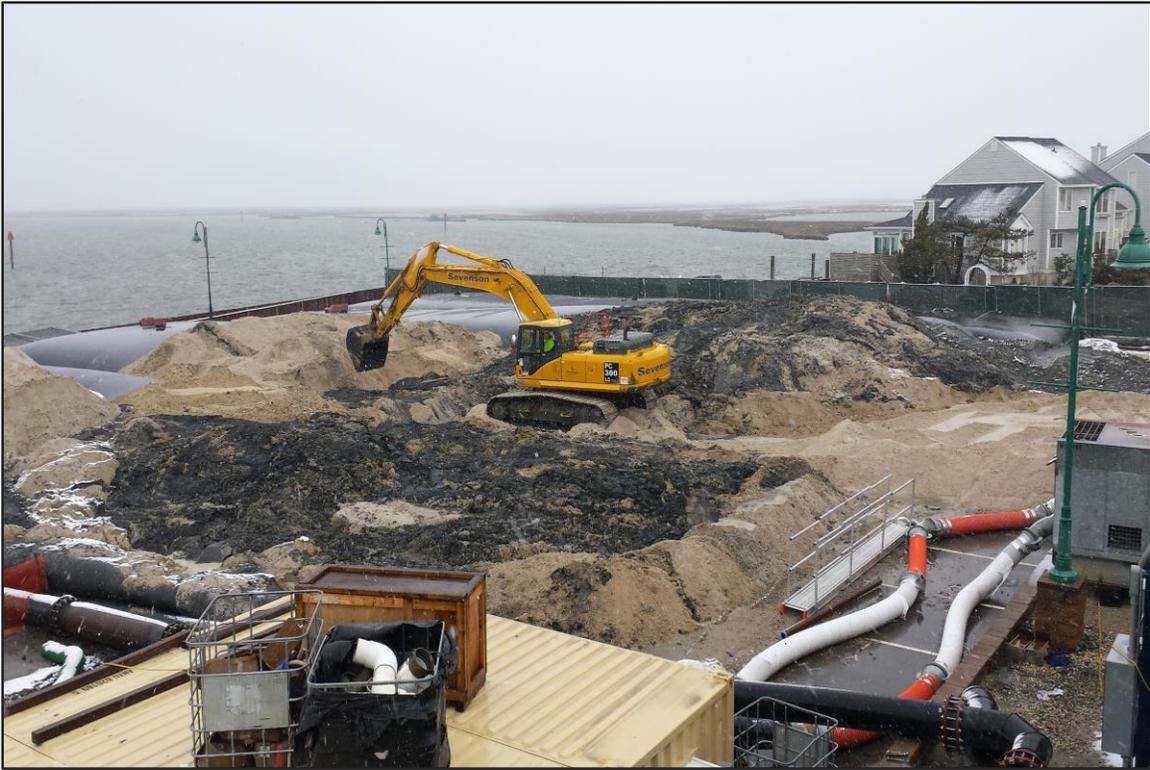
Photograph 3: De-watering Area – Sand blending geobags #6-9. (Looking northwest)

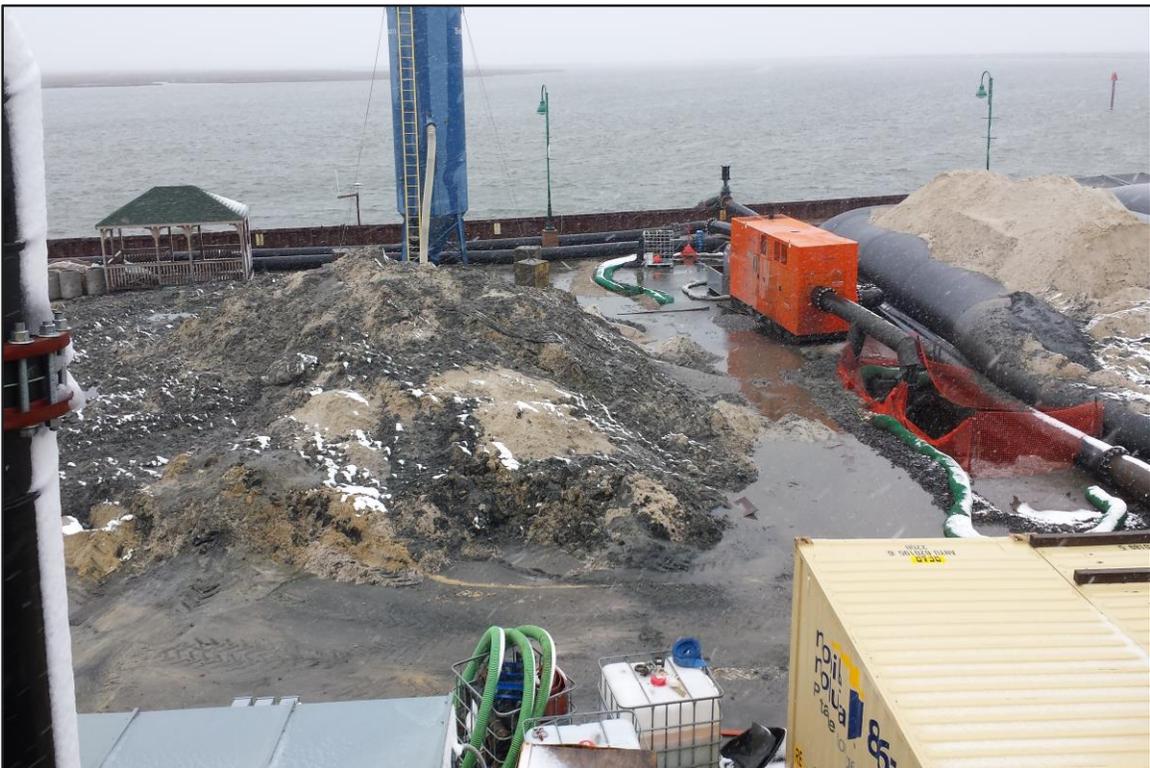
Photograph 4: De-watering Area – Blended material staged for removal. (Looking west)

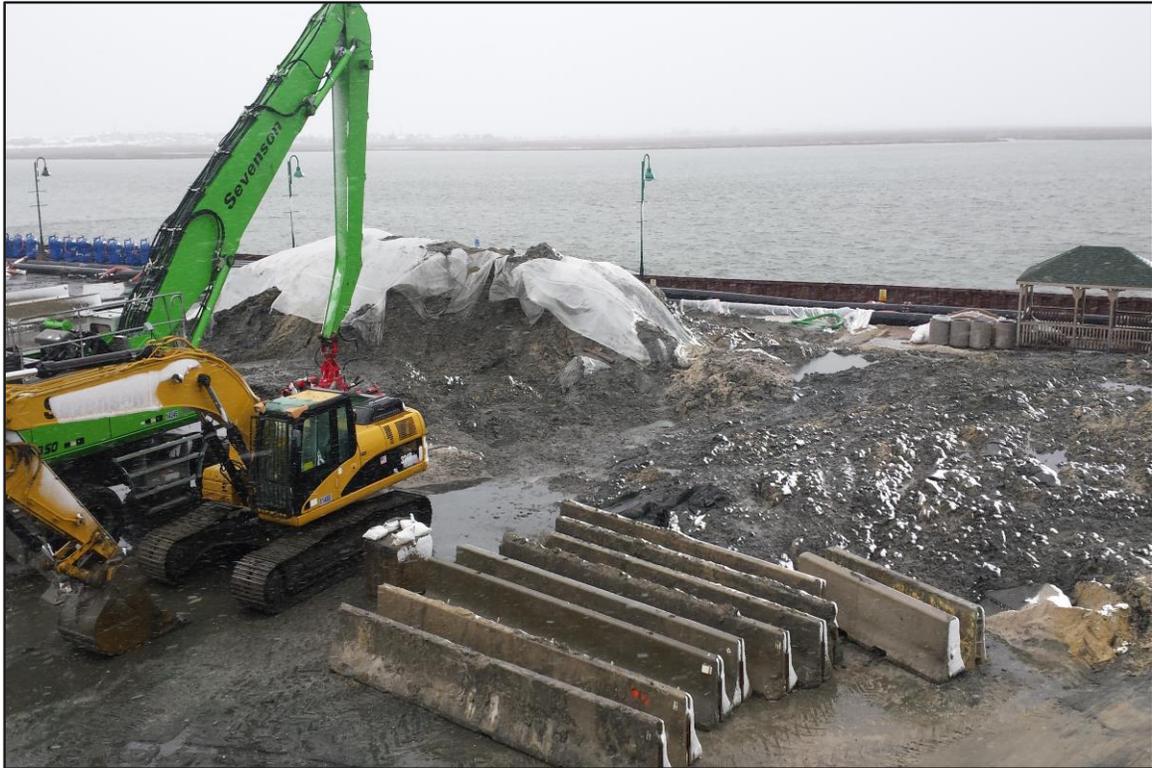
Photograph 5: De-watering Area – Blended material staged for removal, equipment on standby. (Looking west)

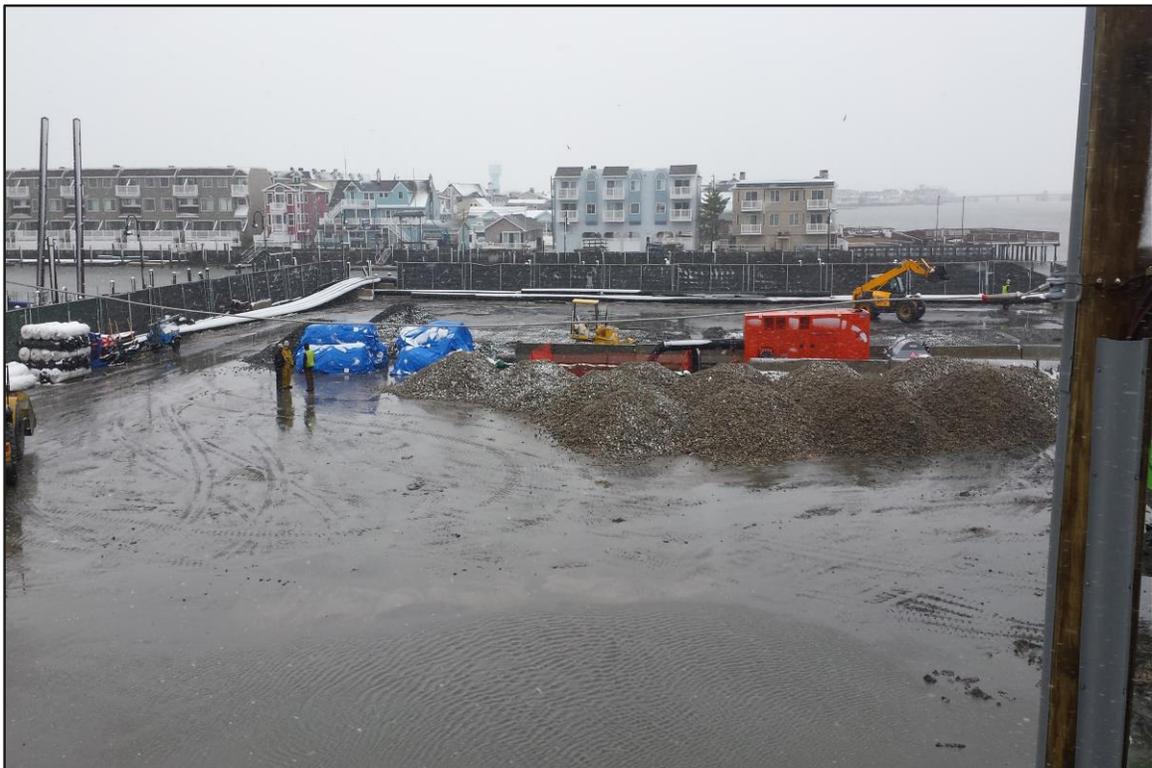
Photograph 6: De-watering Area – Equipment preparing pads for new geobags. (Looking south)

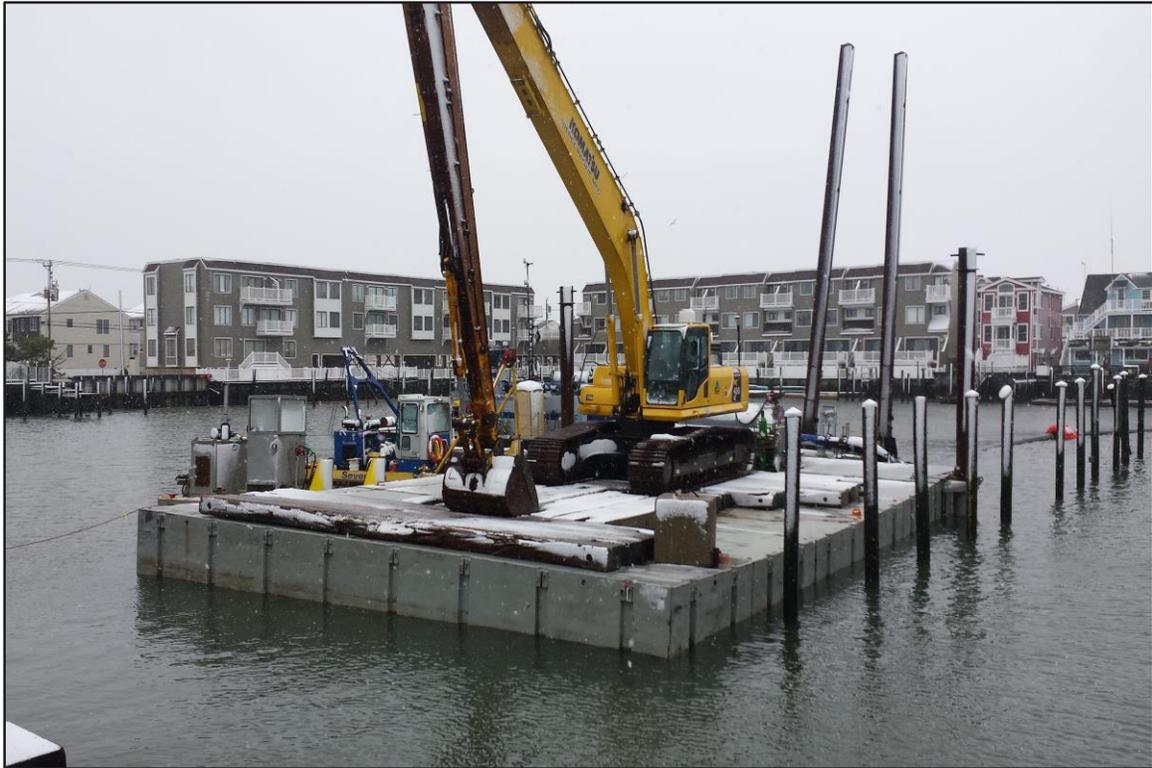
Photograph 7: North Basin – Dredges on standby. (Looking southeast)

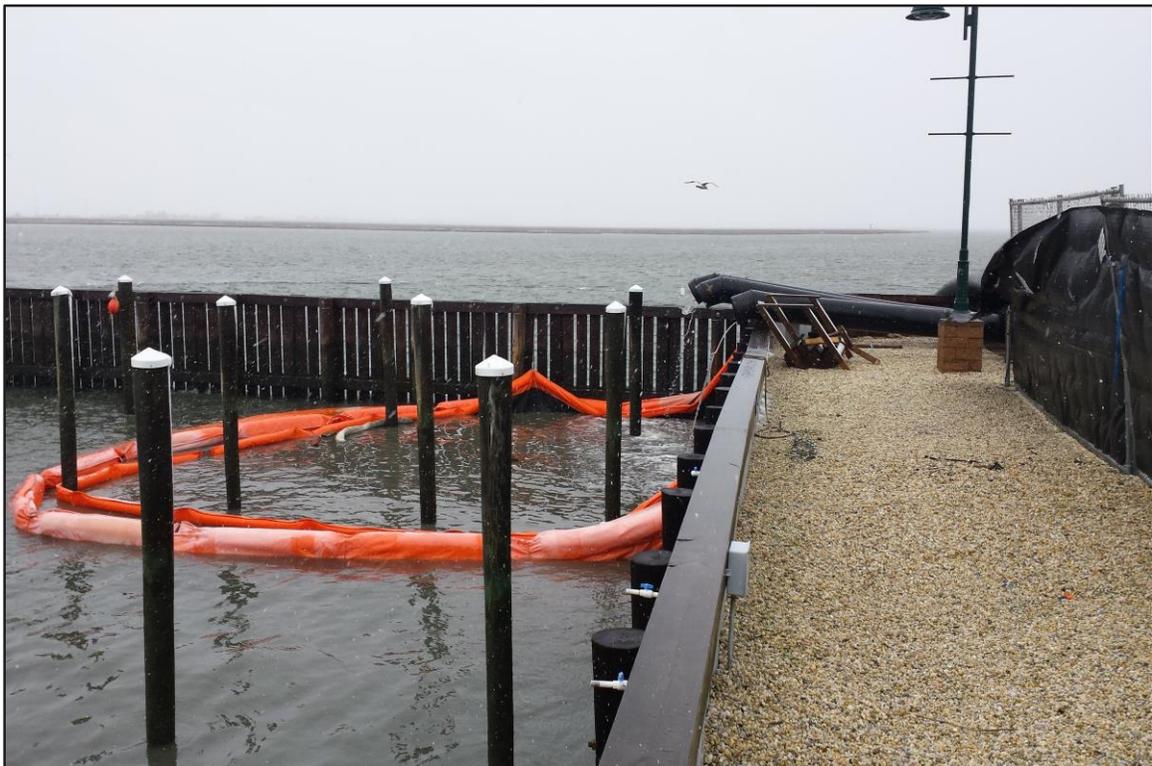
Photograph 8: De-watering Area/North Basin – Discharge pipes in operation. (Looking west)

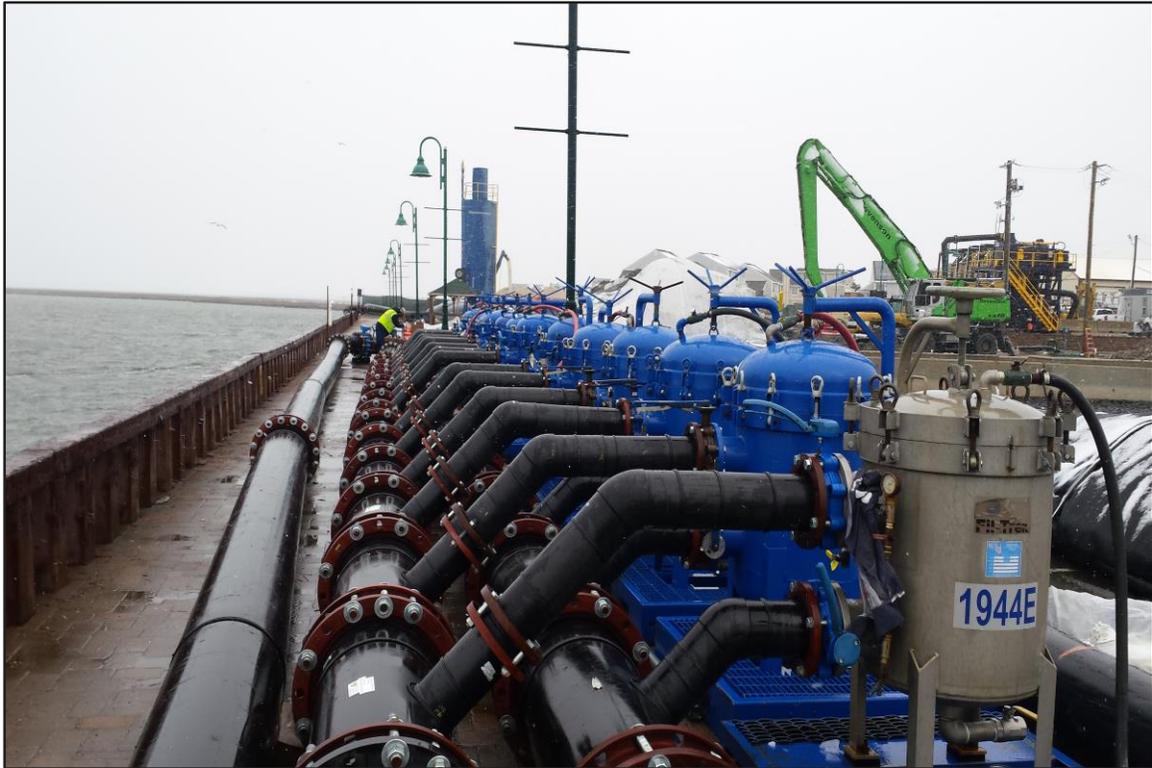
Photograph 9: De-watering Area – Filtration system in operation. (Looking north)

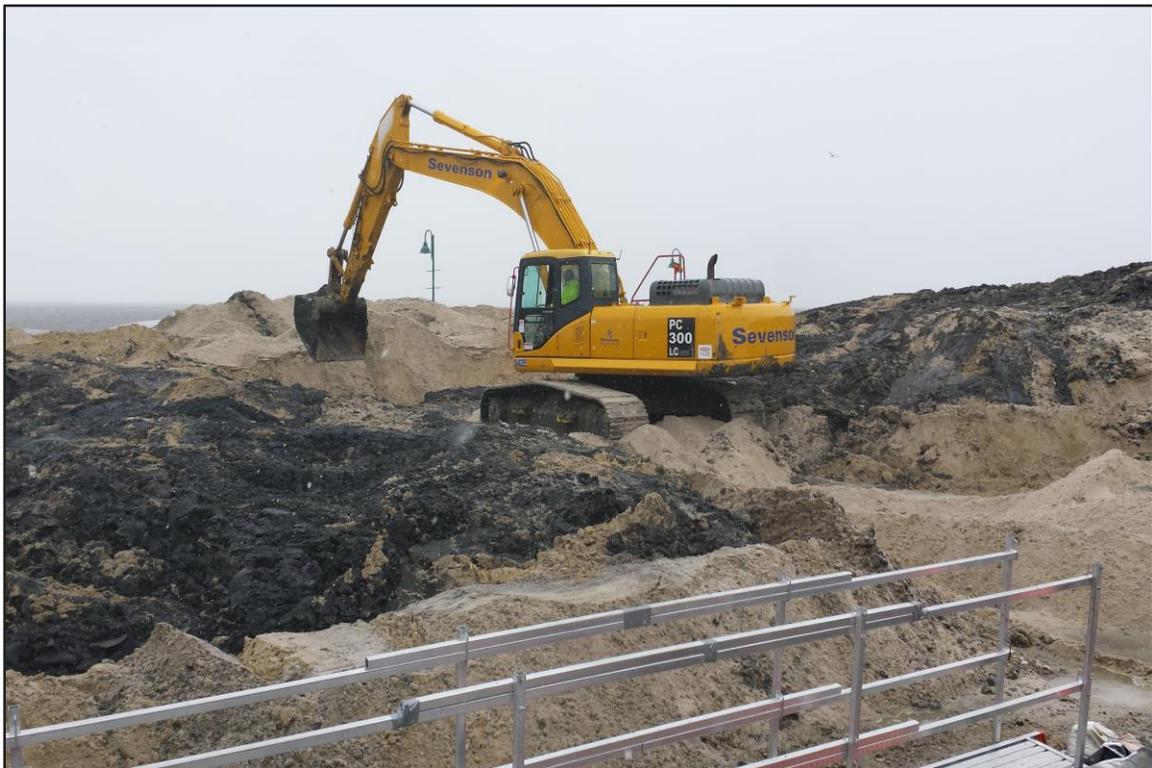
Photograph 10: De-watering Area – Sand blending geobags #6-9. (Looking northwest)

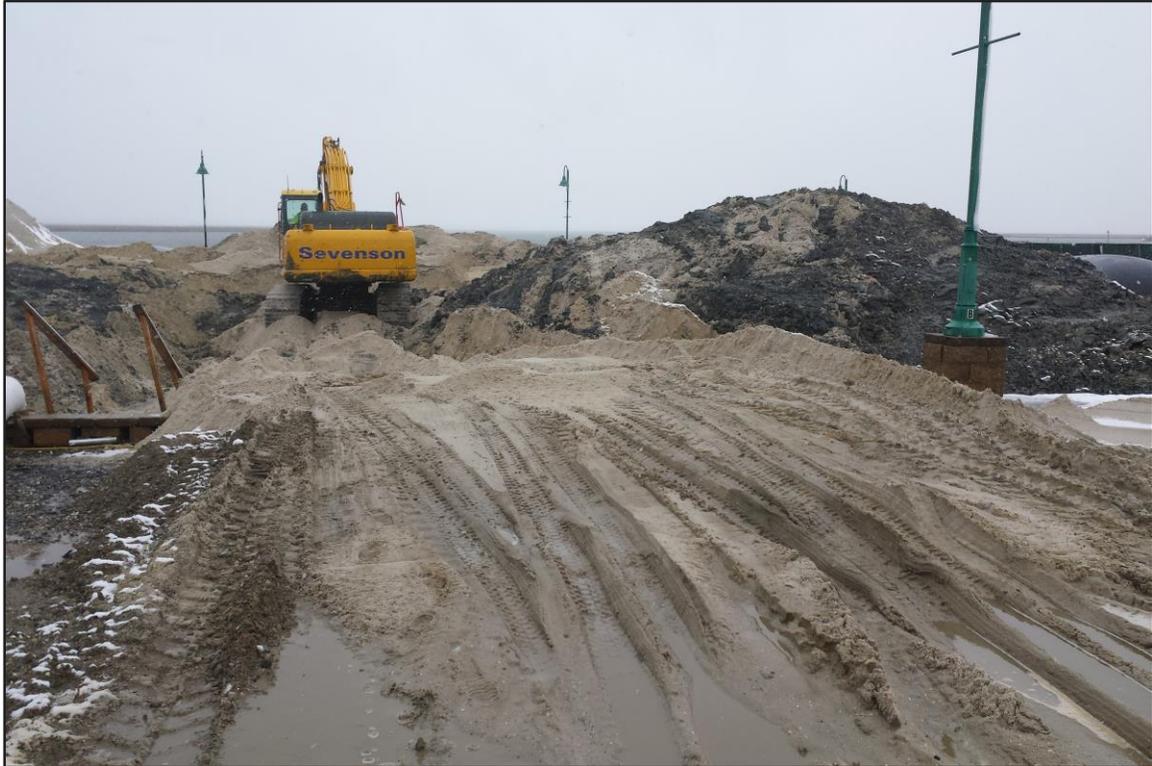
Photograph 11: De-watering Area – Sand blending geobags #6-9. (Looking west)
