FIELD REPORT

TITLE Stone Harbor Maintenance Dredging
 DATE February 9, 2016
 TO Jill Gougher
 COPY MADN
 FROM BEWI
 PROJECT NO A06772

Project Information

Owner: The Borough of Stone Harbor
Contractor: Severson Environmental Services, Inc.

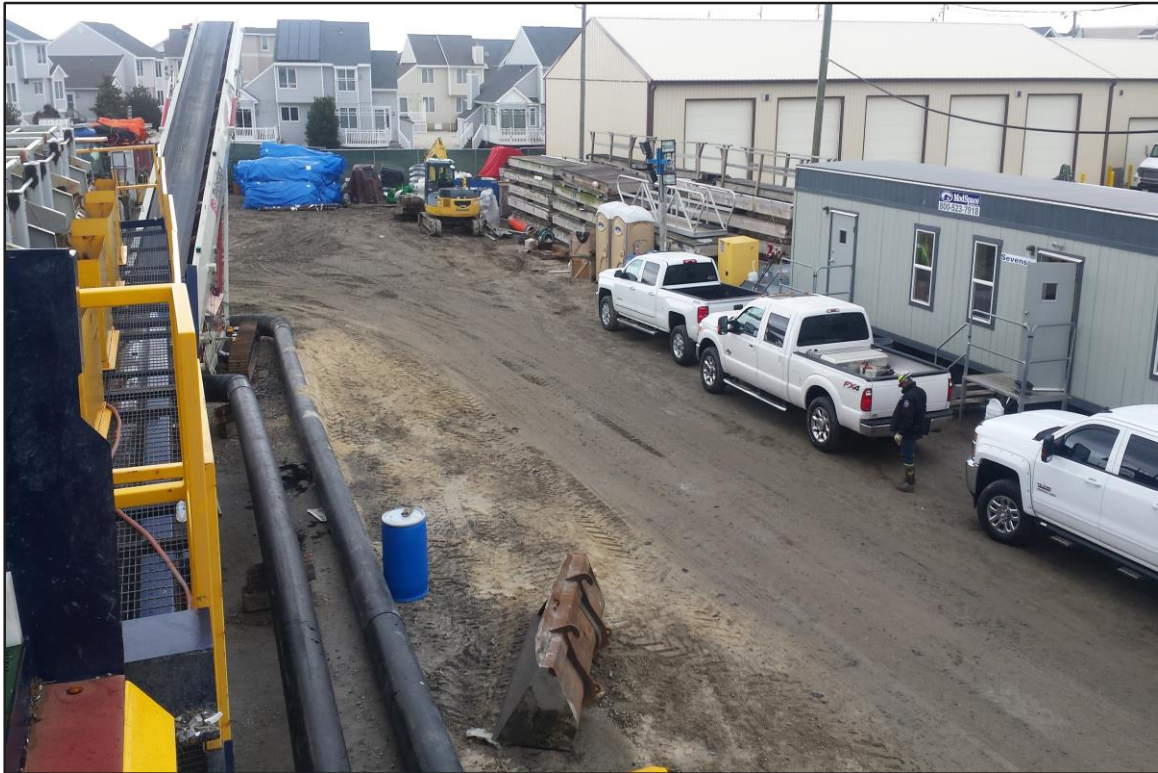
Photograph 1: De-watering Area – Parking and trailer area. (Looking north)

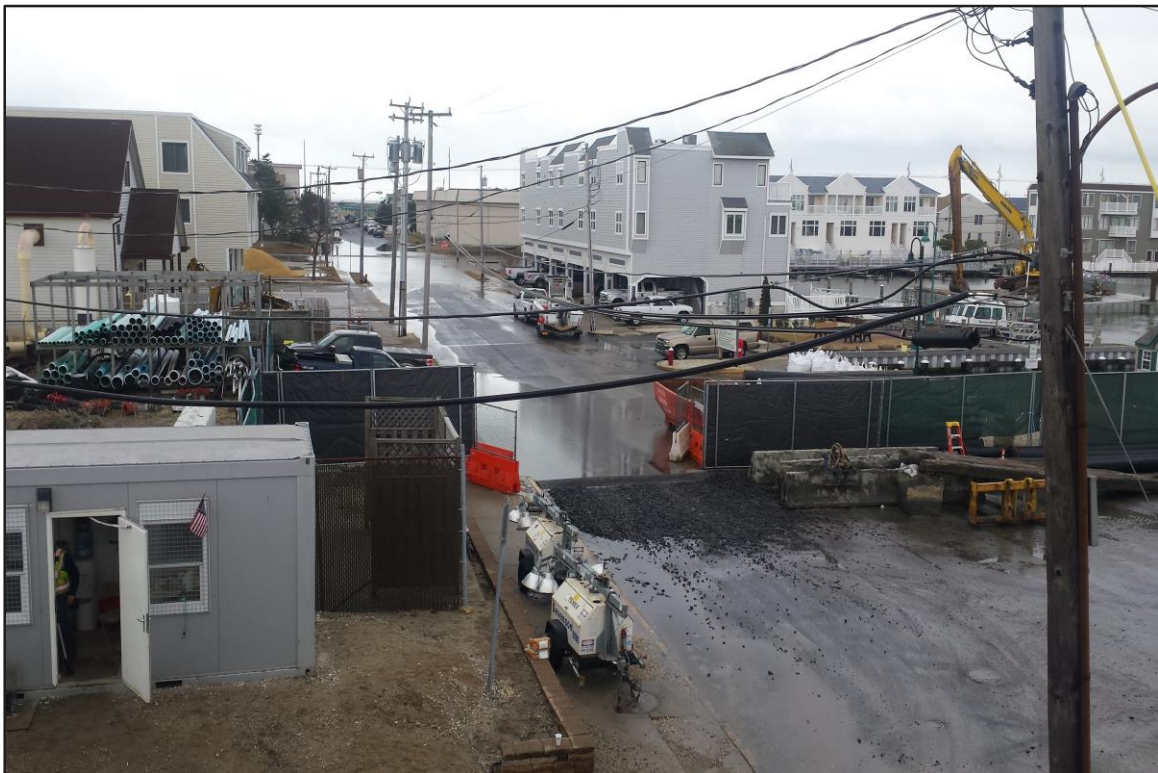
Photograph 2: Site Entrance. (Looking east)

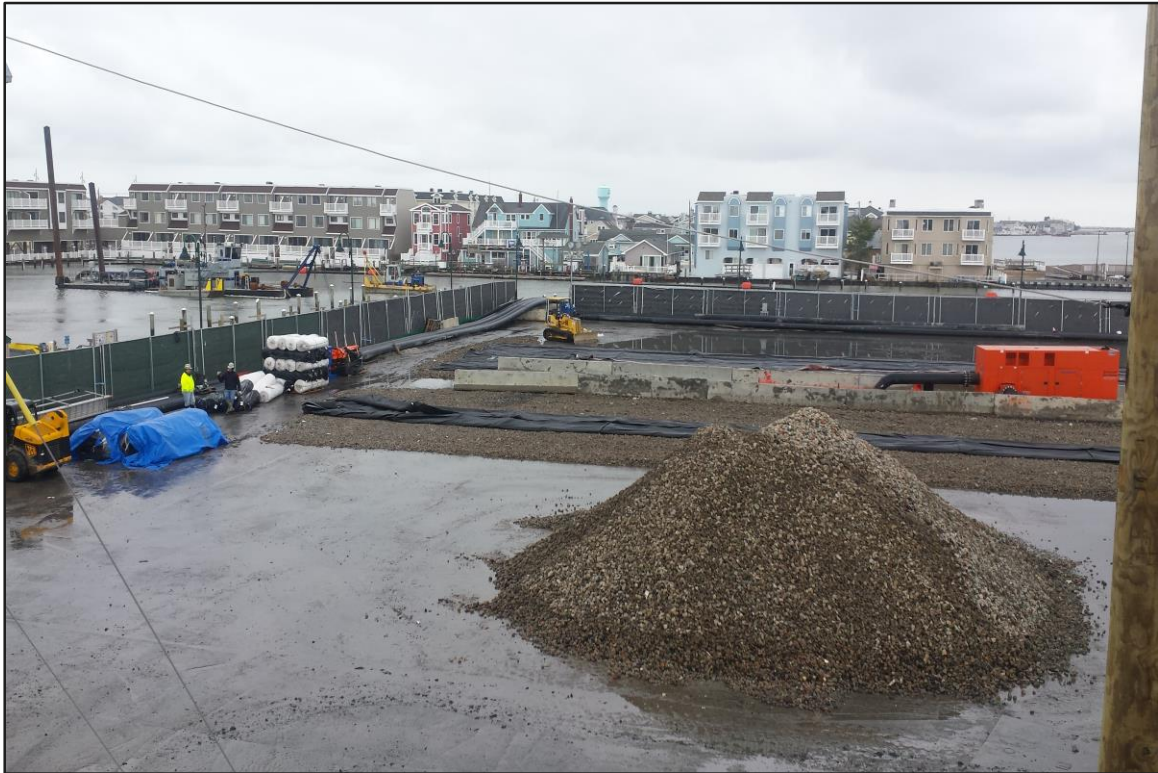
Photograph 3: De-watering Area – Geobag pad preparation in progress. (Looking south)

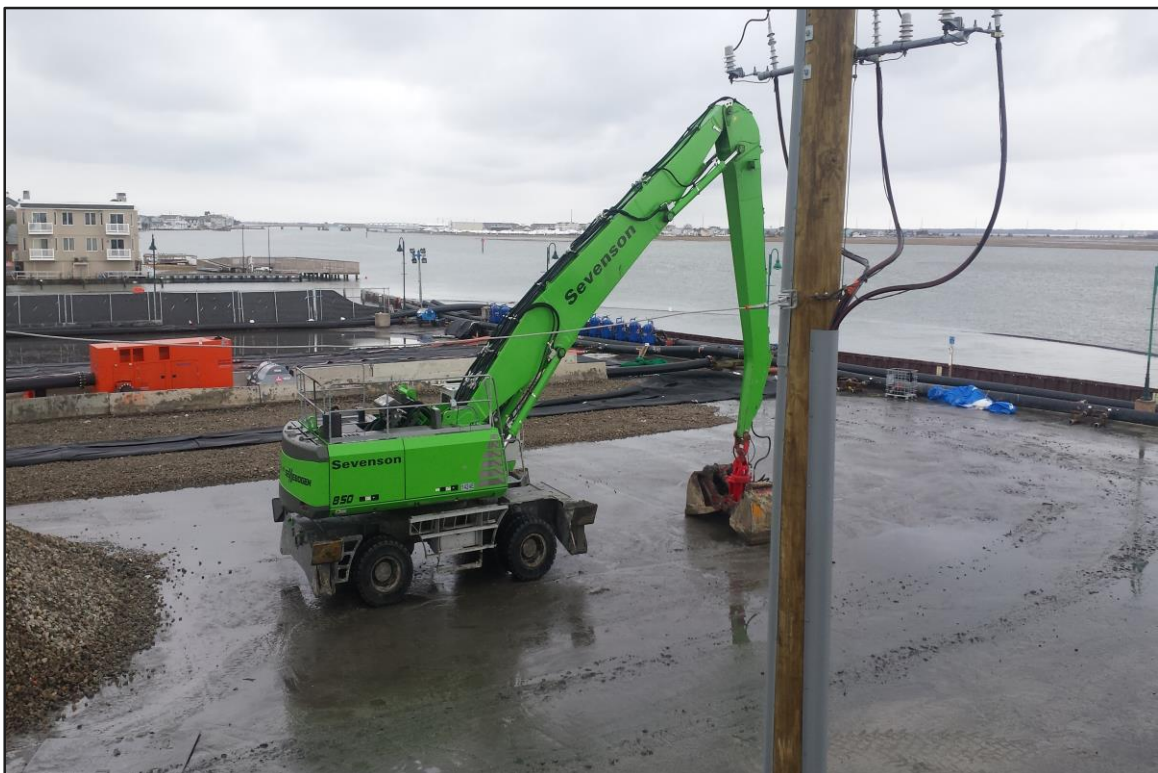
Photograph 4: De-watering Area – Excavator on standby. (Looking southeast)

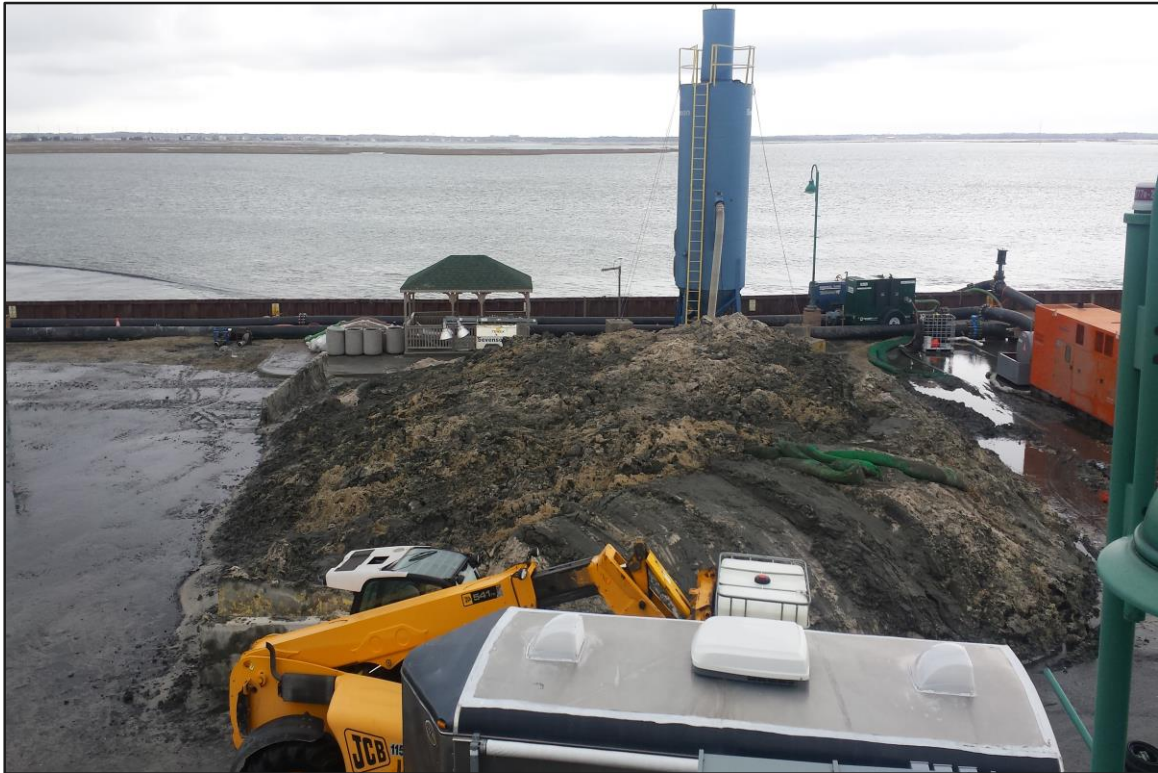
Photograph 5: De-watering Area – Blended material staged for removal. (Looking west)

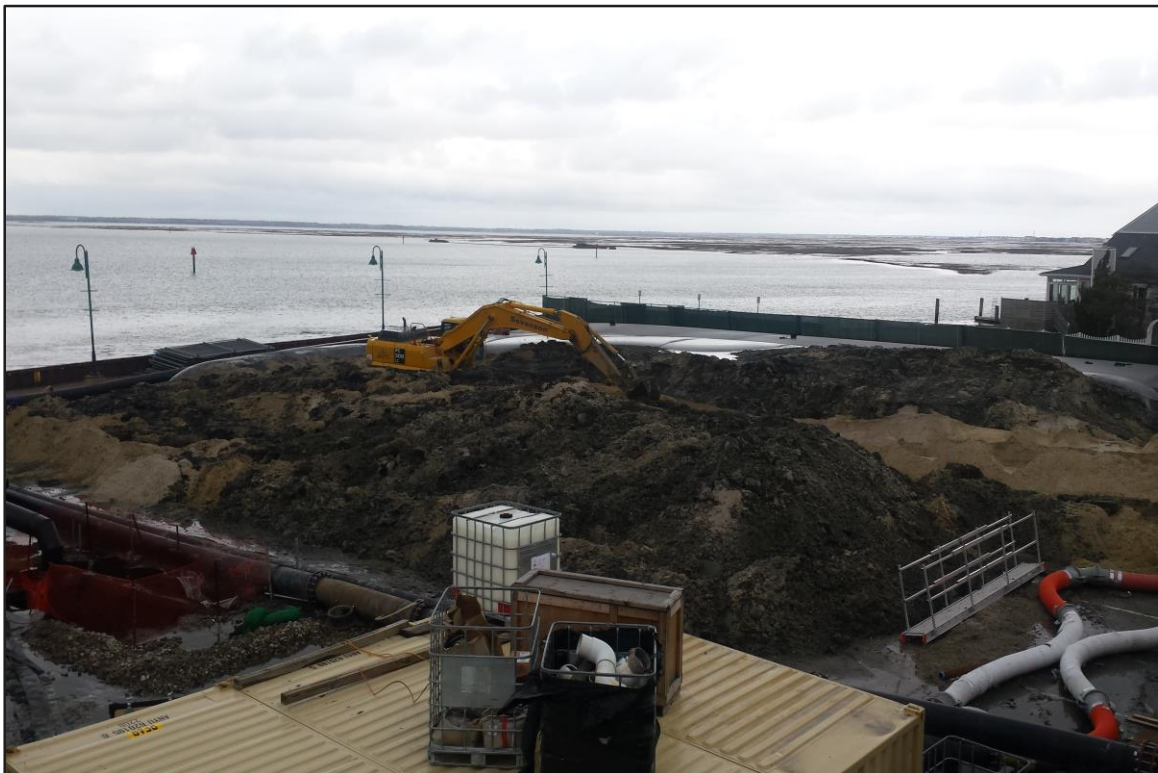
Photograph 6: De-watering Area – Sand blending in progress. (Looking northwest)

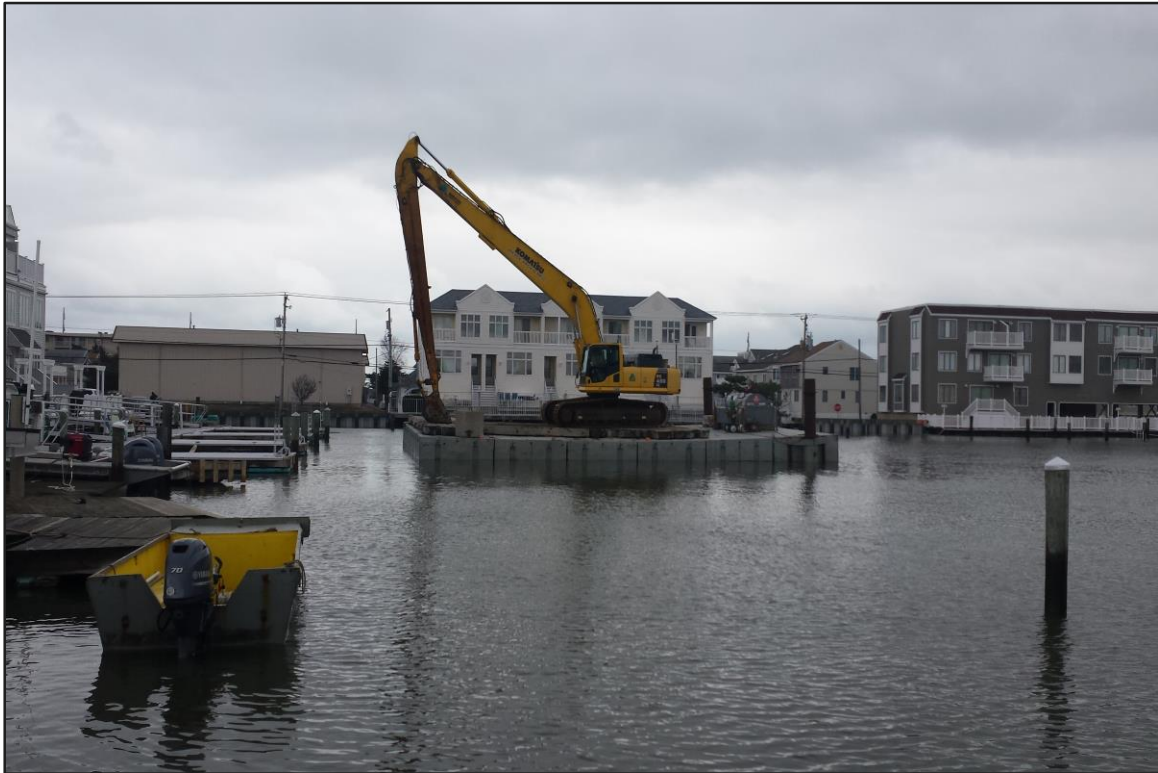
Photograph 7: North Basin – Mechanical dredge on standby. (Looking east)

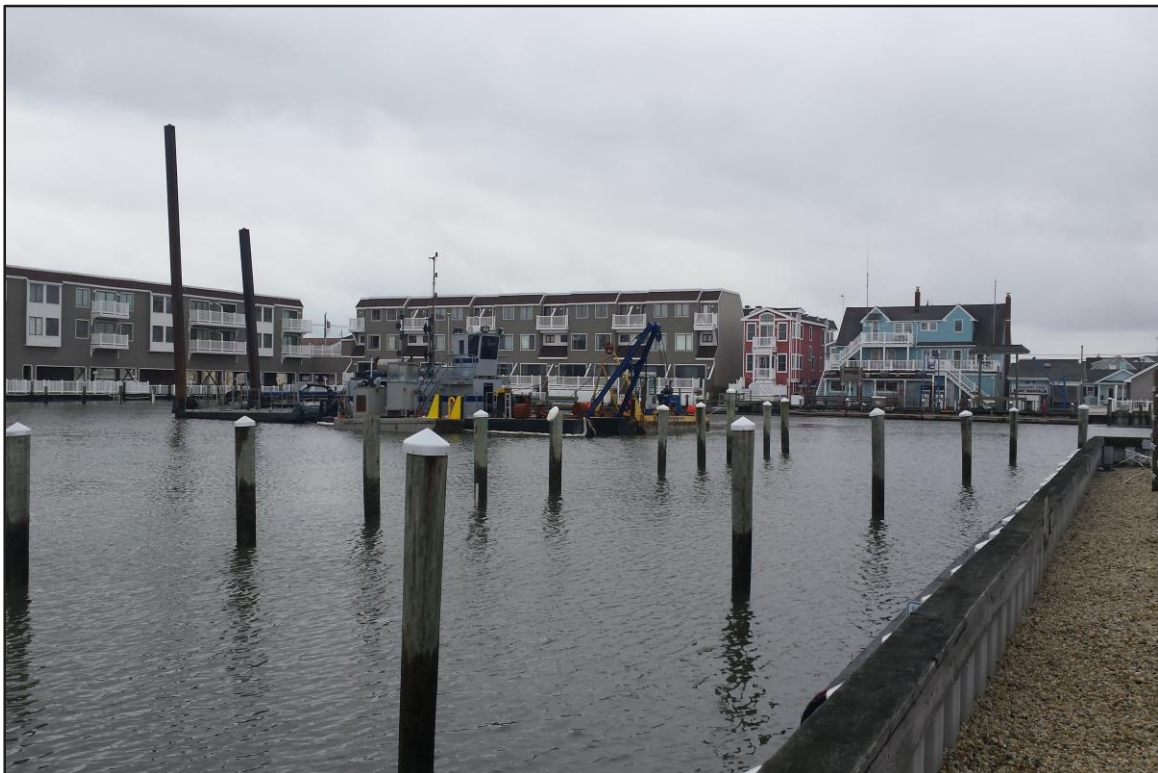
Photograph 8: North Basin – Hydraulic dredge operational. (Looking south)

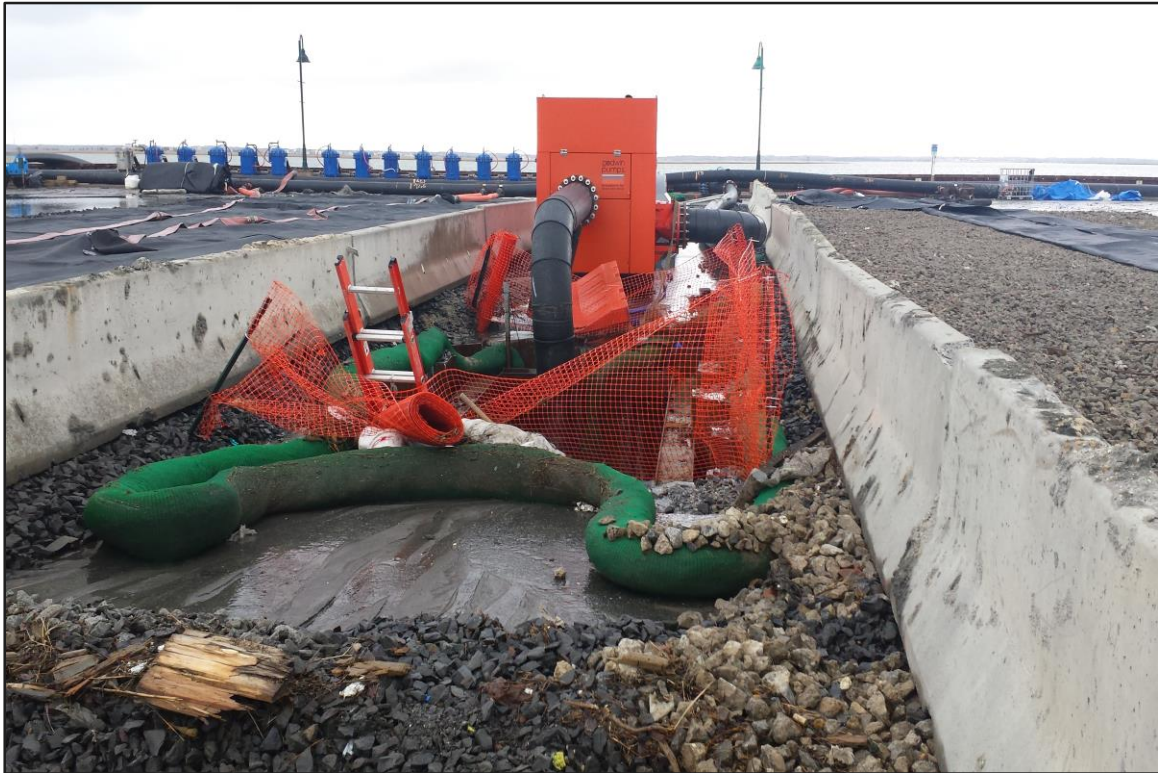
Photograph 9: De-watering Area – Sump pump on standby. (Looking west)

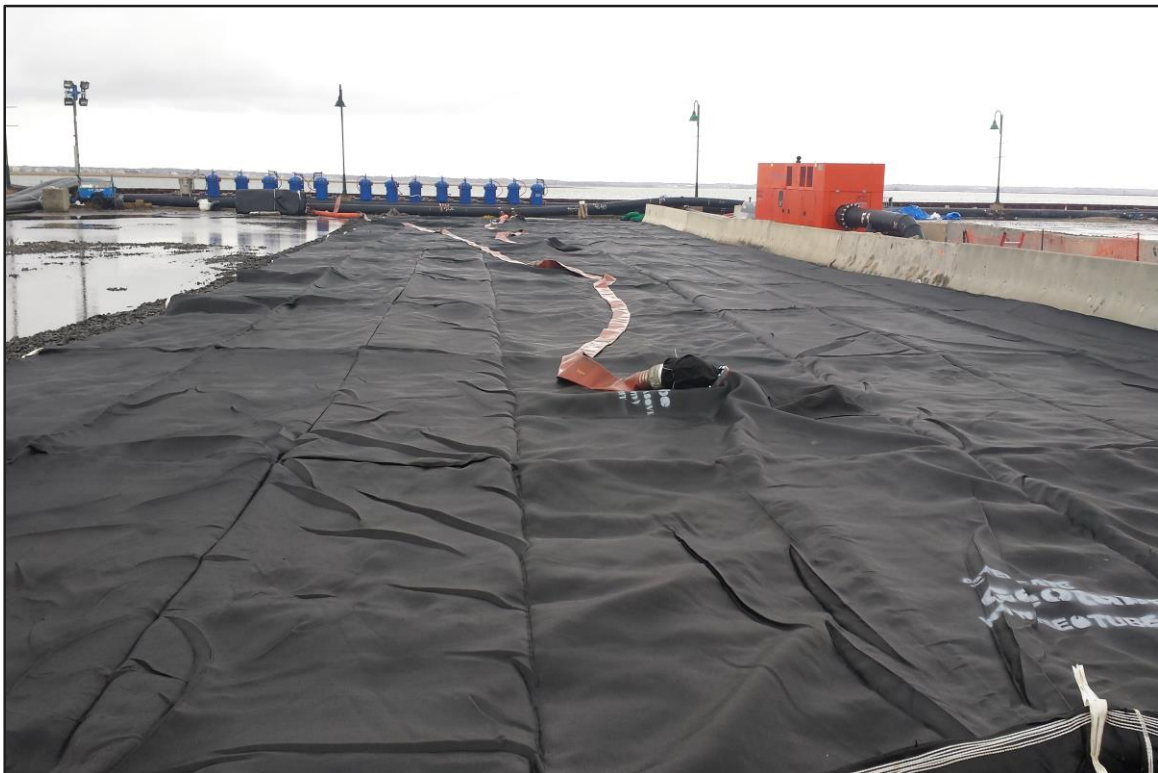
Photograph 10: De-watering Area – New geobag on standby. (Looking west)

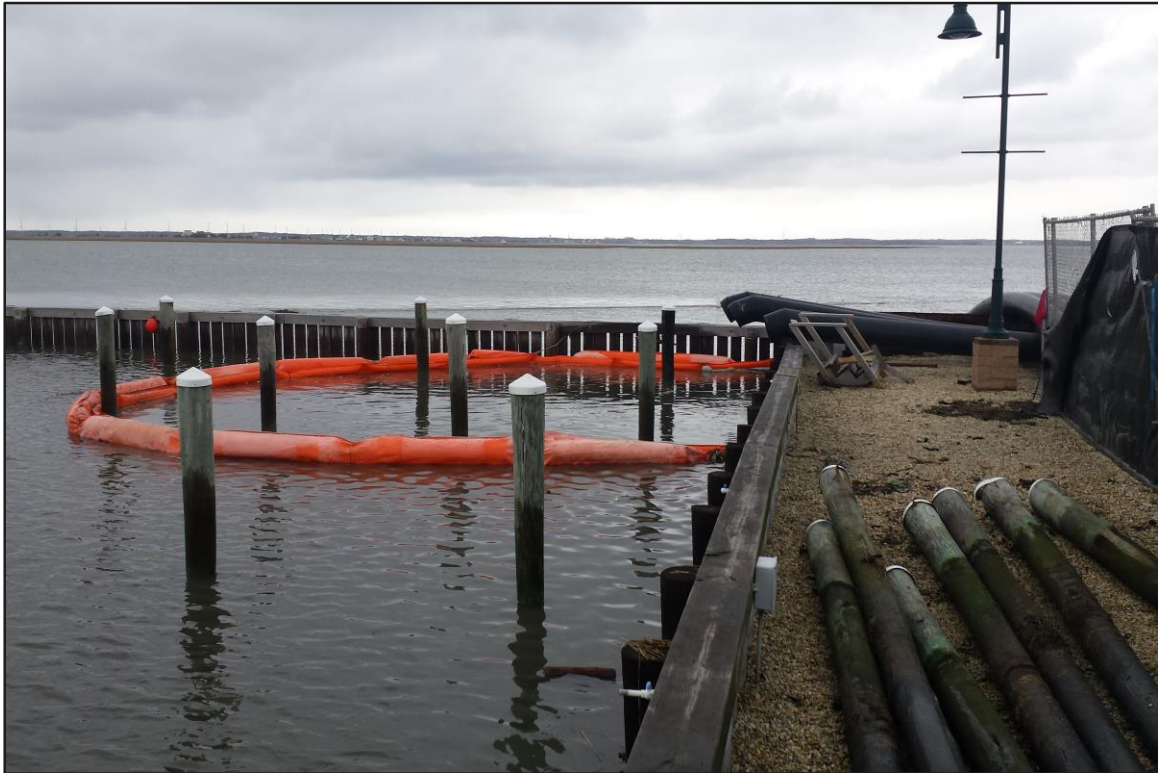
Photograph 11: North Basin/De-watering Area – Discharge pipes on standby. (Looking west)

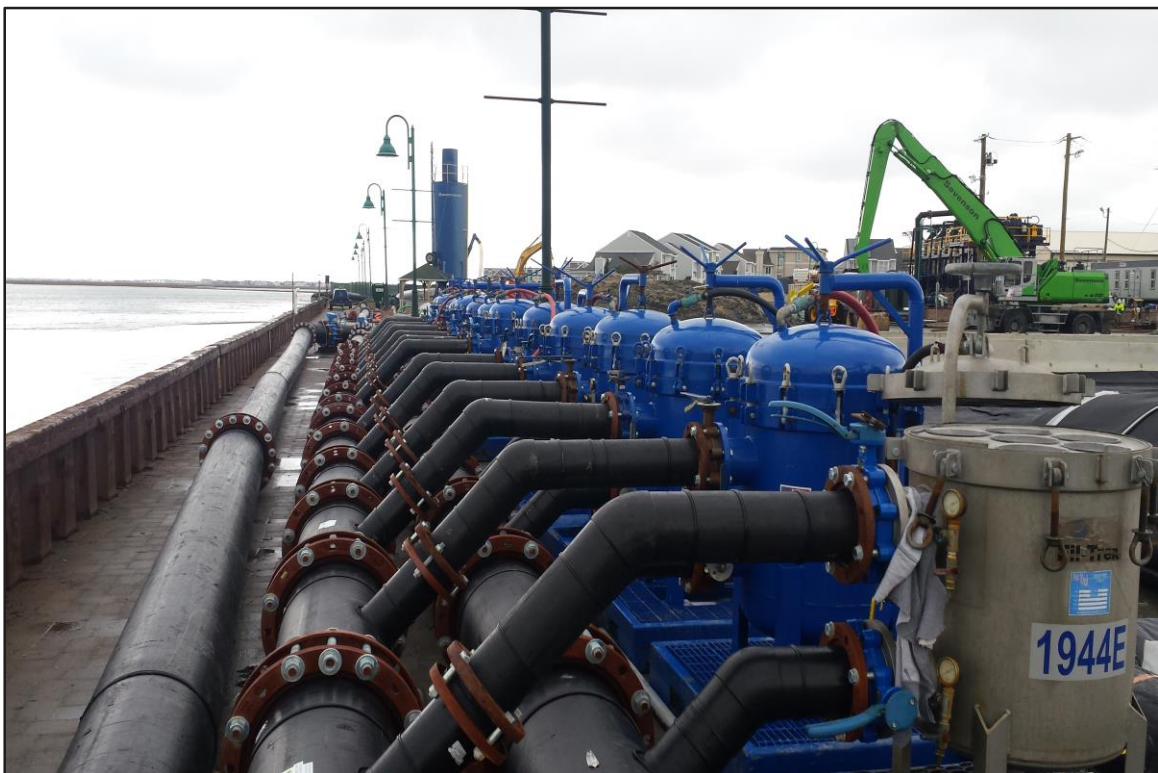
Photograph 12: De-watering Area – Filtration system on standby. (Looking north)
