FIELD REPORT

TITLE Stone Harbor Maintenance Dredging
 DATE February 15, 2016
 TO Jill Gougher
 COPY MADN
 FROM BEWI
 PROJECT NO A06772

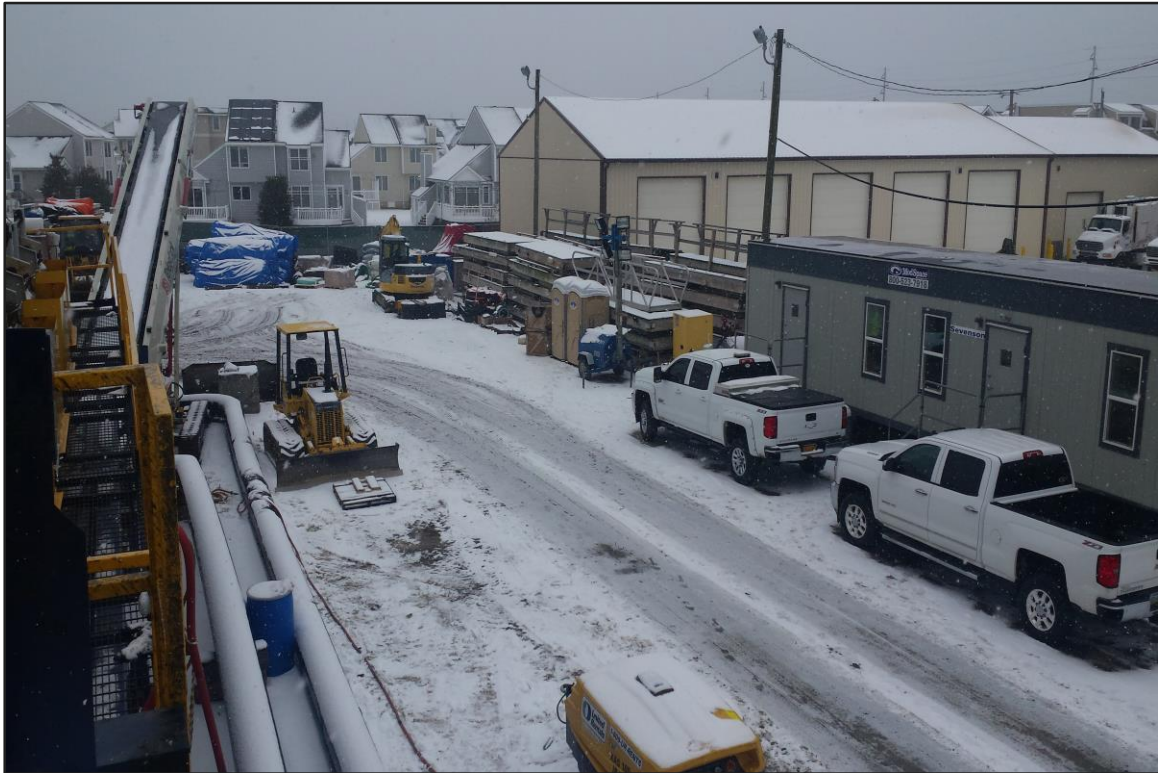
Photograph 1: De-watering Area – Elevated parking area, equipment on standby. (Looking northeast)

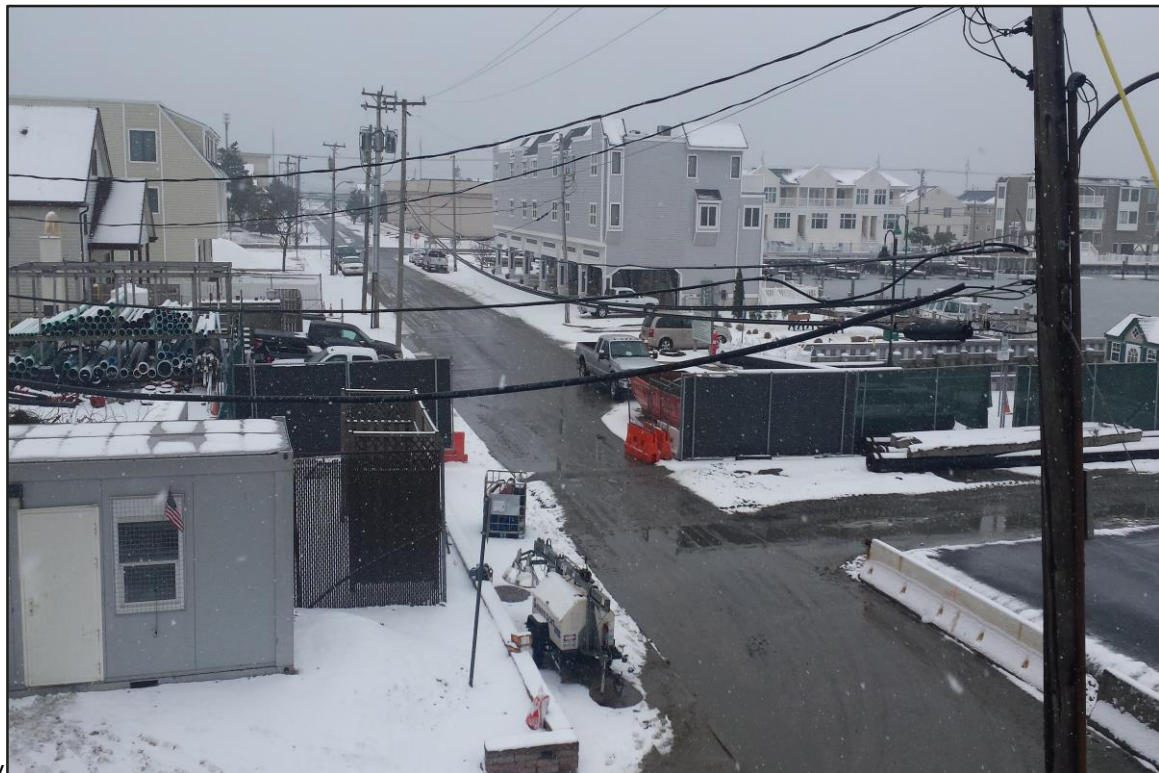
Photograph 2: Site Entrance. (Looking east)

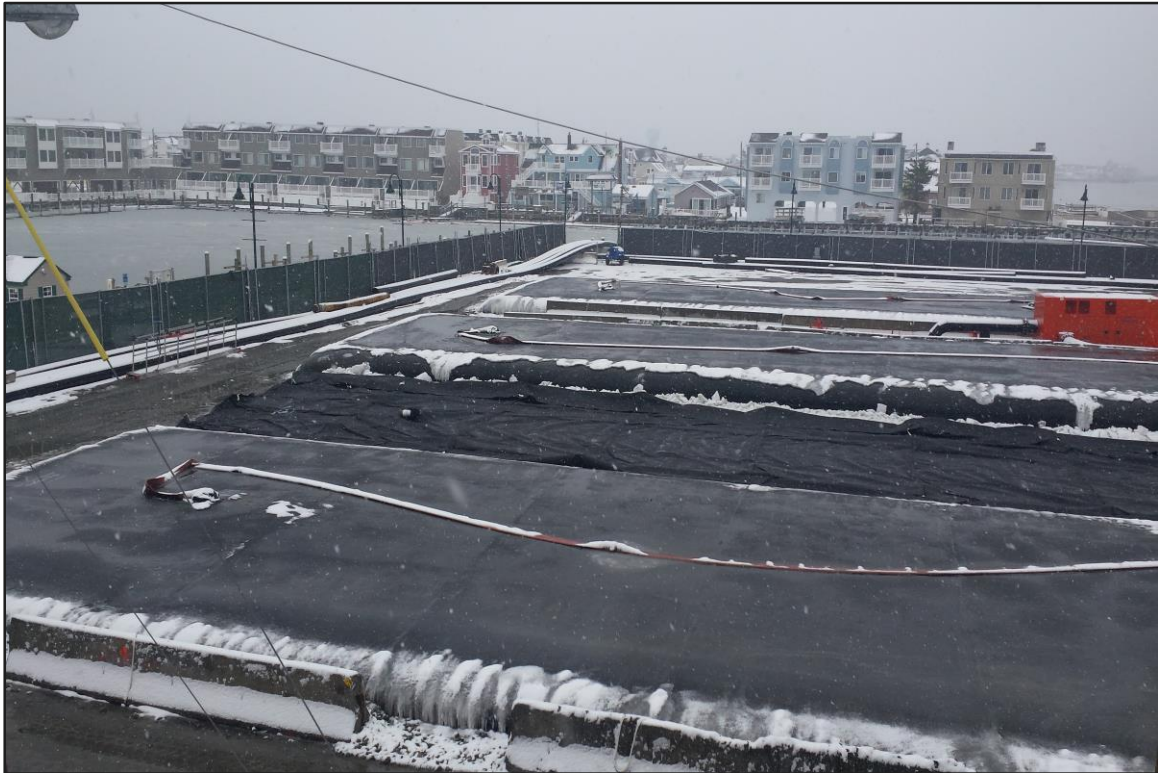
Photograph 3: De-watering Area – Geobags #2-5. (Looking south)

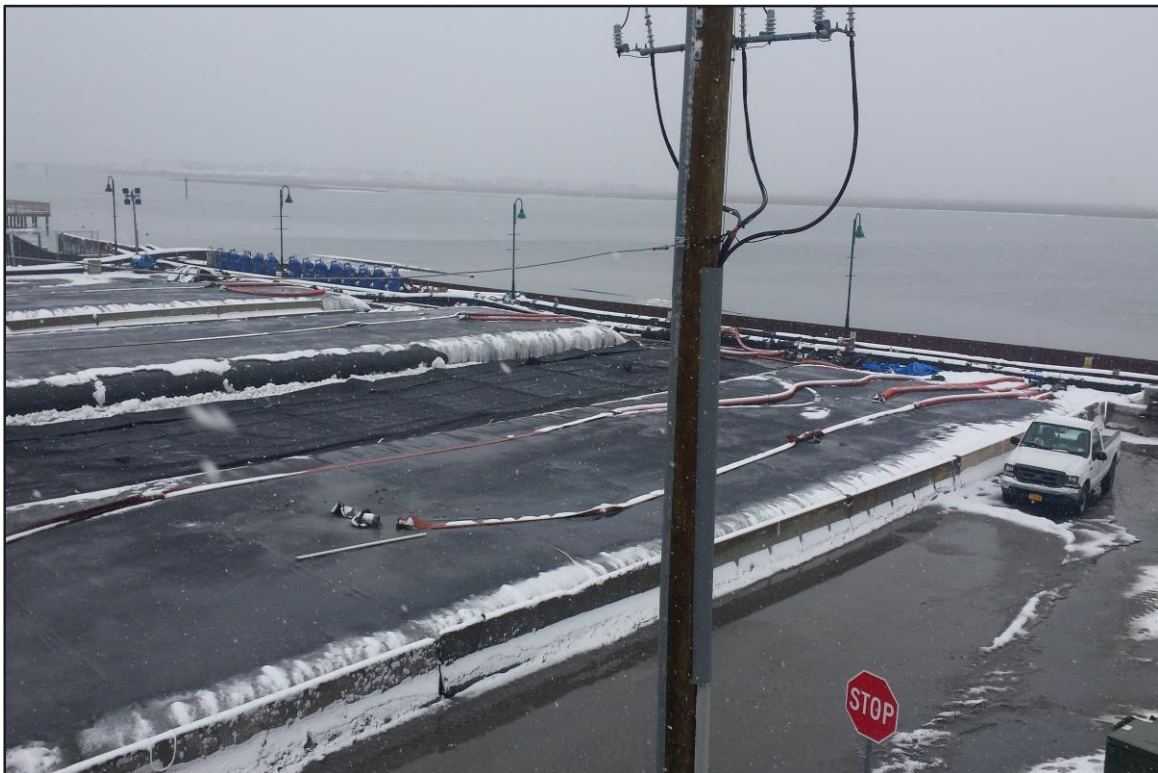
Photograph 4: De-watering Area – Geobags #2-5. (Looking southwest)

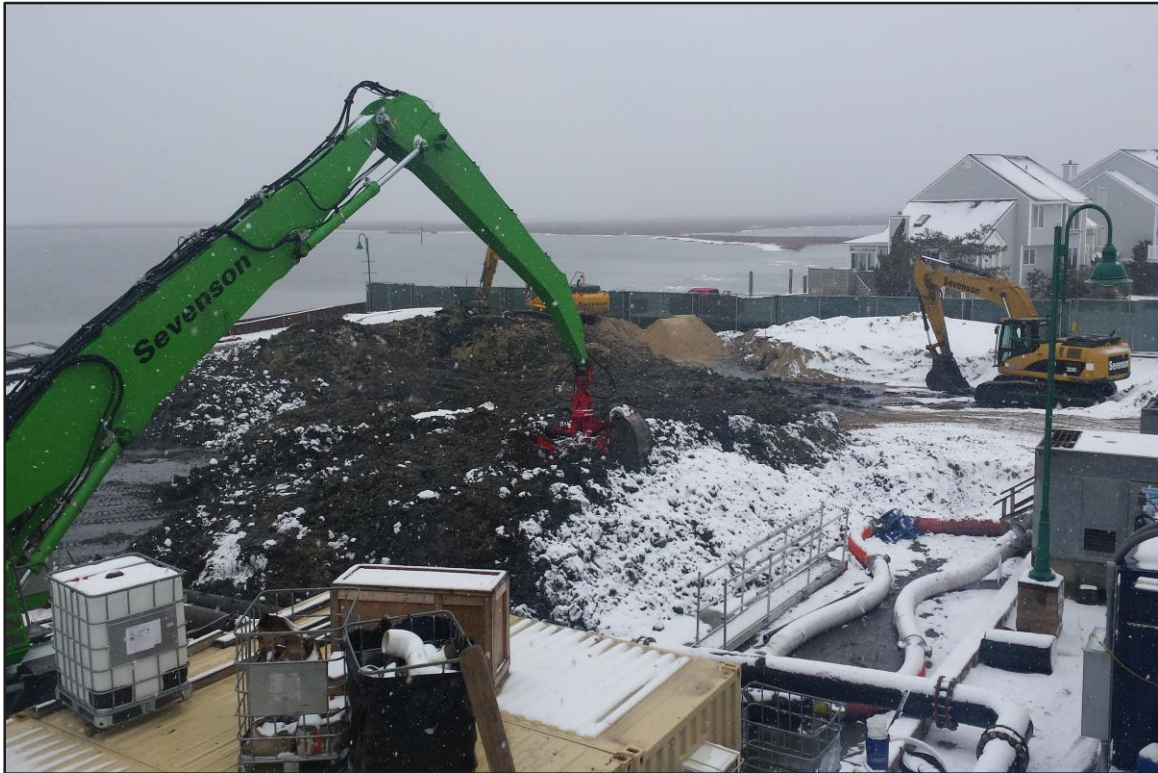
Photograph 5: De-watering Area – Sand blending operations in progress. (Looking northwest)

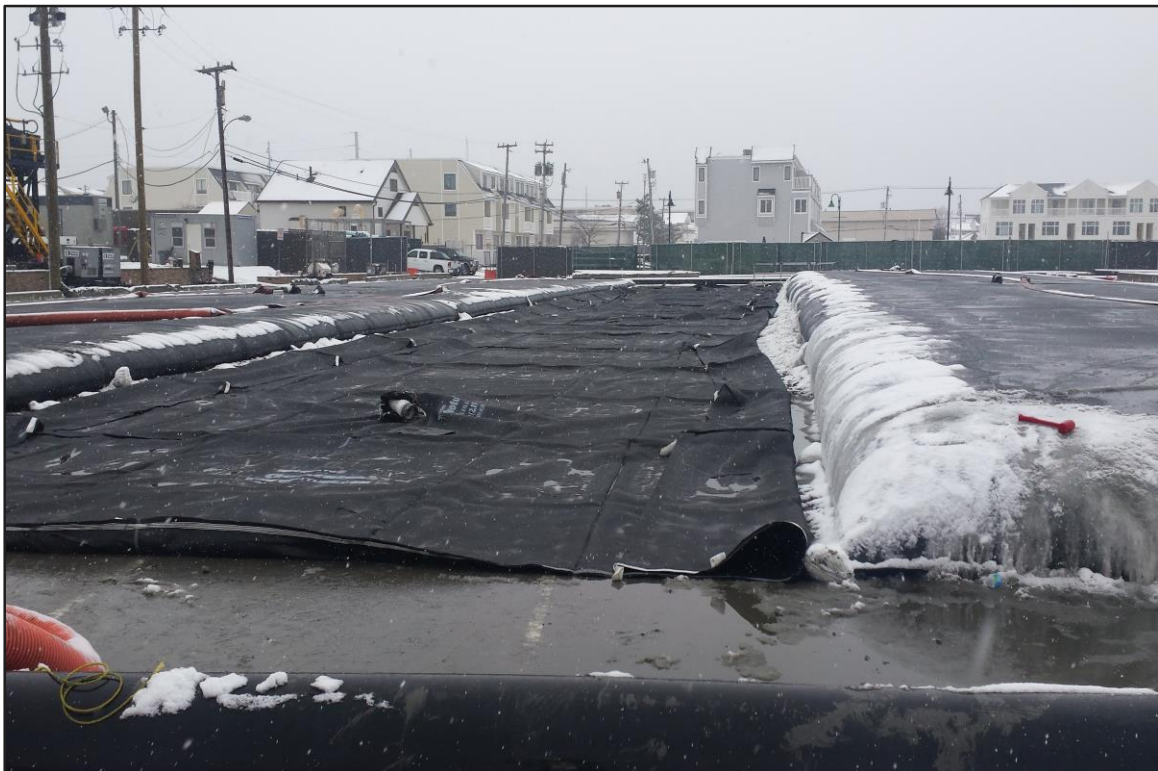
Photograph 6: De-watering Area – Geobag #4. (Looking east)

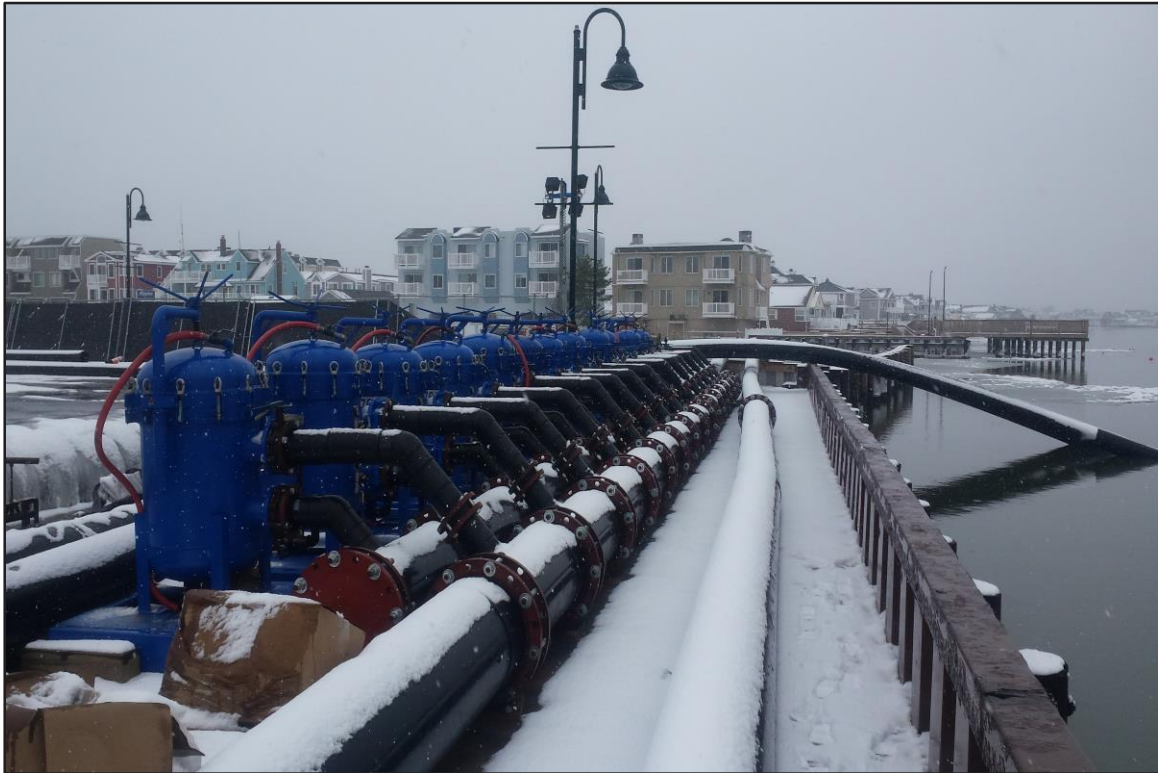
Photograph 7: De-watering area – Filtration system. (Looking south)

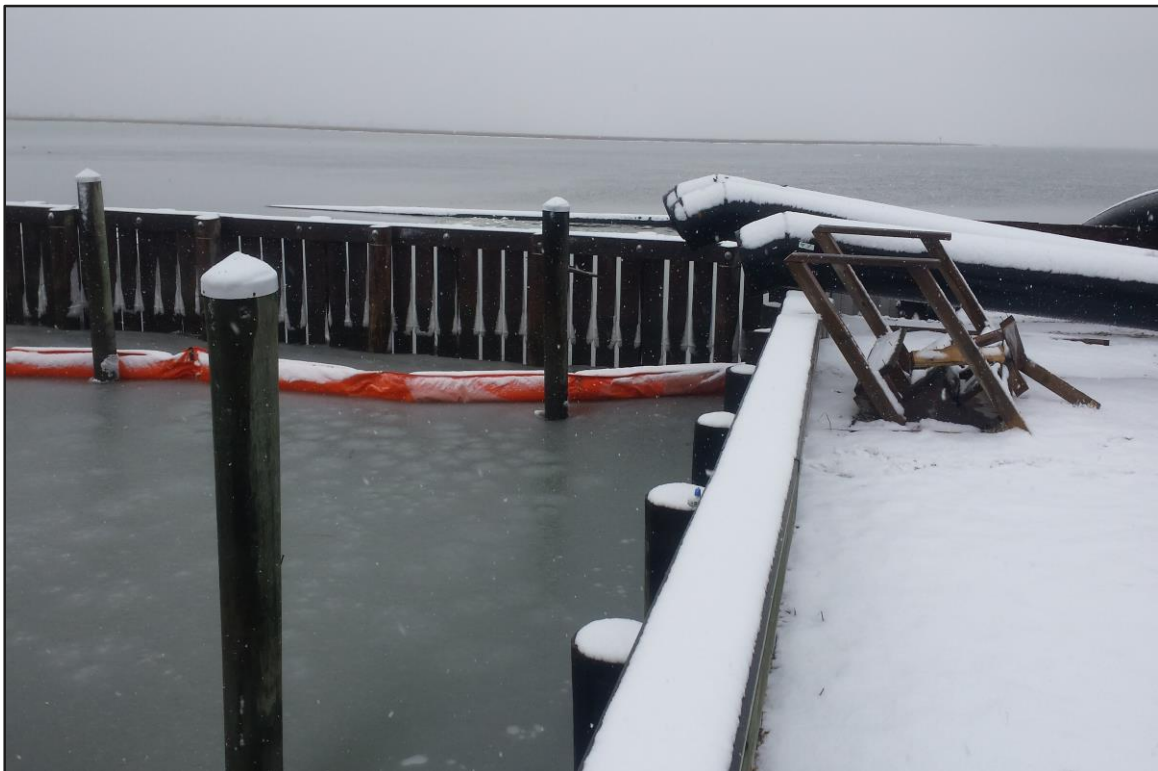
Photograph 8: De-watering Area/North Basin – Discharge pipes. (Looking west)

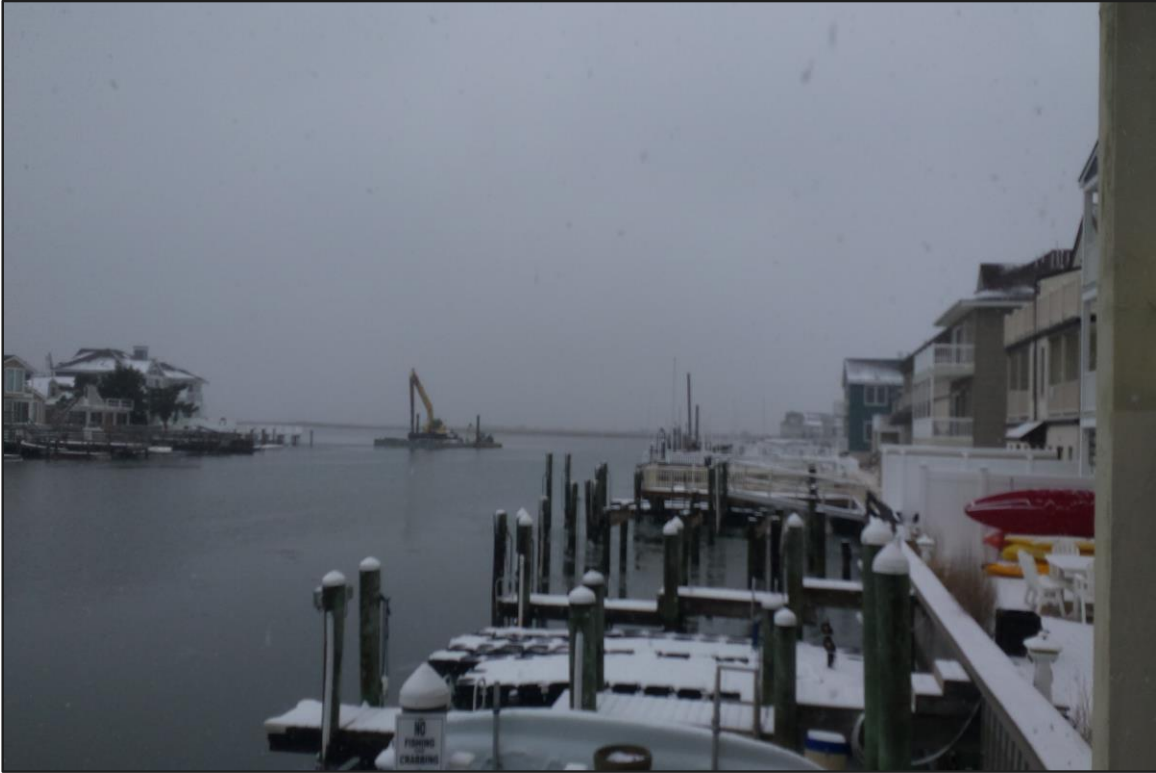
Photograph 9: Shelter Haven – Dredges at the mouth of Shelter Haven. (Looking west)

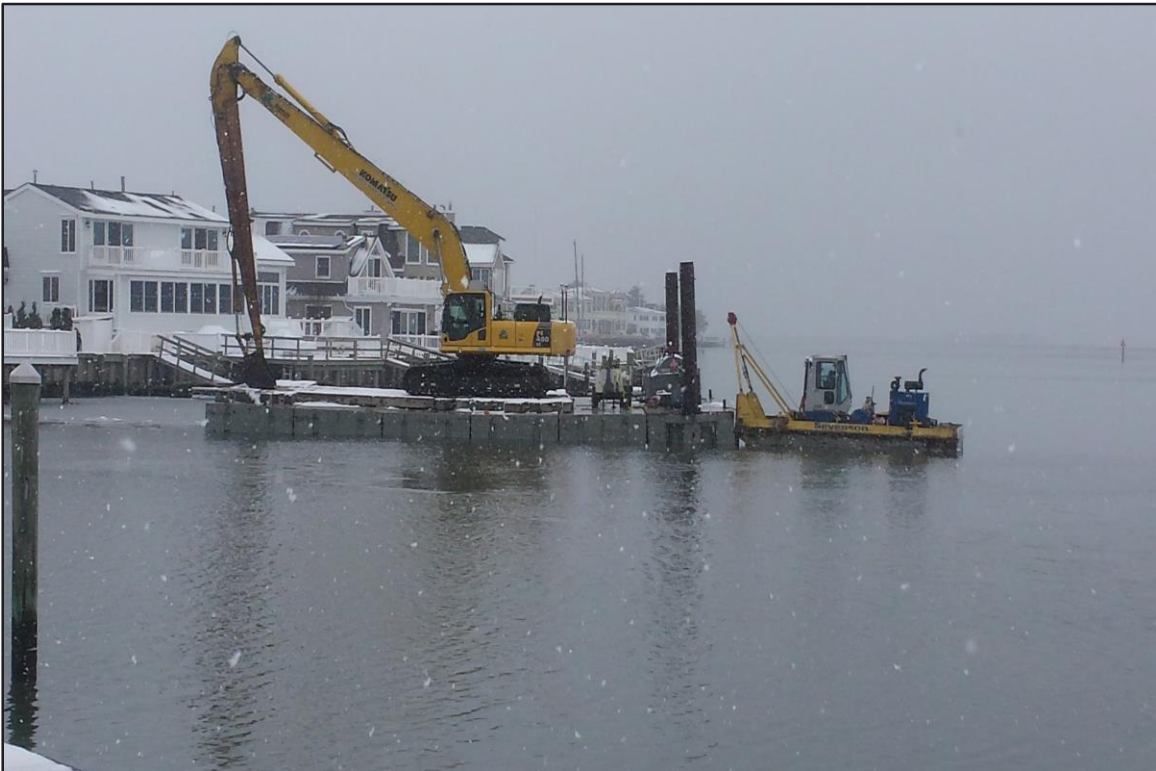
Photograph 10: Shelter Haven – Mechanical dredge. (Looking south)

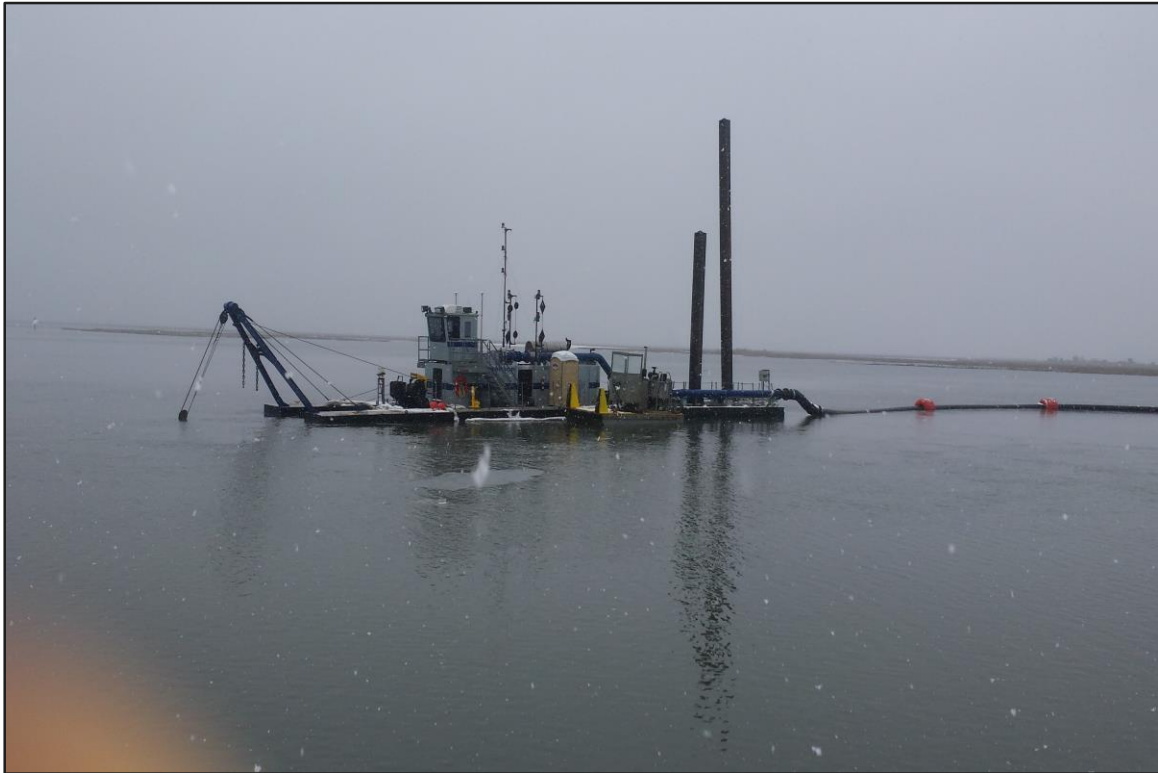
Photograph 11: Shelter Haven – Hydraulic dredge. (Looking west)

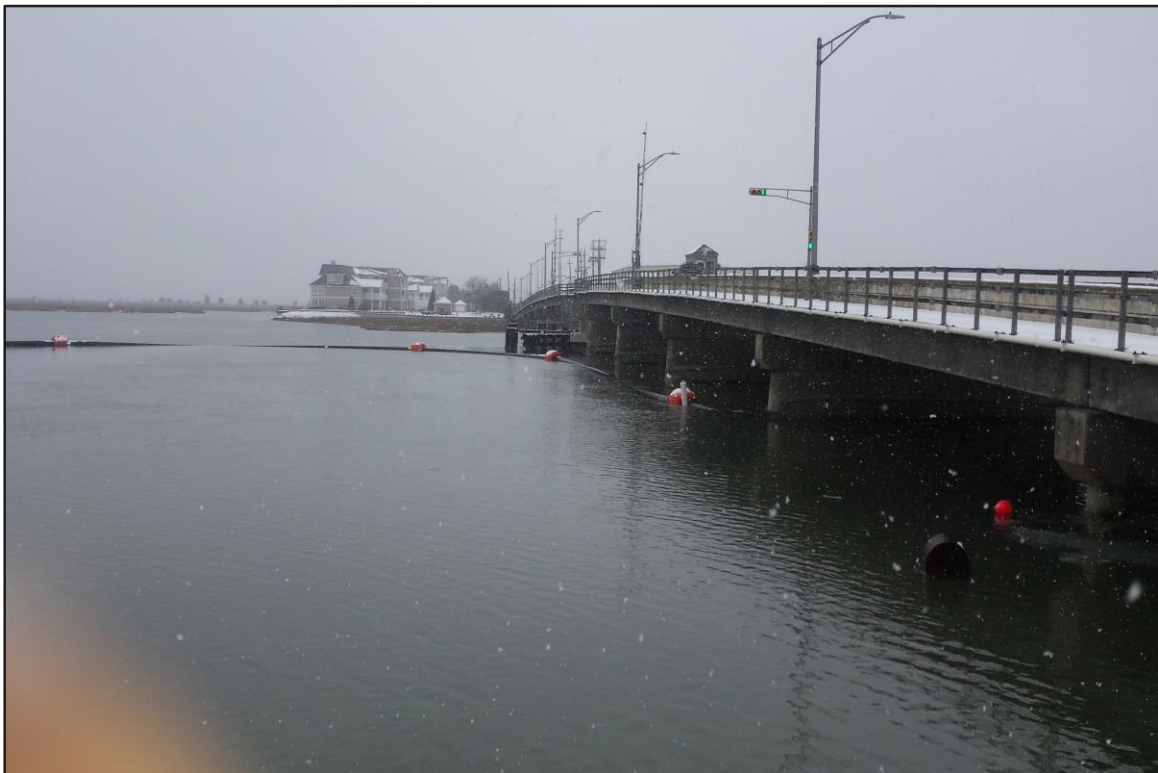
Photograph 12: Shelter Haven – Pipeline stretching north towards the de-watering area. (Looking west)
