FIELD REPORT

TITLE Stone Harbor Maintenance Dredging
 DATE February 19, 2016
 TO Jill Gougher
 COPY MADN
 FROM BEWI
 PROJECT NO A06772

Project Information

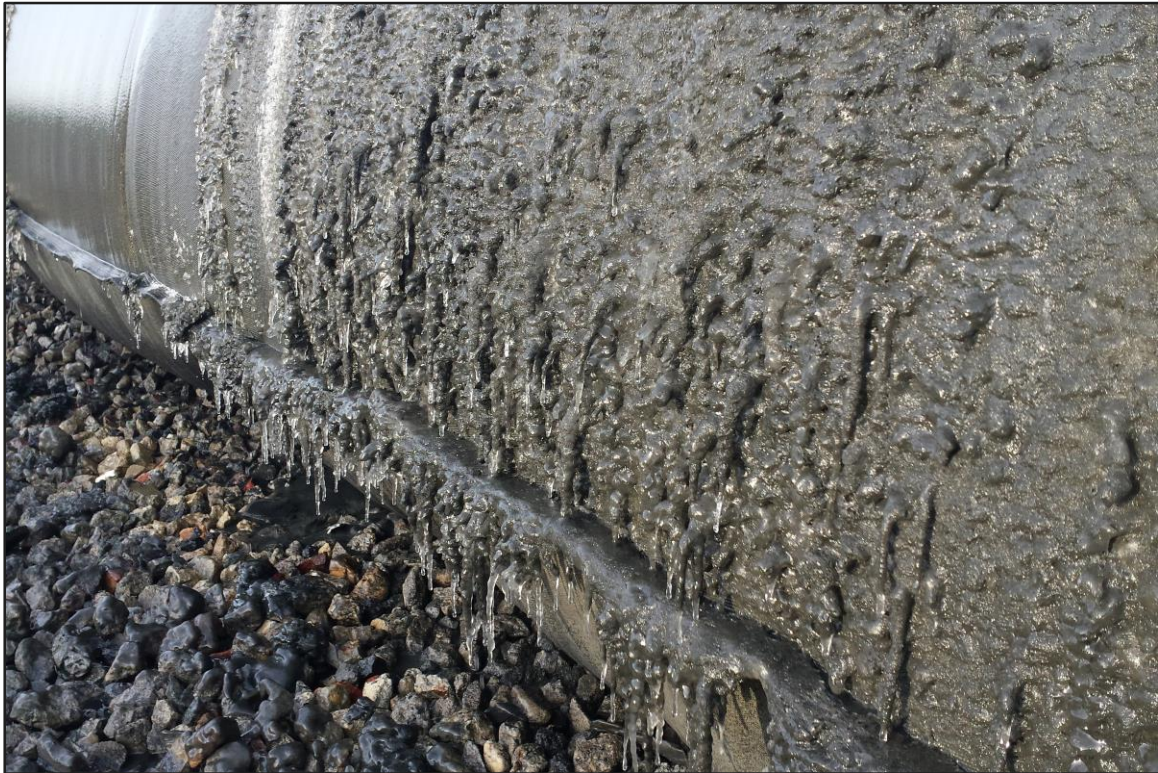
Photograph 1: De-watering Area – Frozen geobag runoff.

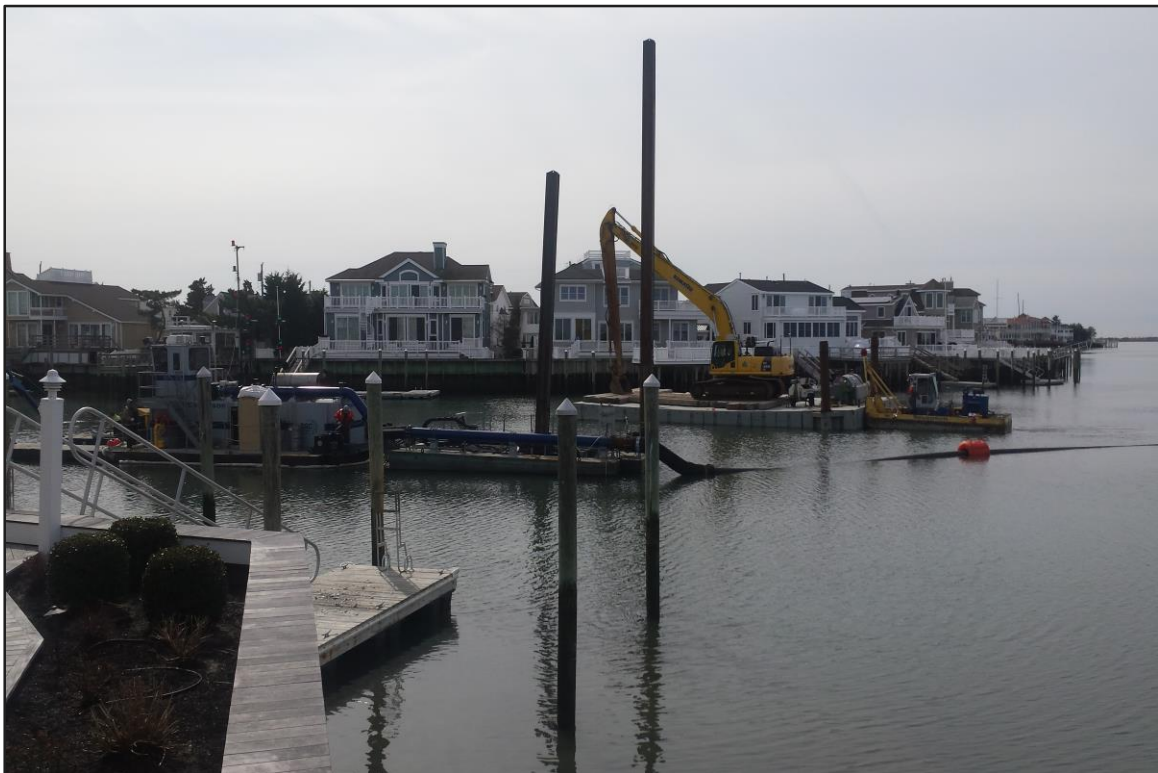
Photograph 2: Shelter Haven – Hydraulic and mechanical dredges. (Looking south)

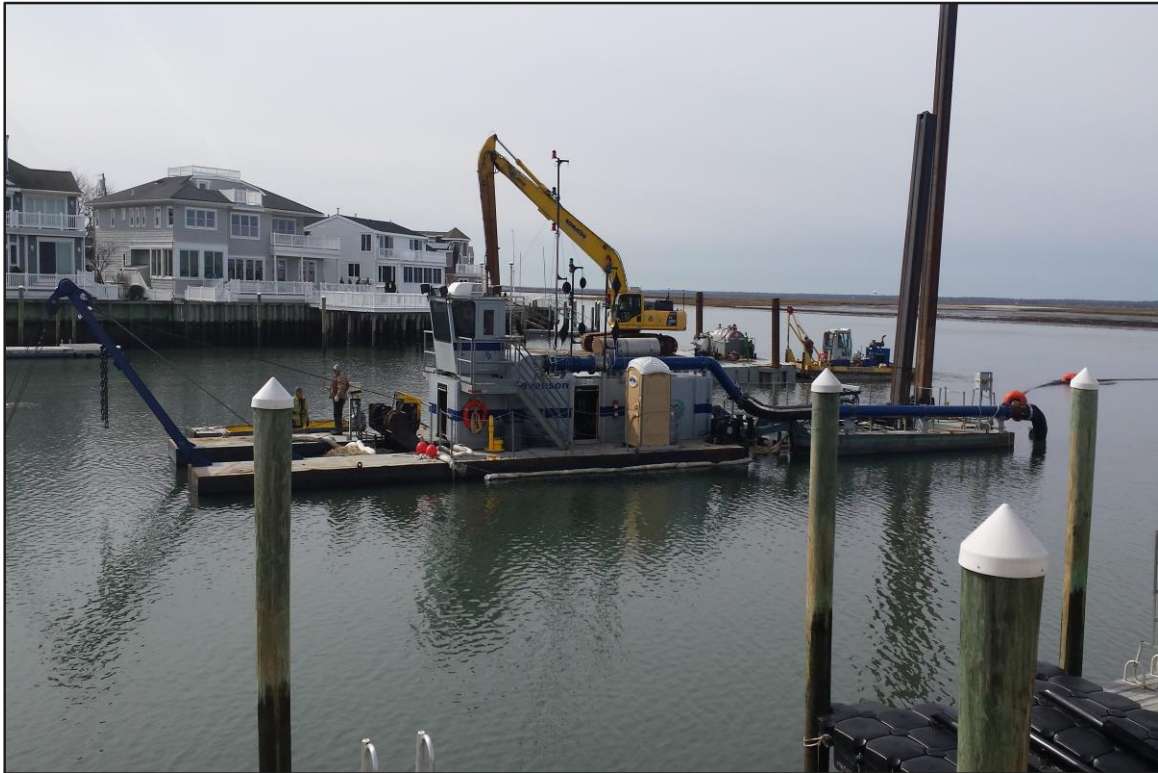
Photograph 3: Shelter Haven – Hydraulic and mechanical dredges. (Looking southwest)

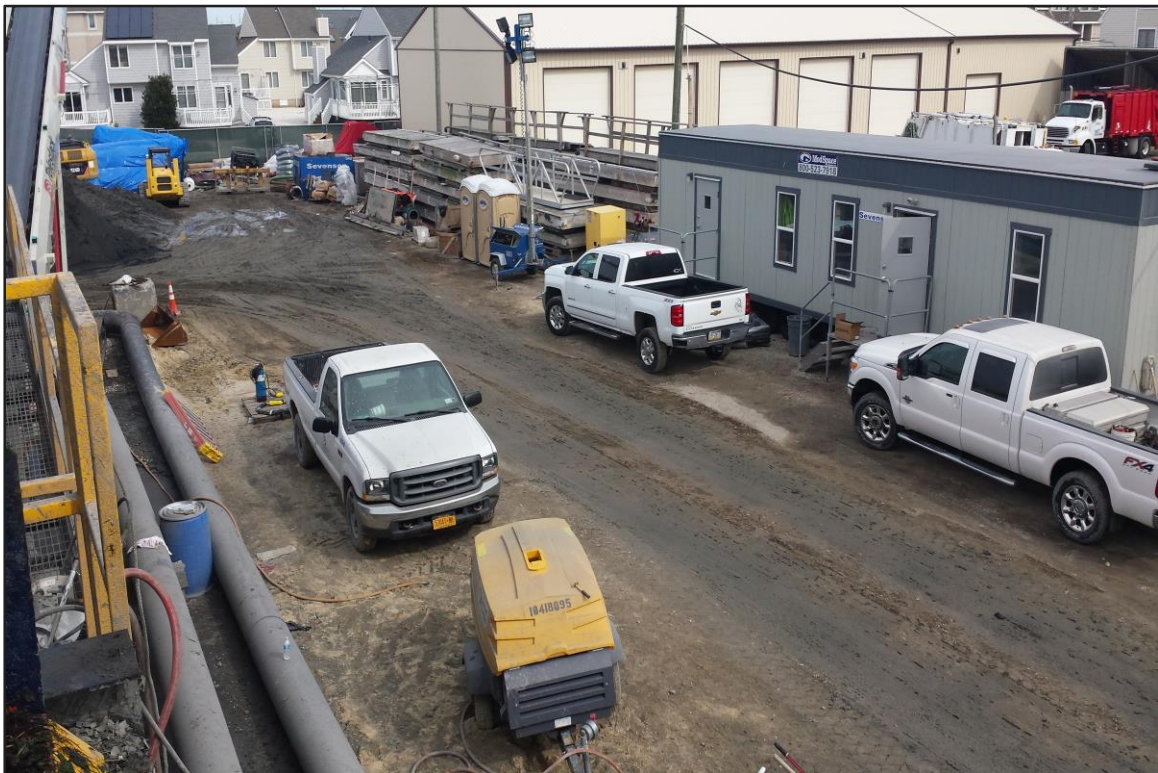
Photograph 4: De-watering Area – Elevated parking area. (Looking northeast)

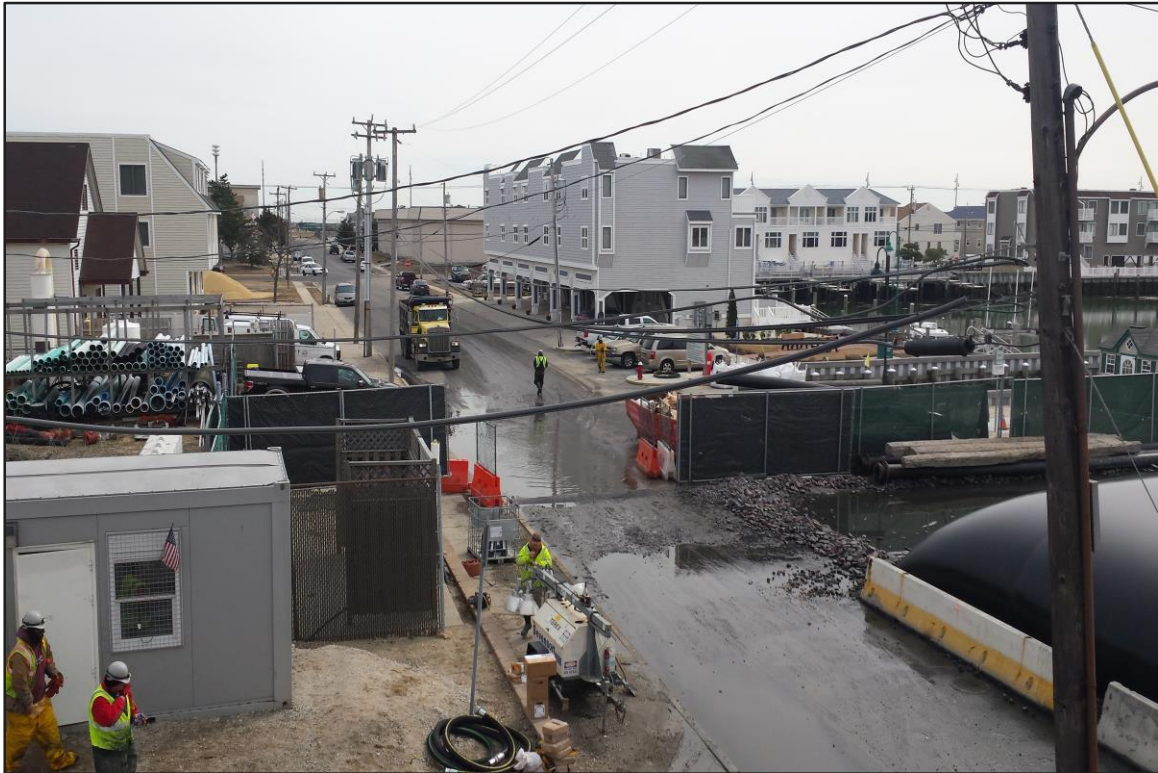
Photograph 5: Site Entrance. (Looking east)

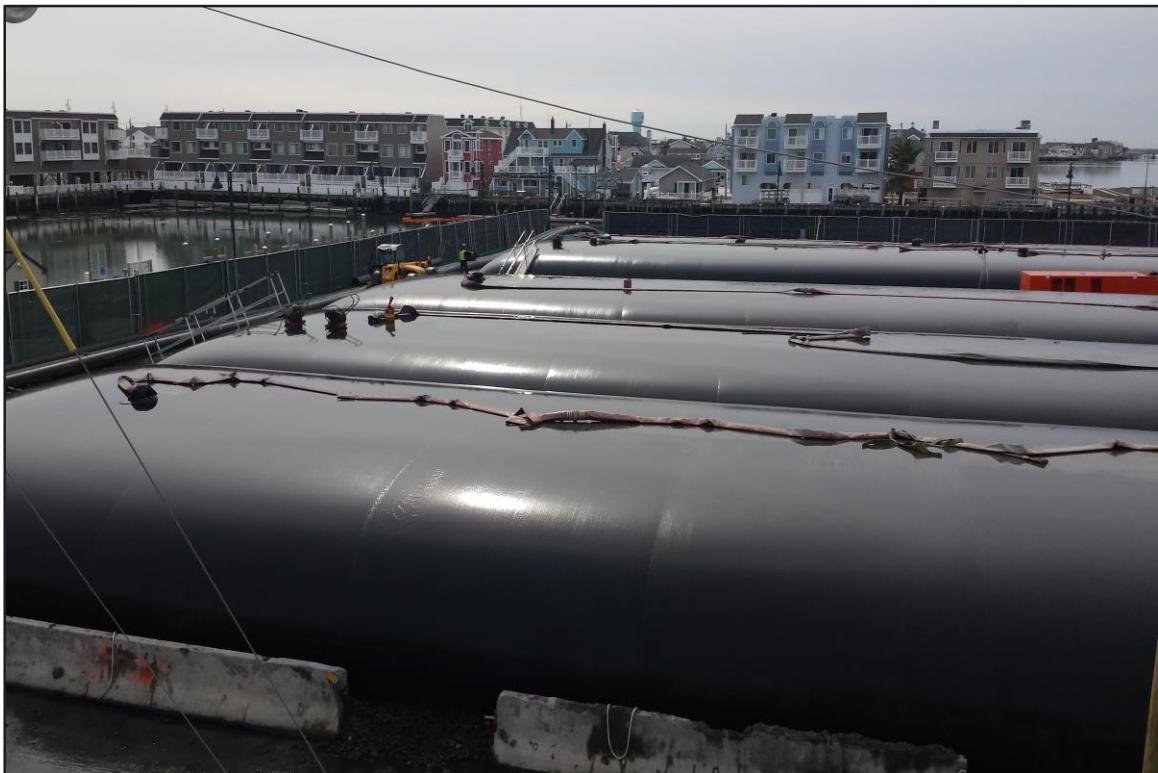
Photograph 6: De-watering Area – Geobags #1-5 in operation. (Looking south)

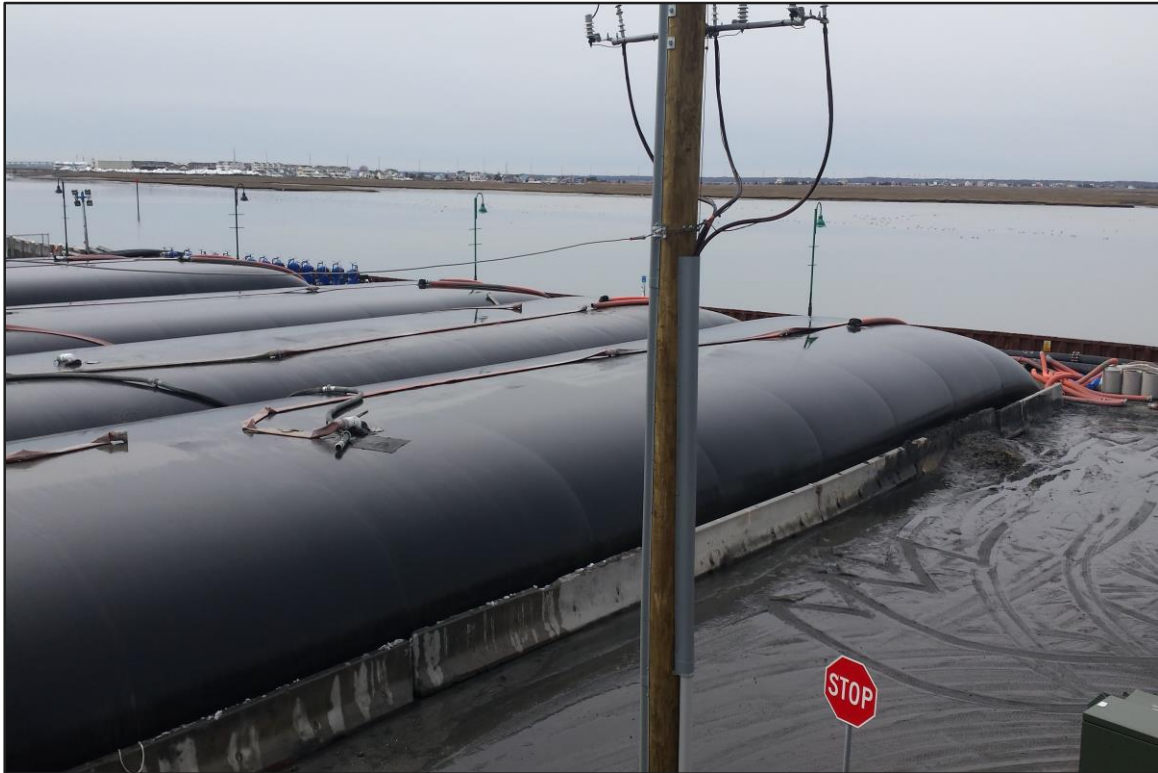
Photograph 7: De-watering Area – Geobags #2-5 in operation. (Looking southwest)

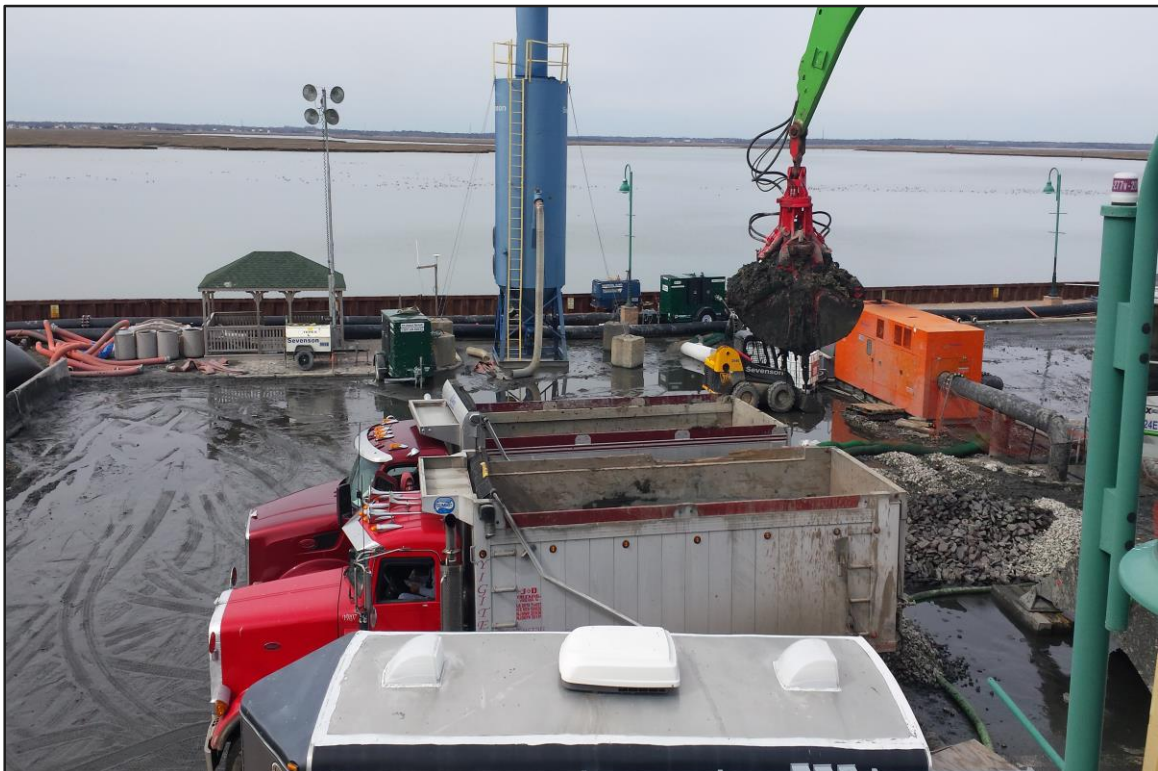
Photograph 8: De-watering Area – Trucks loaded with blended dredge material. (Looking west)

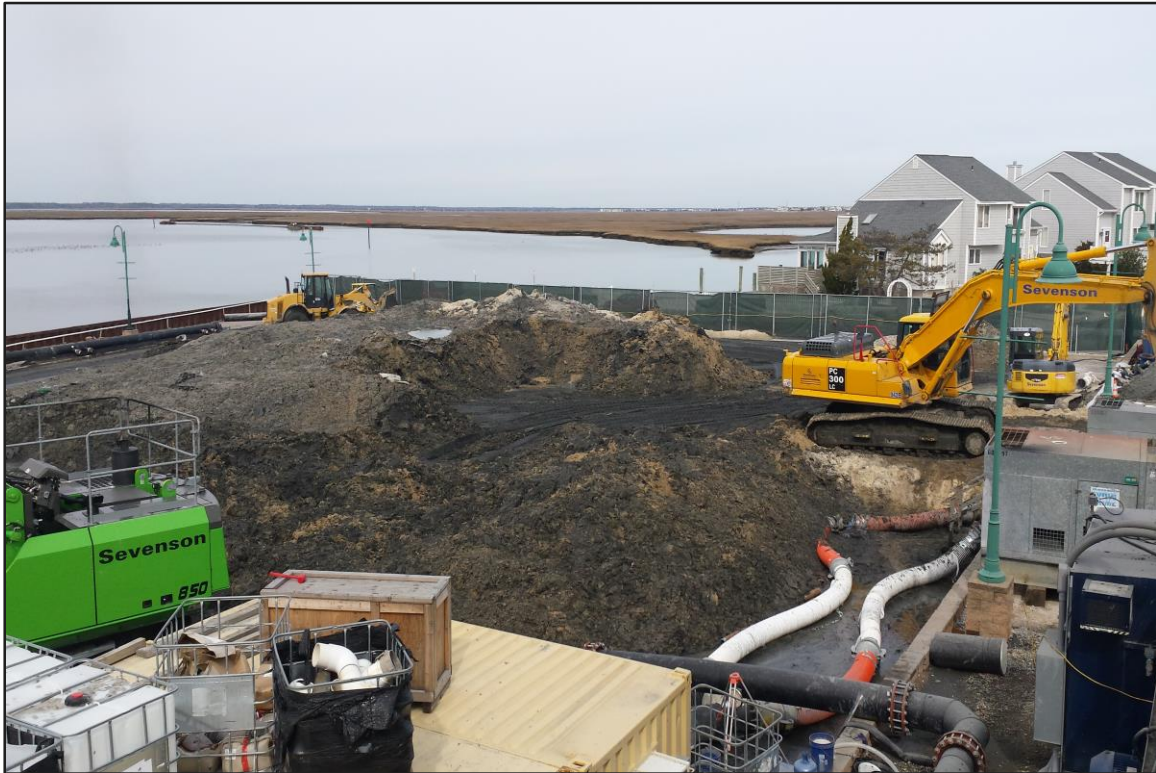
Photograph 9: De-watering Area – Blended dredge material staged for removal. (Looking northwest)

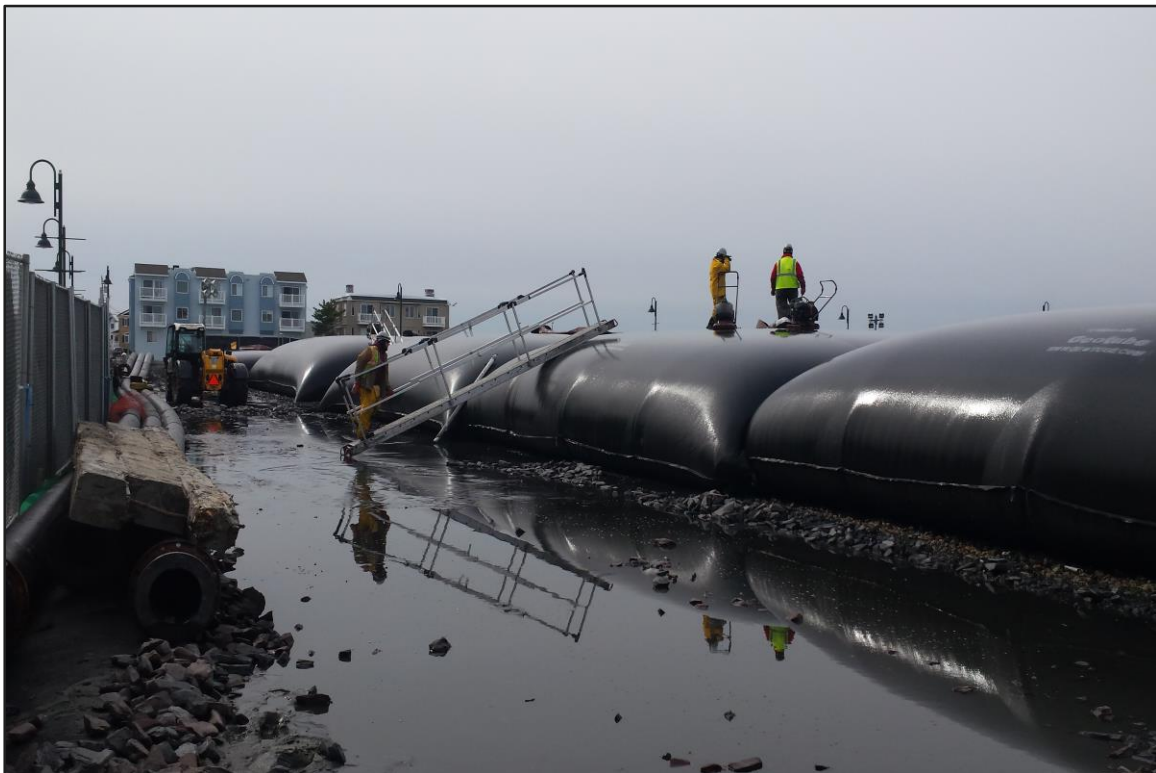
Photograph 10: De-watering Area – Geobags #1-5 in operation. (Looking southwest)

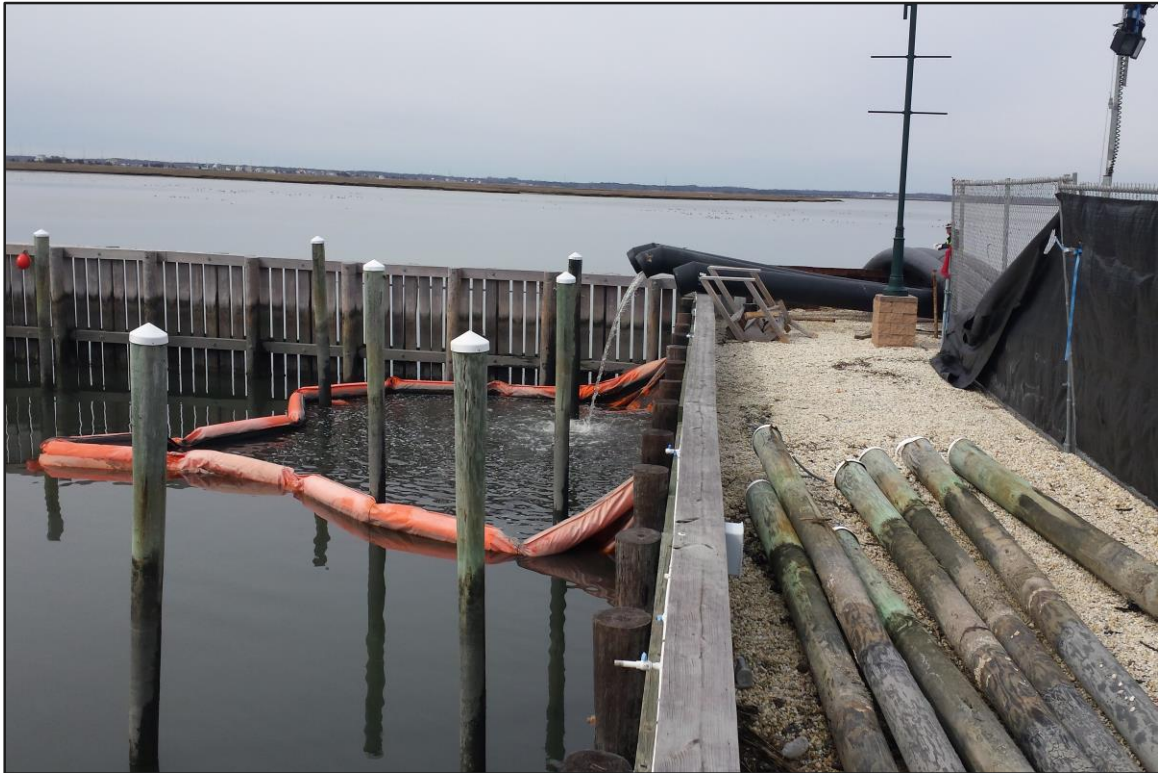
Photograph 11: North Basin/De-watering Area – Discharge pipes in operation. (Looking west)

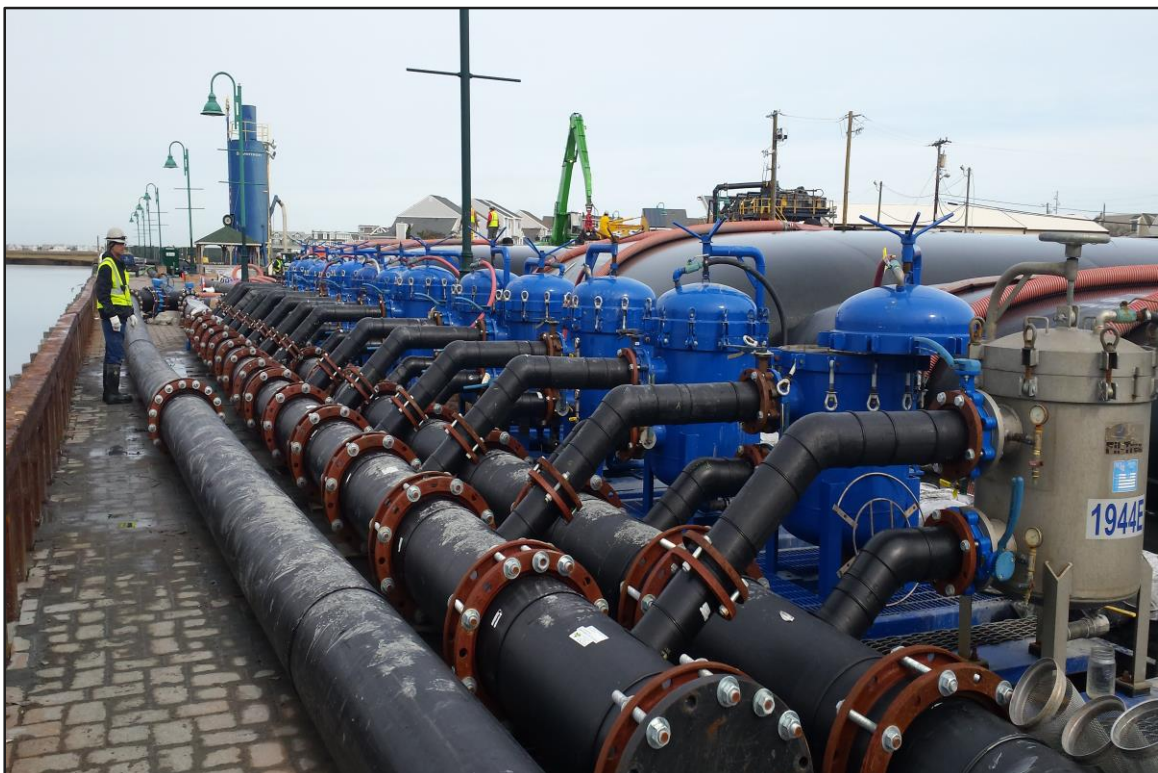
Photograph 12: De-watering Area – Filtration system in operation. (Looking north)

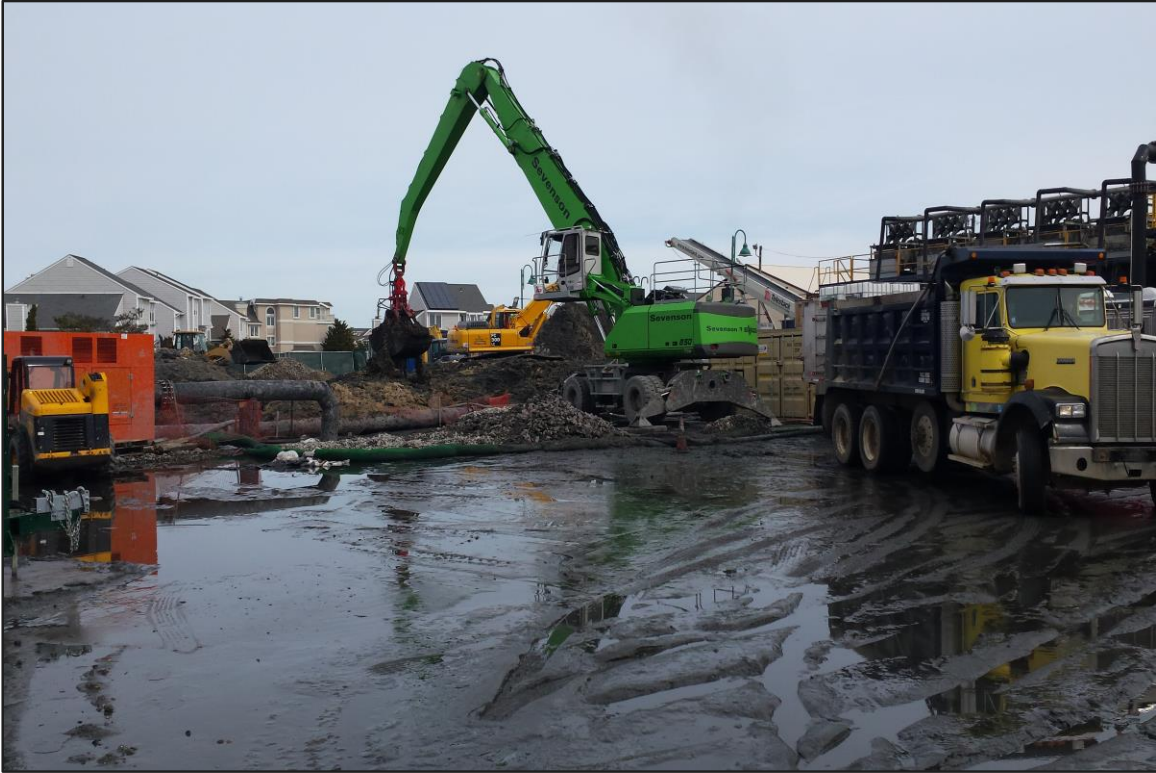
Photograph 13: De-watering Area – Trucks loaded with blended dredge material. (Looking north)
