FIELD REPORT

TITLE Stone Harbor Maintenance Dredging
 DATE February 22, 2016
 TO Jill Gougher
 COPY MADN
 FROM BEWI
 PROJECT NO A06772

Project Information

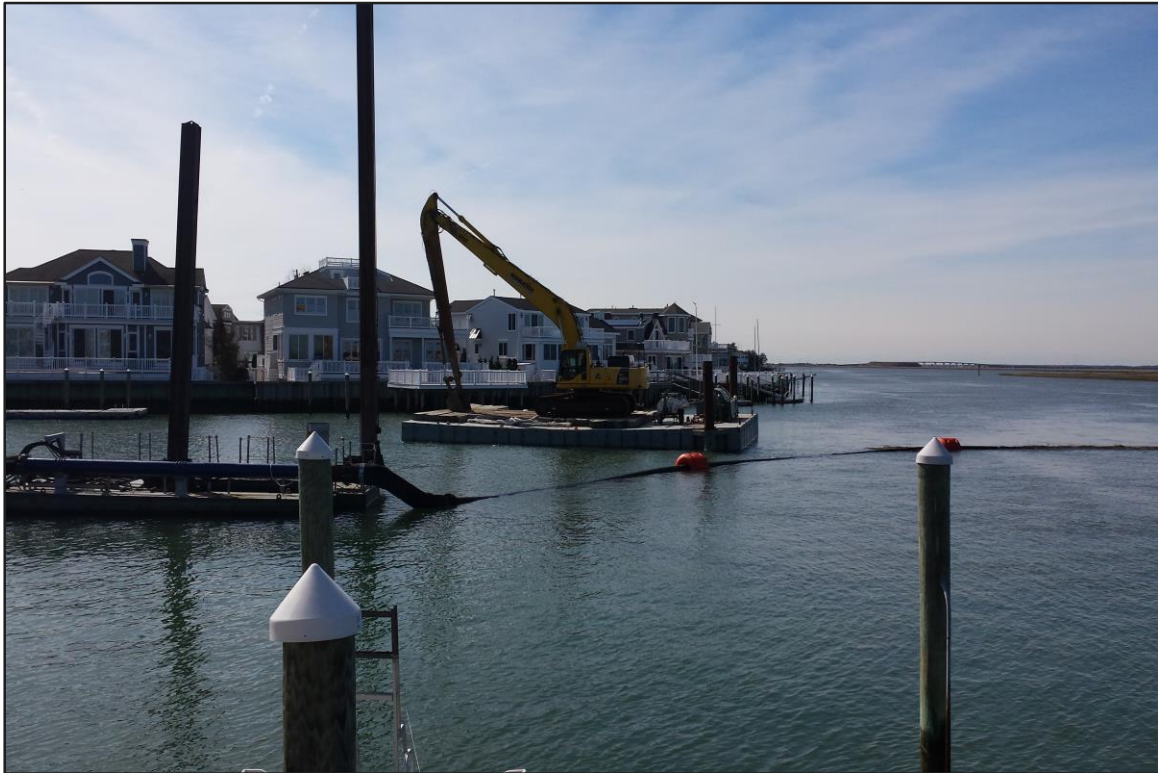
Photograph 1: Shelter Haven – Mechanical dredge on standby. (Looking south)

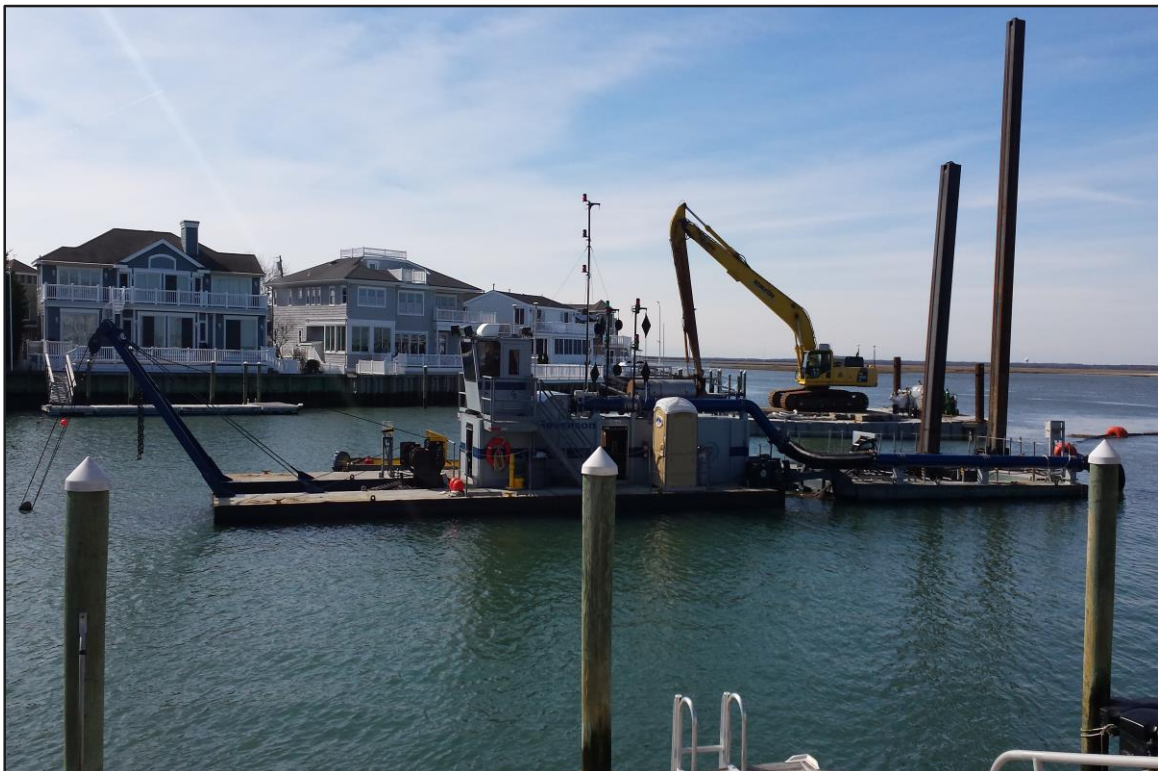
Photograph 2: Shelter Haven - Hydraulic Dredge in operation. (Looking south)

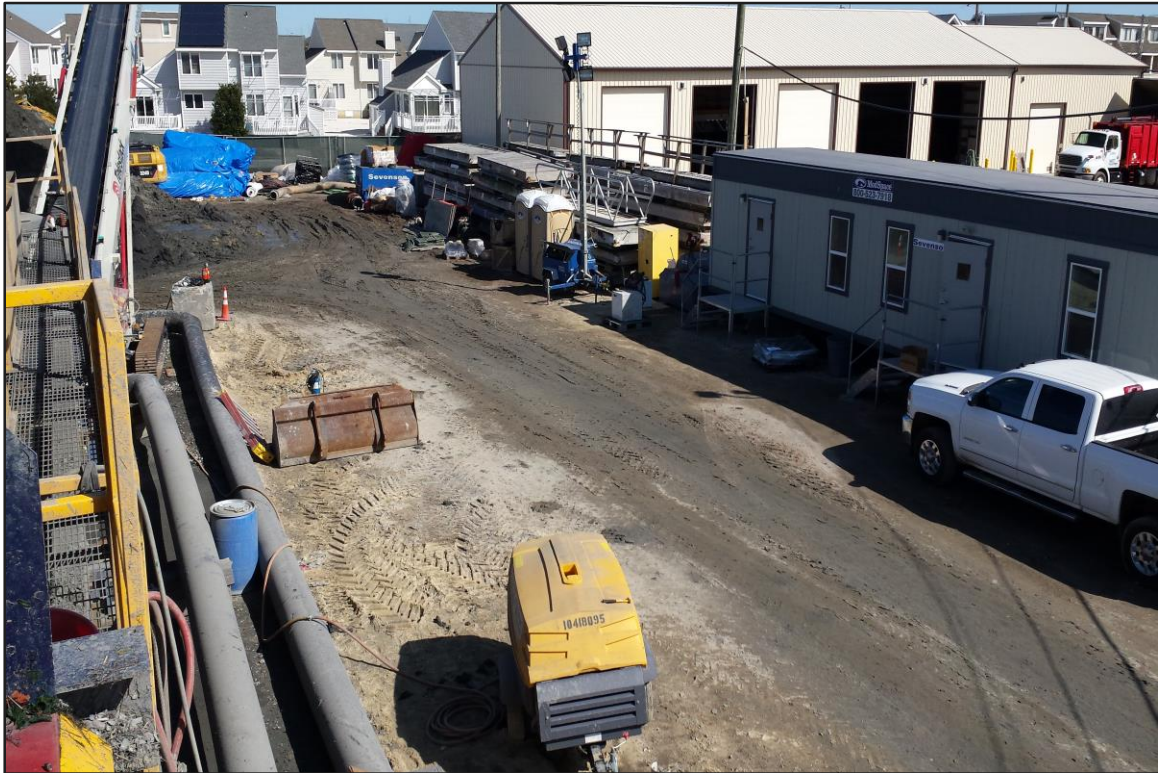
Photograph 3: De-watering Area – Elevated parking area. (Looking northeast)

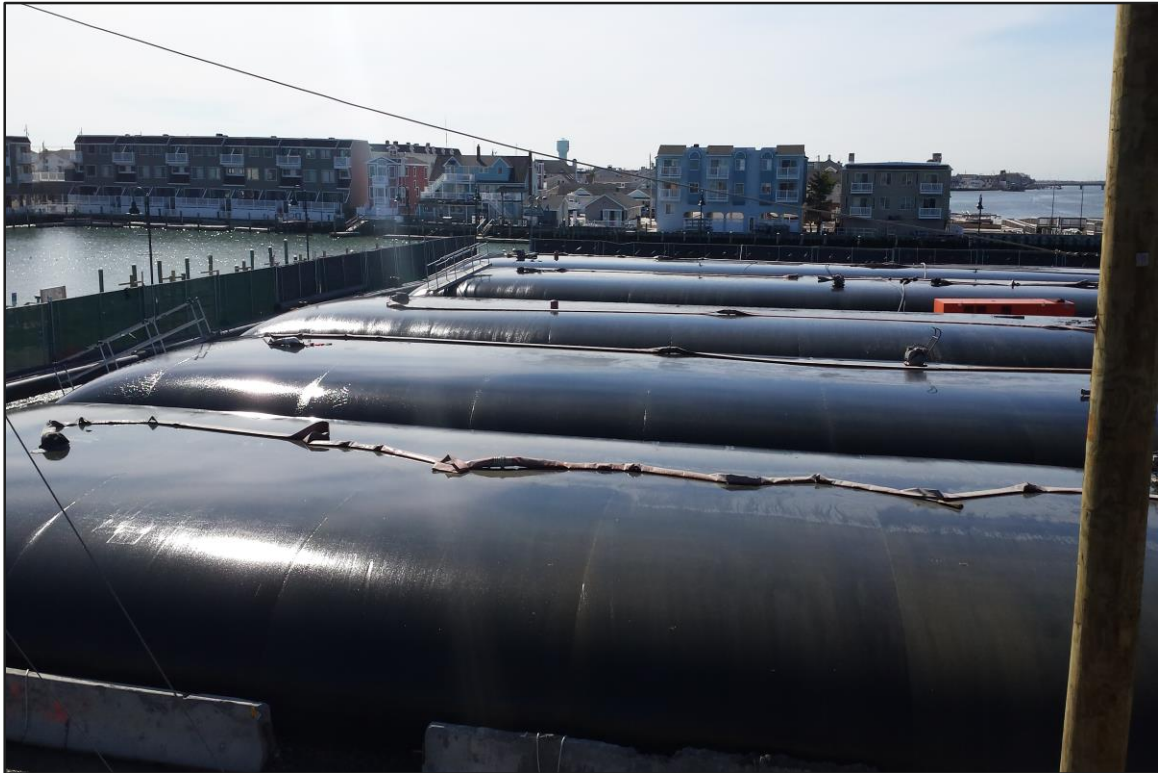
Photograph 5: De-watering Area – Geobags #1-5 in operation. (Looking south)

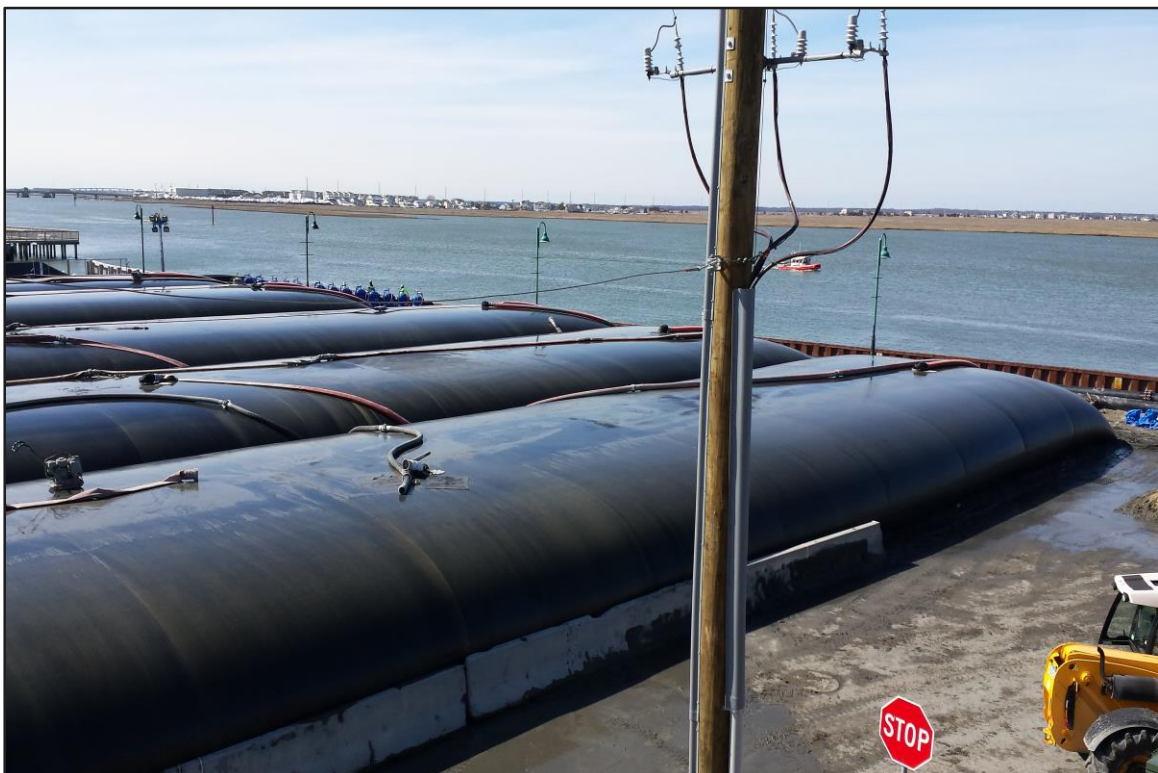
Photograph 6: De-watering Area – Geobags #1-5 in operation. (Looking southwest)

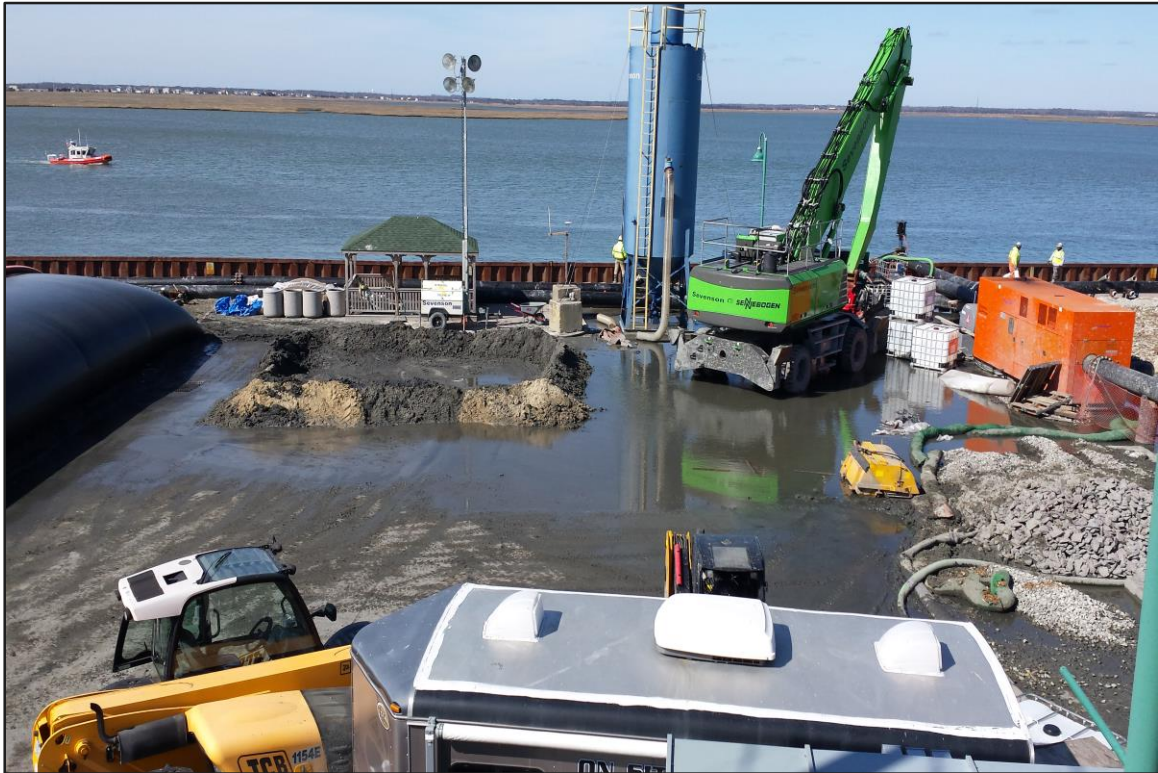
Photograph 7: De-watering Area – Equipment on standby. (Looking west)

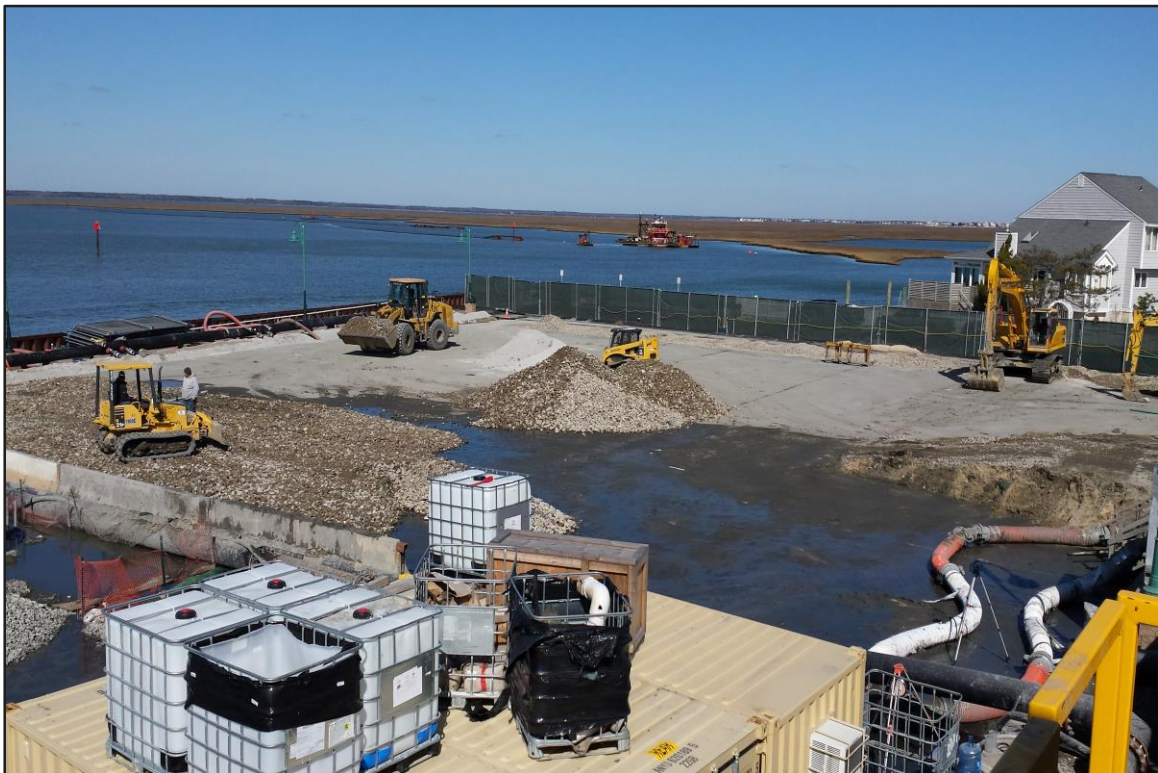
Photograph 8: De-watering Area – Pad preparation for geobags #6-9. (Looking northwest)

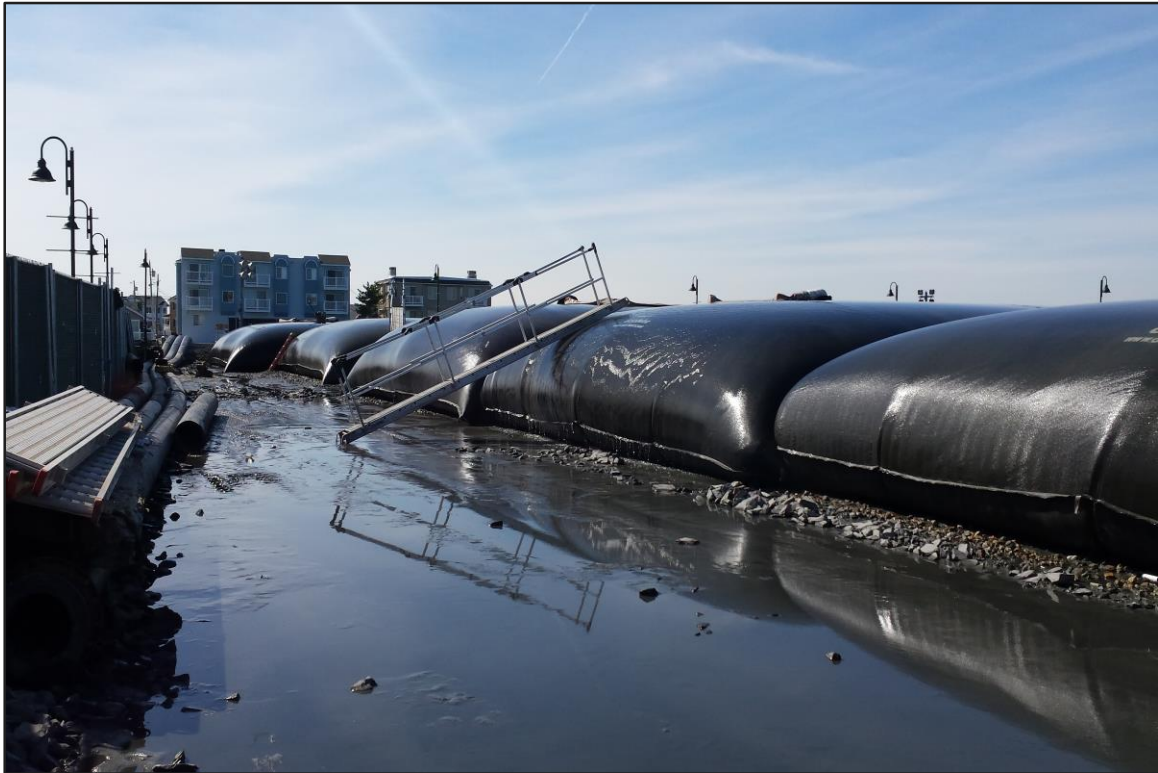
Photograph 9: De-watering Area – Geobags #1-5 in operation. (Looking south)

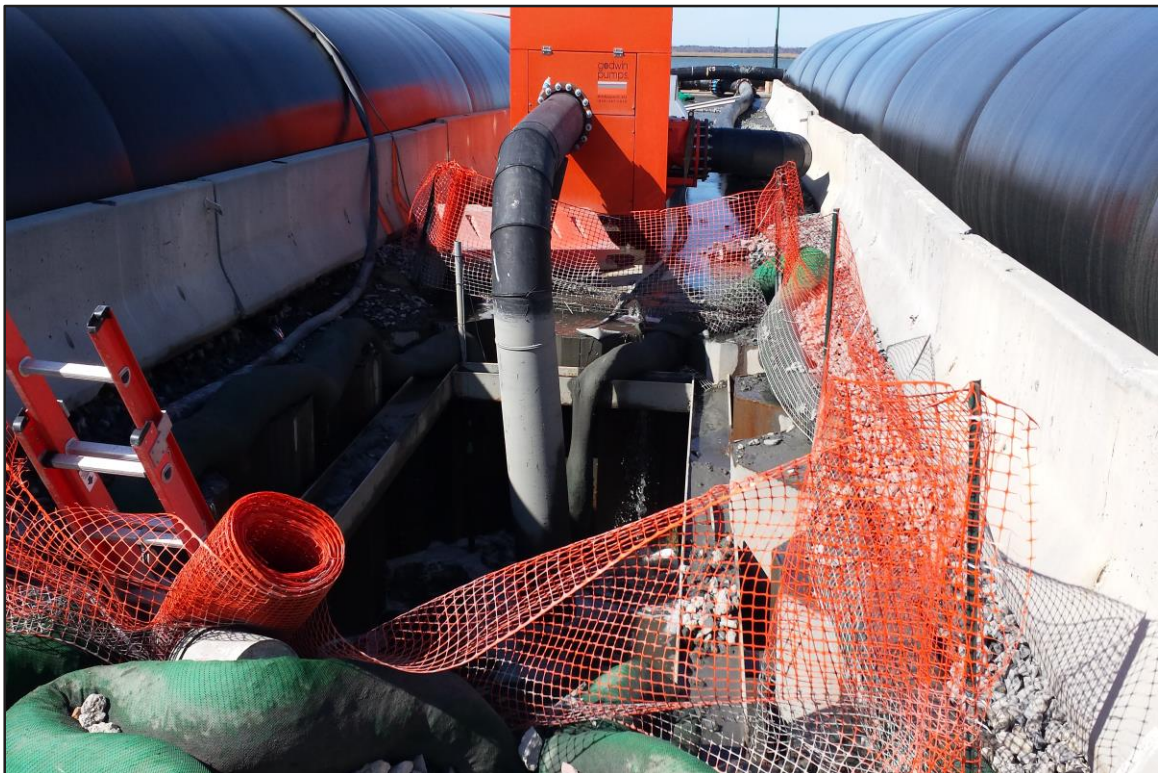
Photograph 10: De-watering Area – Sump pump in operation. (Looking west)

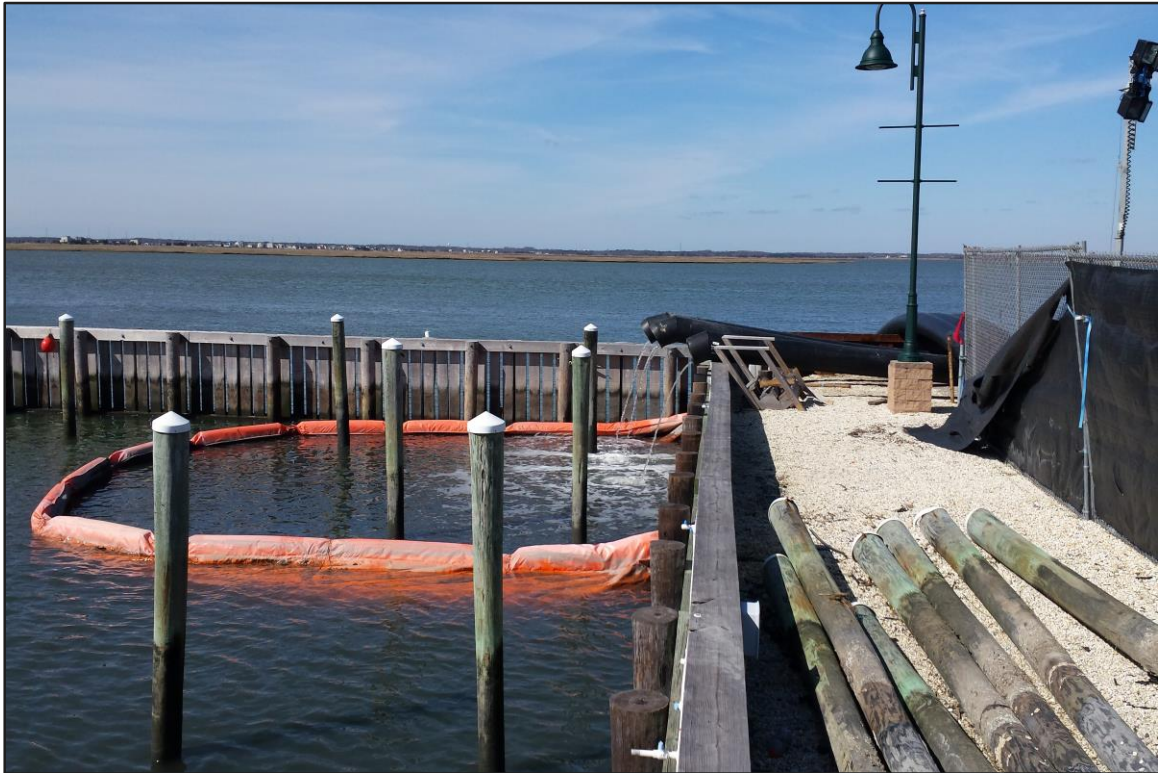
Photograph 11: North Basin/De-watering Area – Discharge pipes in operation. (Looking west)

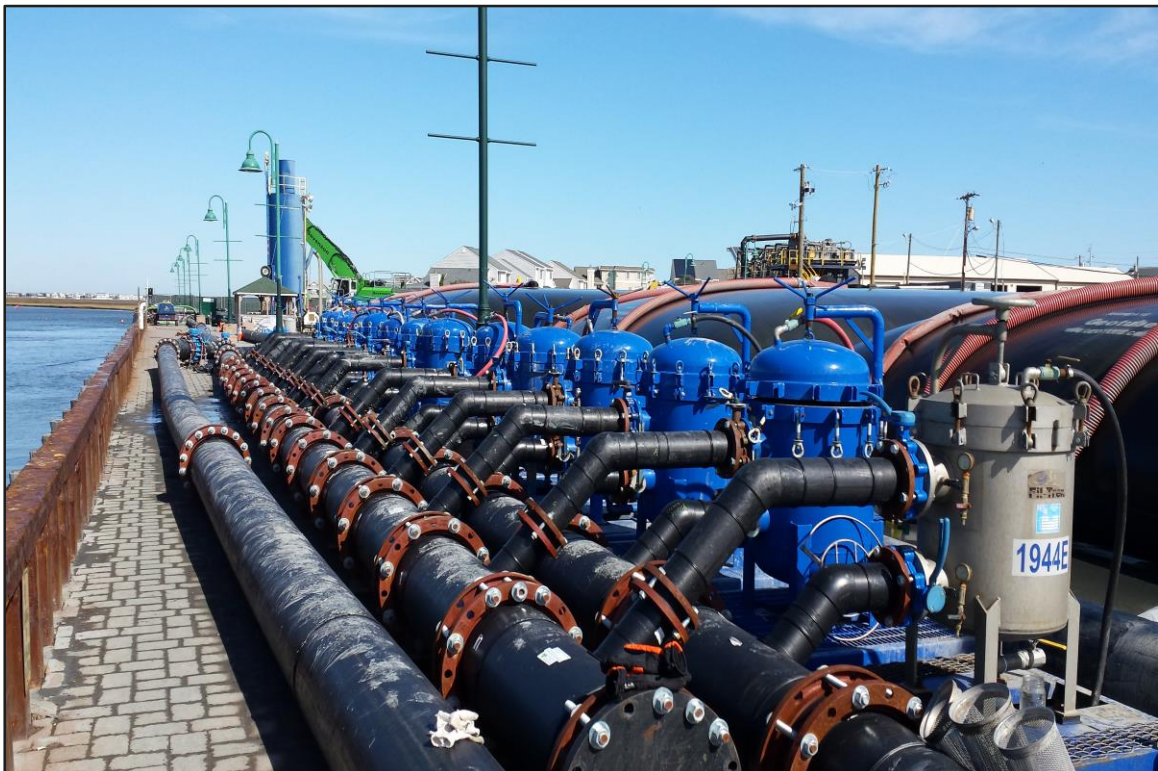
Photograph 12: De-watering Area – Filtration system in operation. (Looking north)

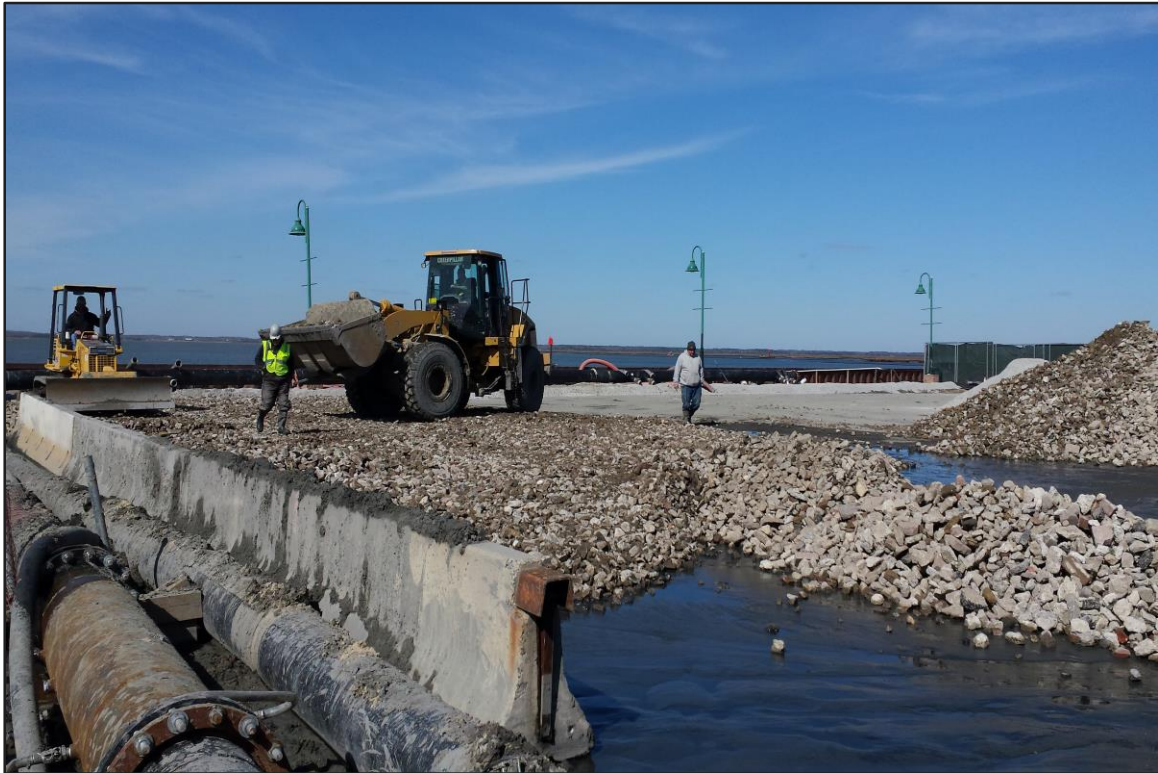
Photograph 13: De-watering Area – Pad preparation for geobags #5-9. (Looking northwest)
