## FIELD REPORT

TITLE Stone Harbor Maintenance Dredging  
 DATE March 10, 2016  
 TO Jill Gougher  
 COPY MADN  
 FROM BEWI  
 PROJECT NO A06772

**Owner:** The Borough of Stone Harbor  
**Contractor:** Severson Environmental Services, Inc.

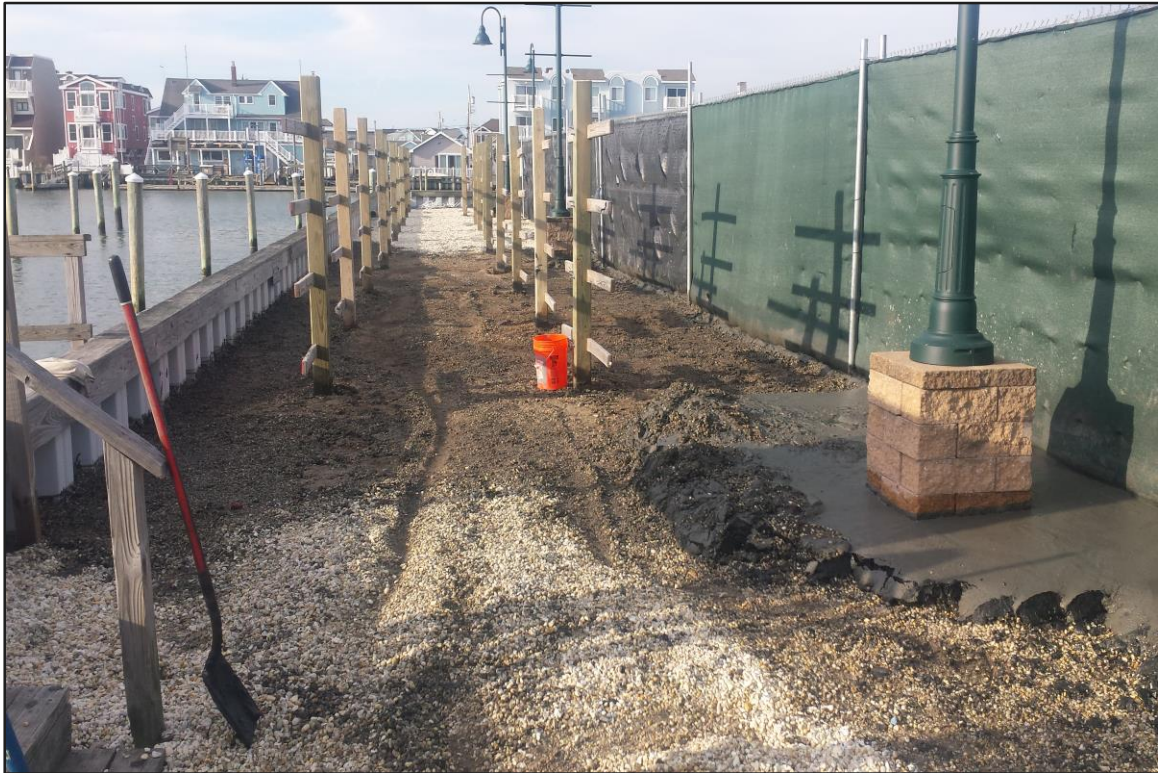
*Photograph 1: De-Watering Area – Cleanup of dredge slurry. (Looking south)*

**Actions to be Taken:** Cleanup.

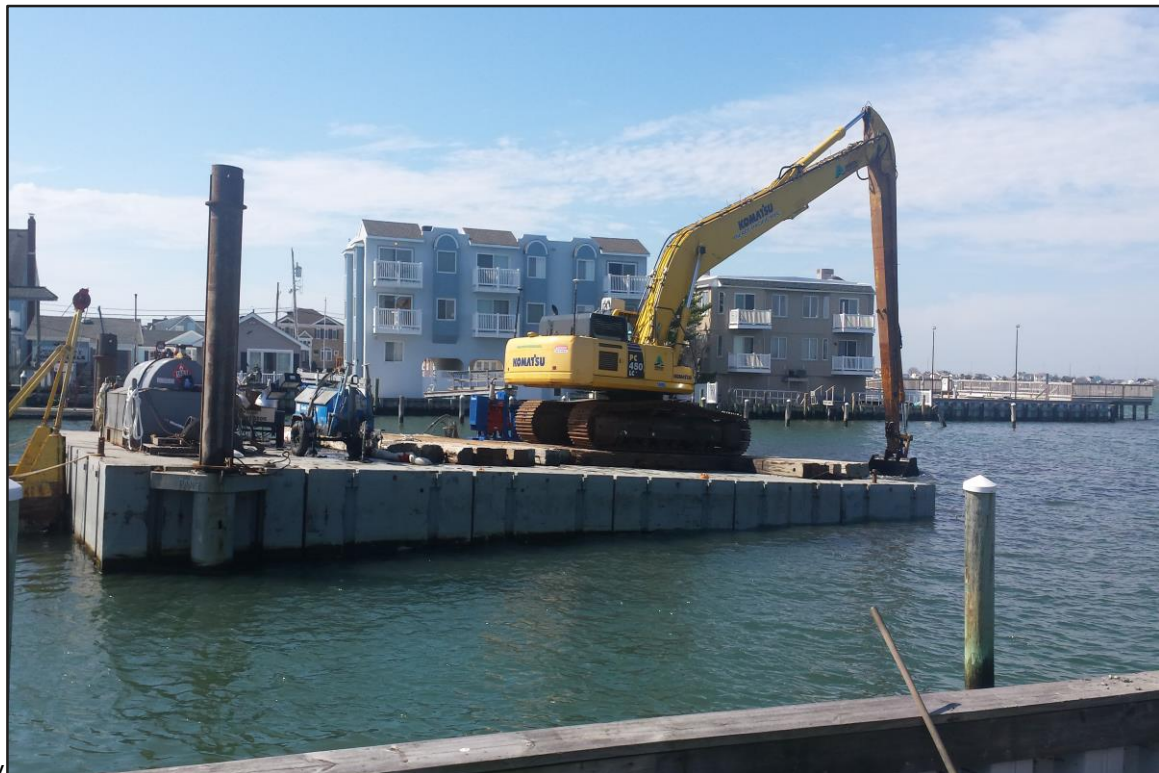
*Photograph 2: North Basin – Mechanical dredging in progress. (Looking south)*

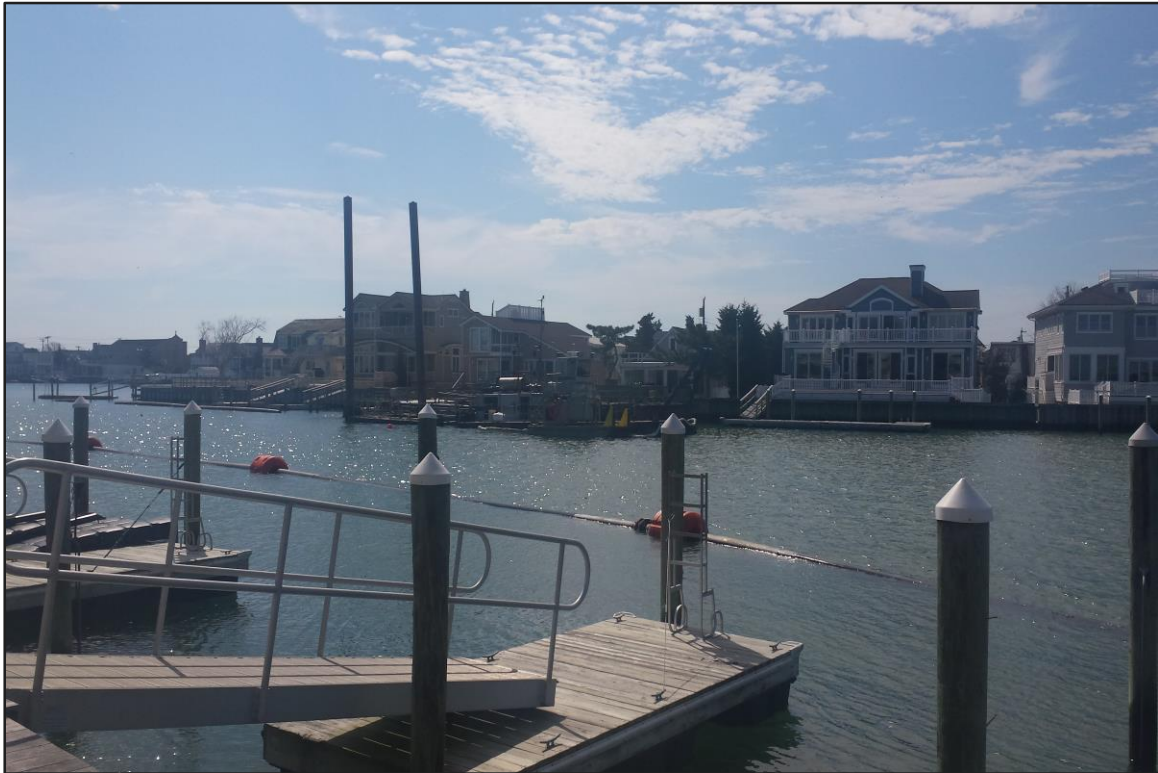
*Photograph 3: Shelter Haven – Hydraulic dredge on standby. (Looking southeast)*

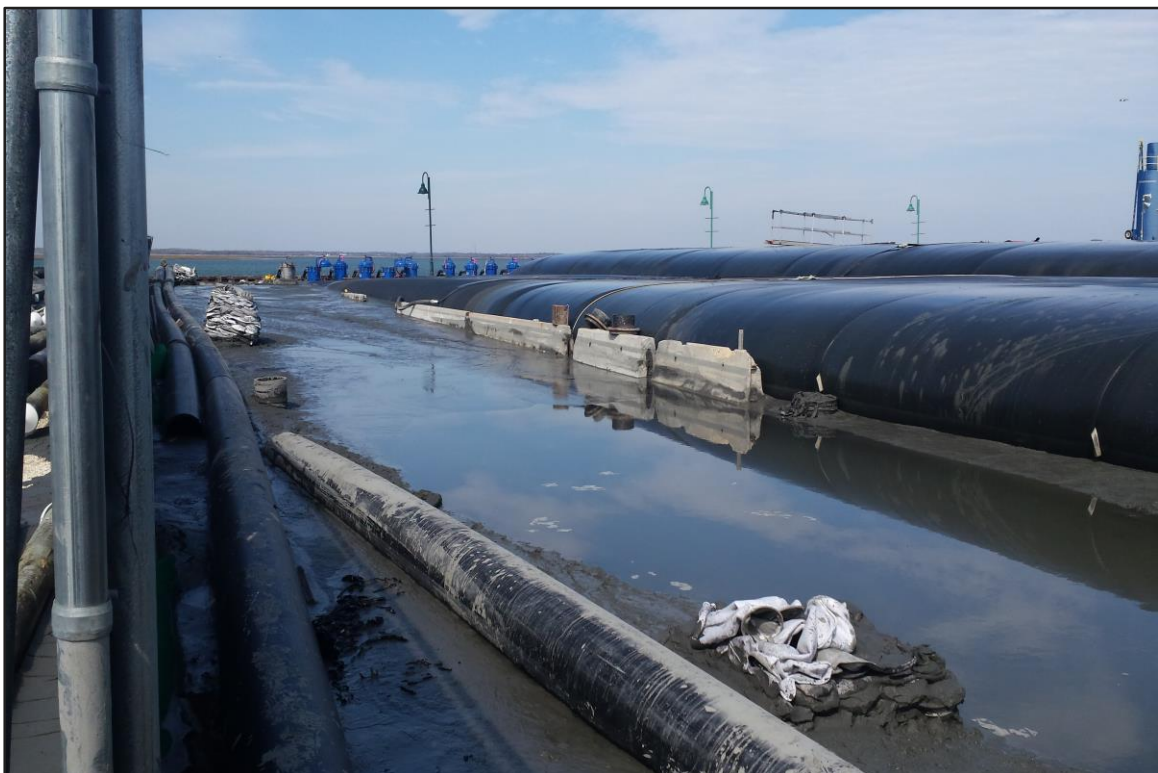
*Photograph 4: De-Watering Area – Dredged material from geobag failure. (Looking west)*

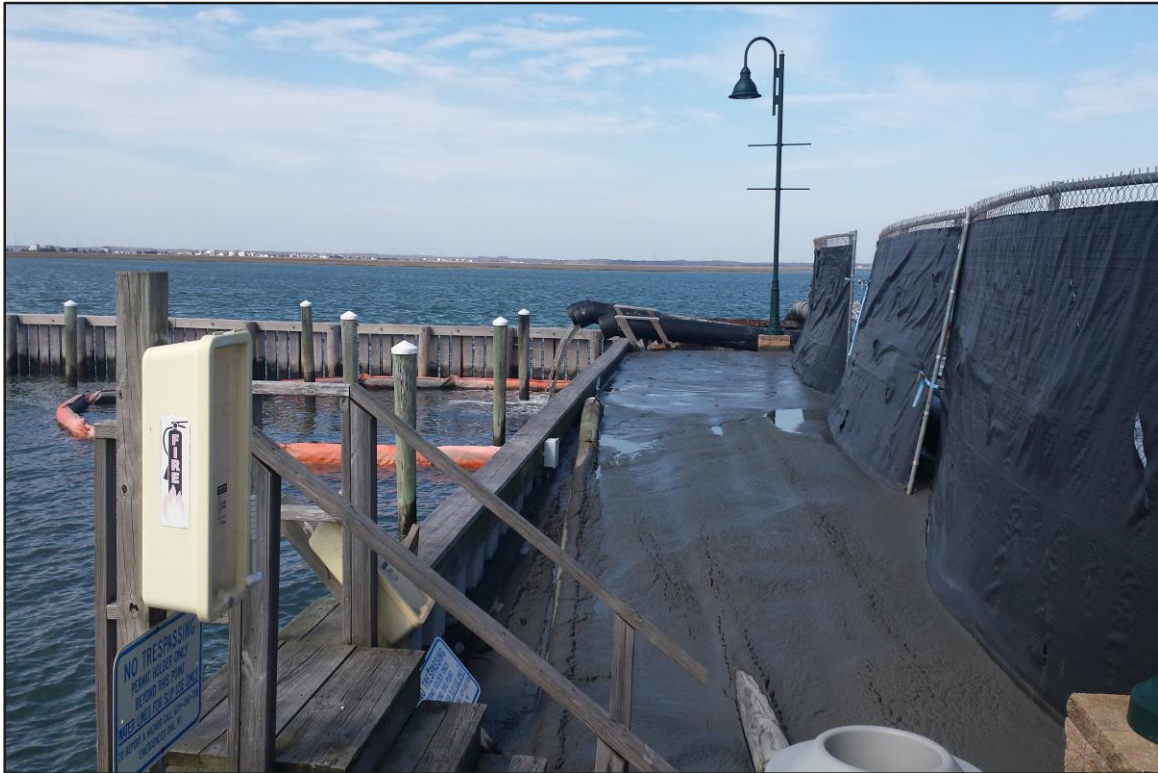
*Photograph 5: De-watering Area/North Basin – Dredged material, discharge pipes. (Looking west)*

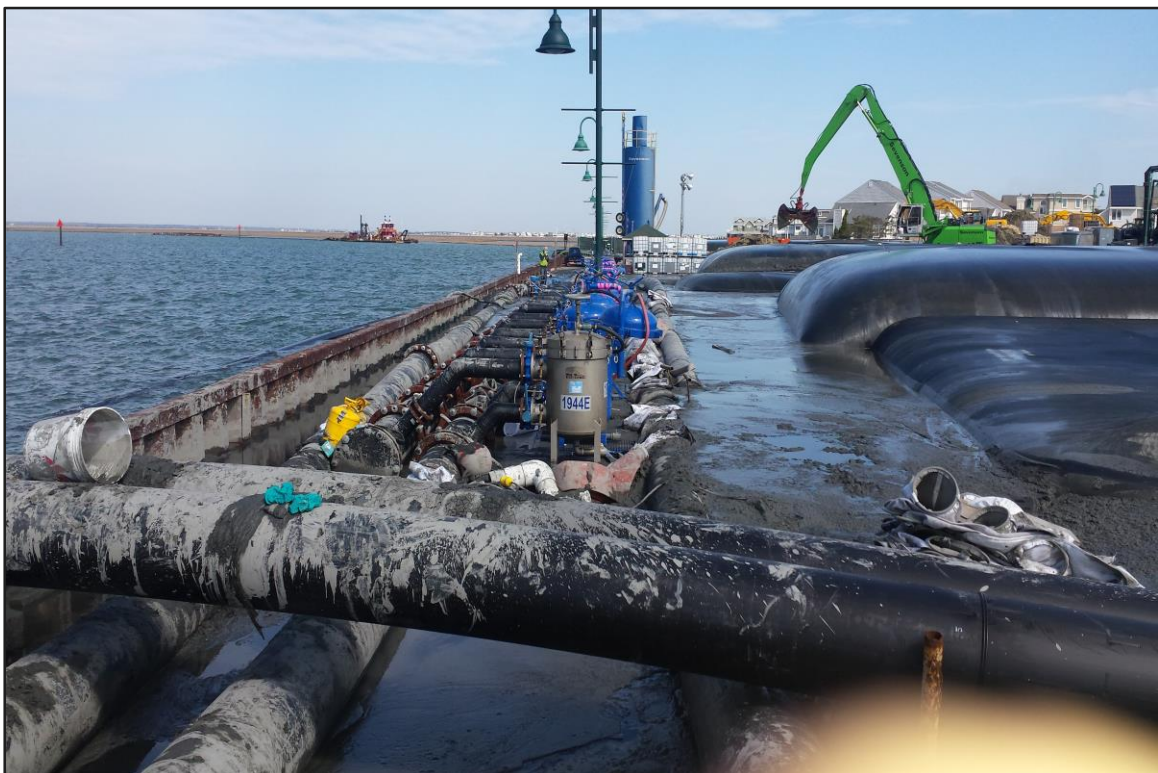
*Photograph 6: De-Watering Area – Dredged material, filtration system. (Looking north)*

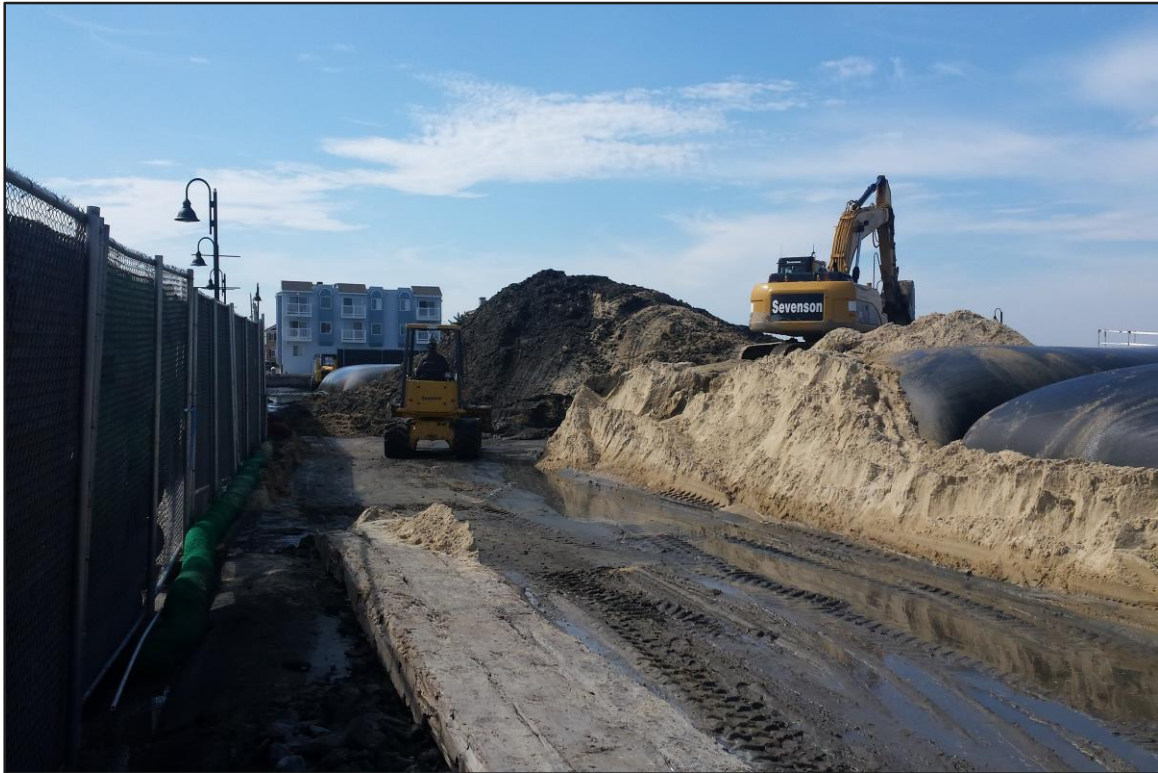
*Photograph 7: De-Watering Area – Sand blending in progress. (Looking south)*

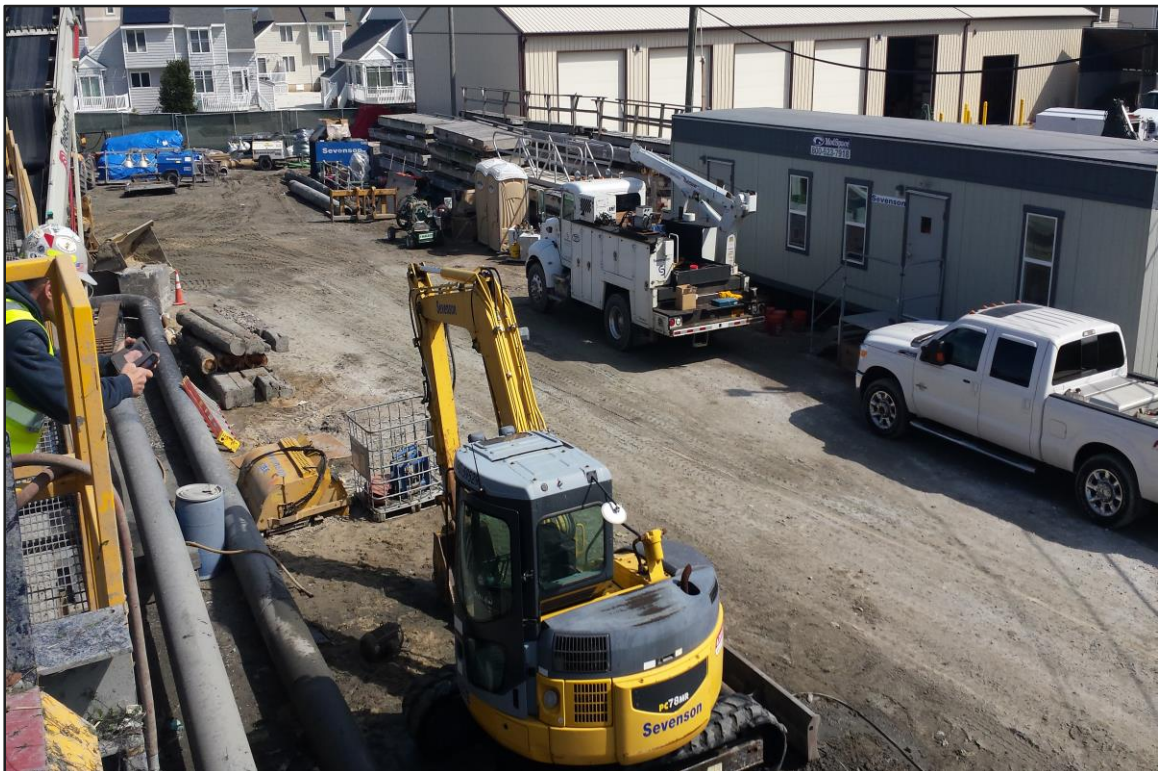
*Photograph 8: De-Watering Area – Elevated parking area, equipment on standby. (Looking northeast)*

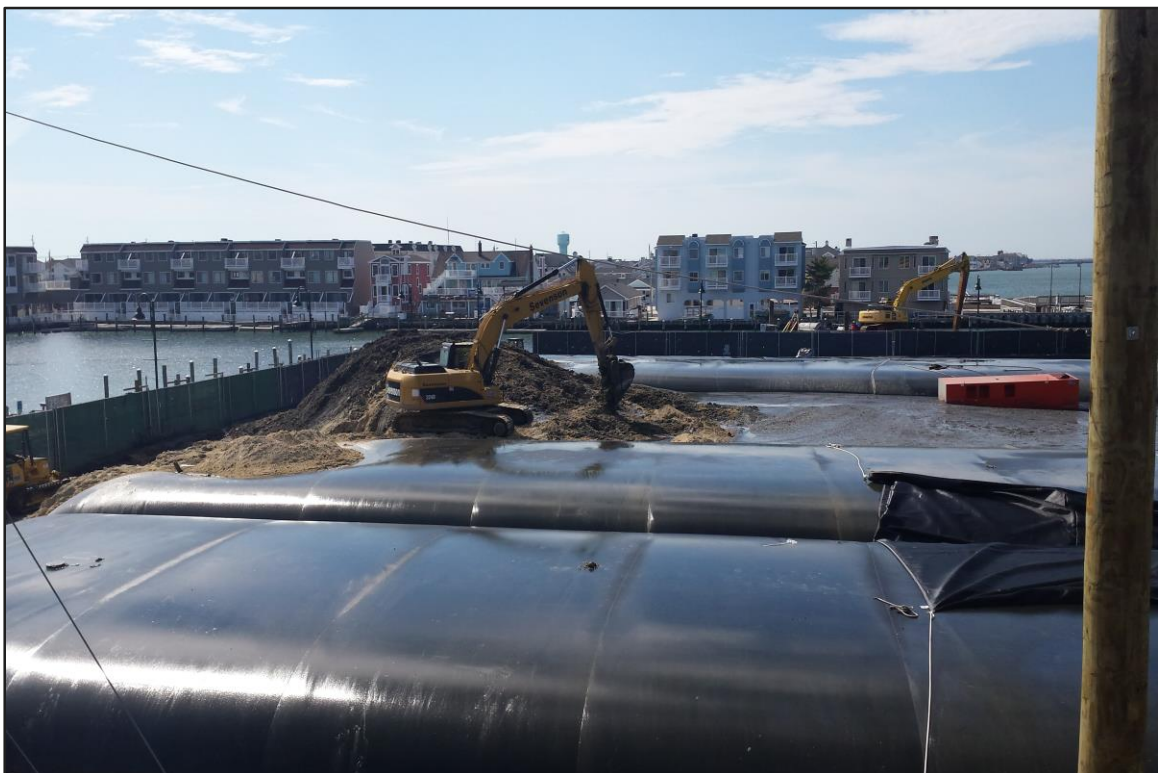
*Photograph 10: De-watering Area – Sand blending in progress. (Looking south)*

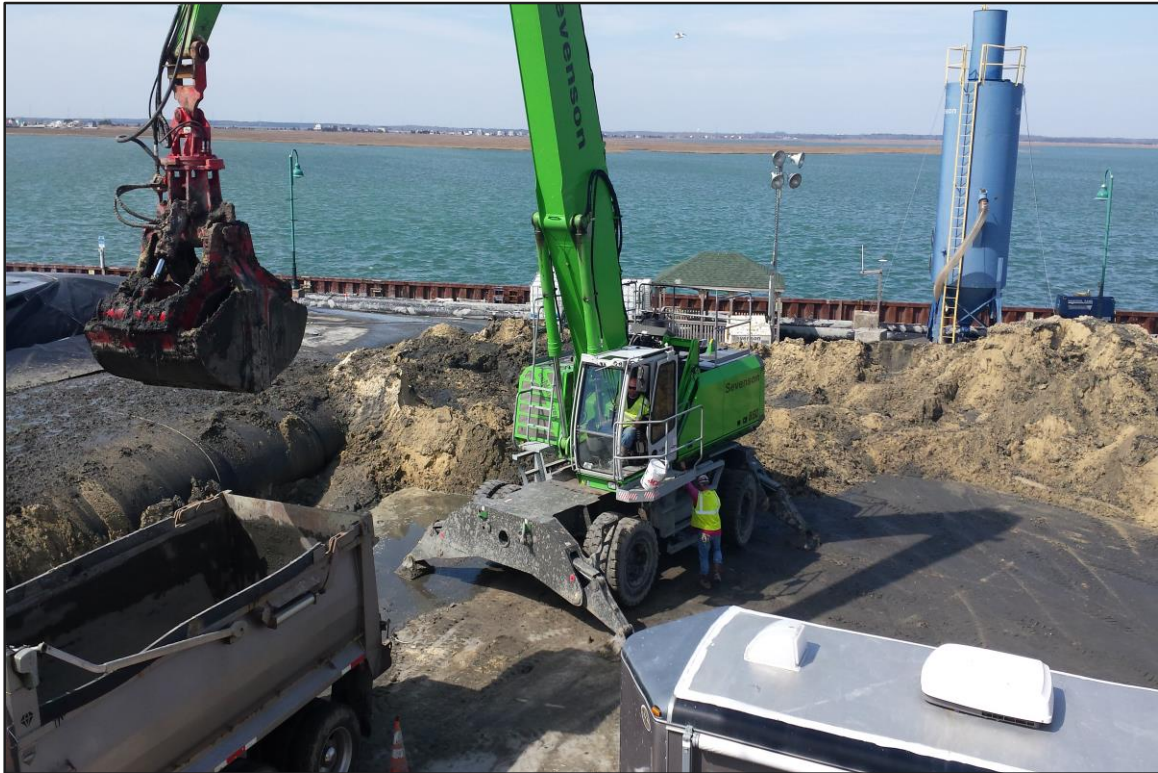
*Photograph 11: De-Watering Area – Material disposal in progress. (Looking west)*

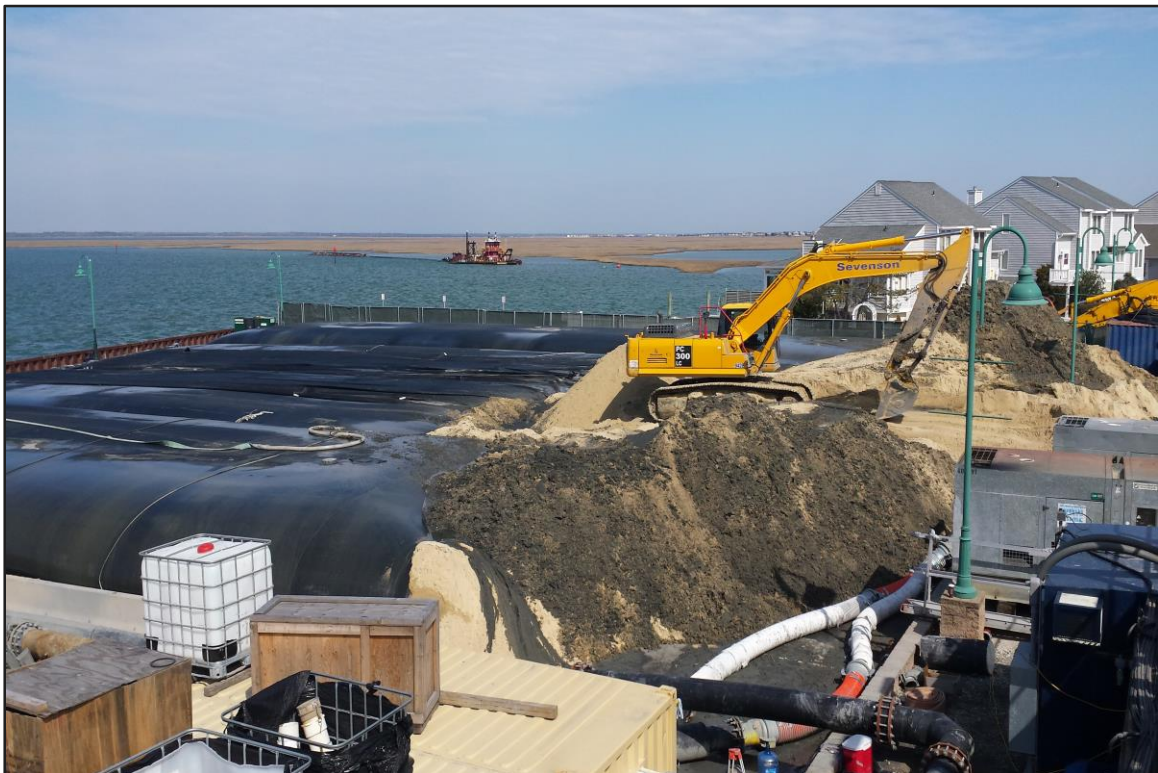
*Photograph 12: De-Watering Area – Sand blending in progress. (Looking north)*
