FIELD REPORT

TITLE Stone Harbor Maintenance Dredging
DATE March 18, 2016
TO Jill Gougher
COPY Matt Dalon, Ben Wilk
FROM Peter Grinnell
PROJECT NO A06772

Purpose of Visit: Observation of work in progress

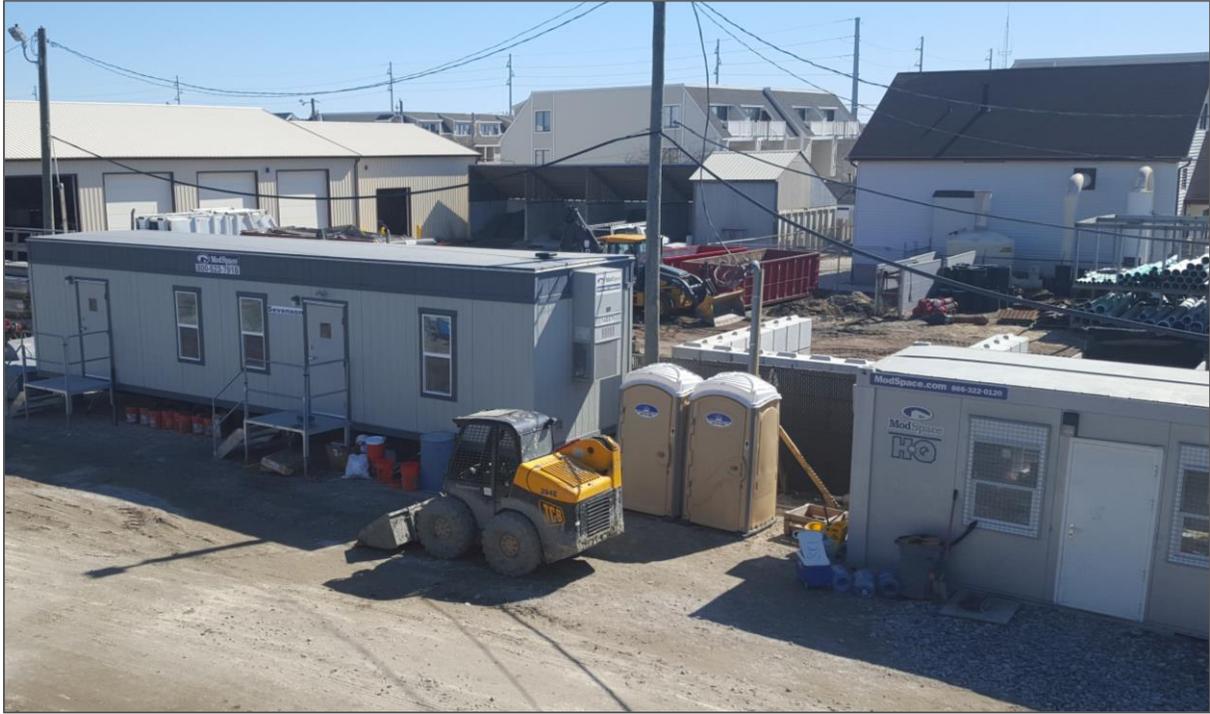
Photograph 1: De-watering Area – Elevated parking lot, equipment on standby. (Looking north)

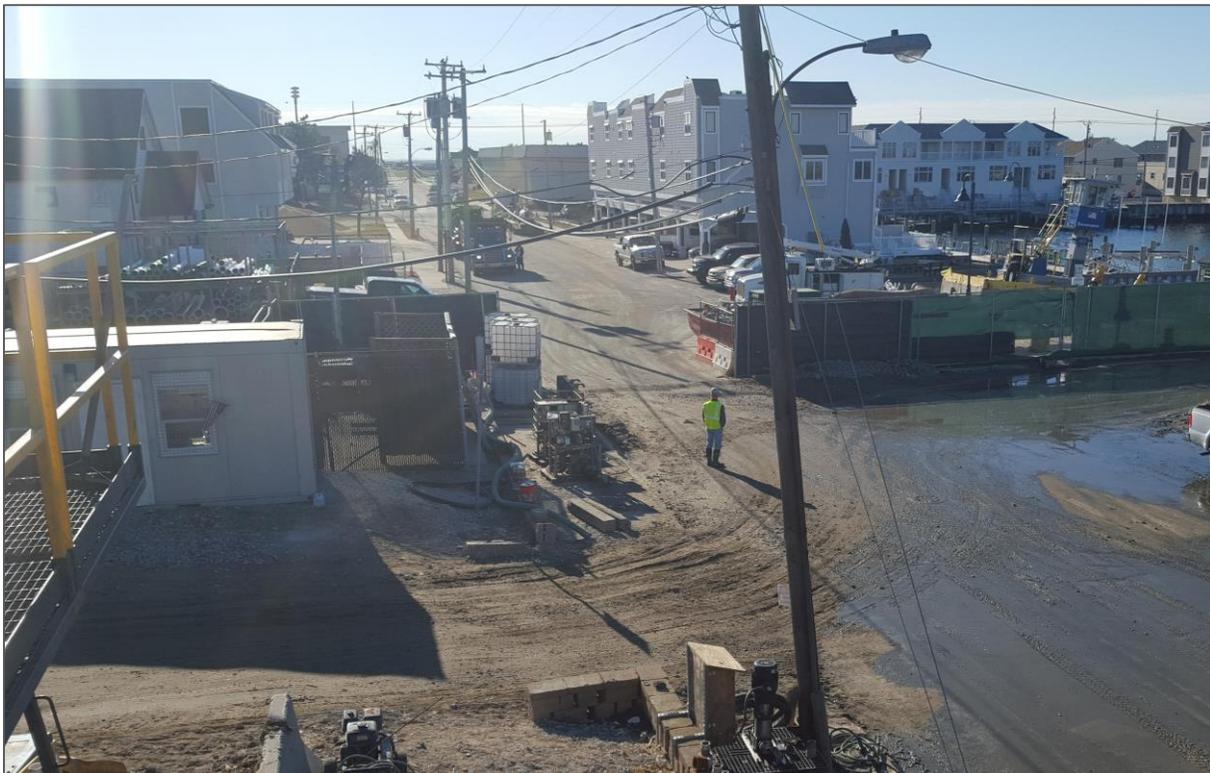
Photograph 2: Site Entrance. (Looking east)

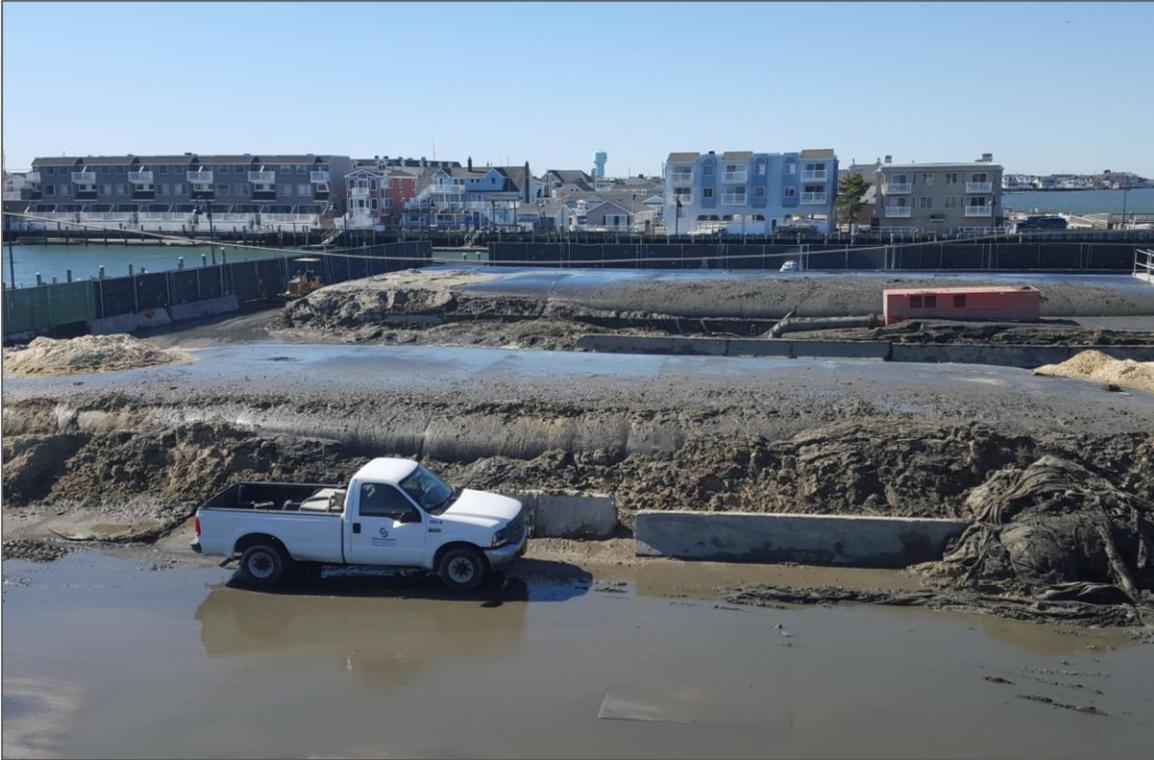
Photograph 3: De-watering Area – Sand blending in progress. (Looking south)

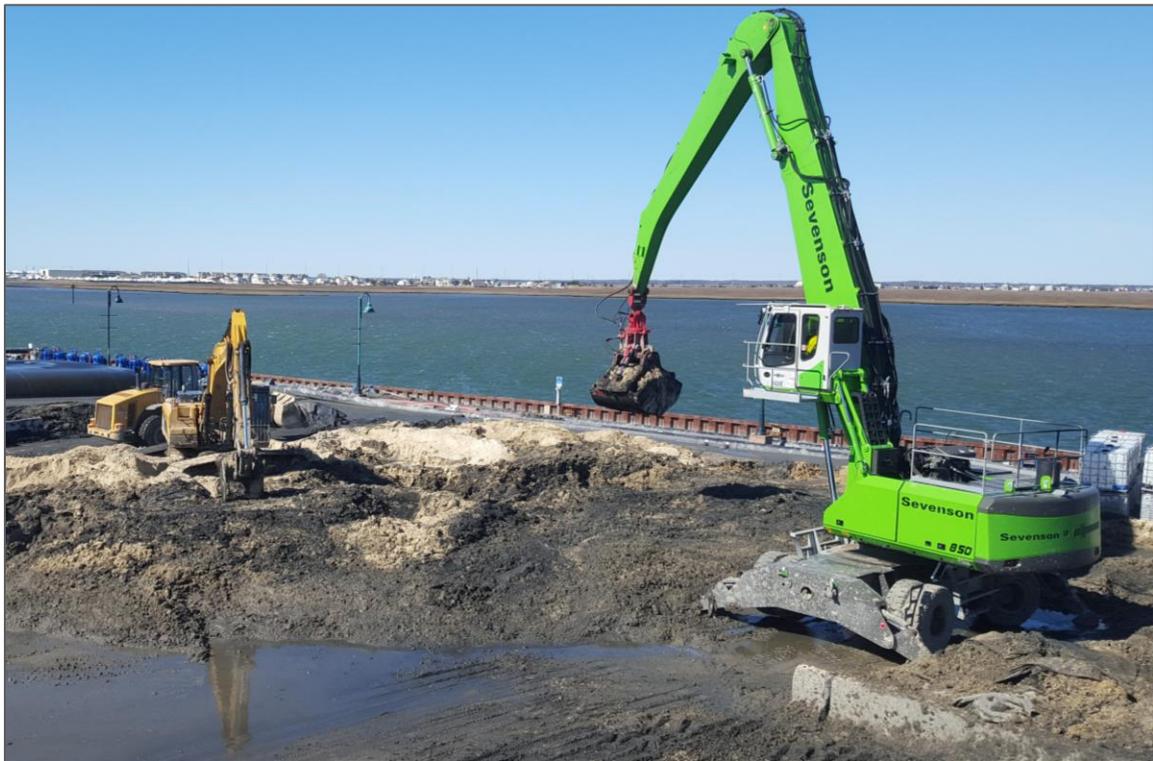
Photograph 4: De-watering Area – Sand blending in progress. (Looking southwest)

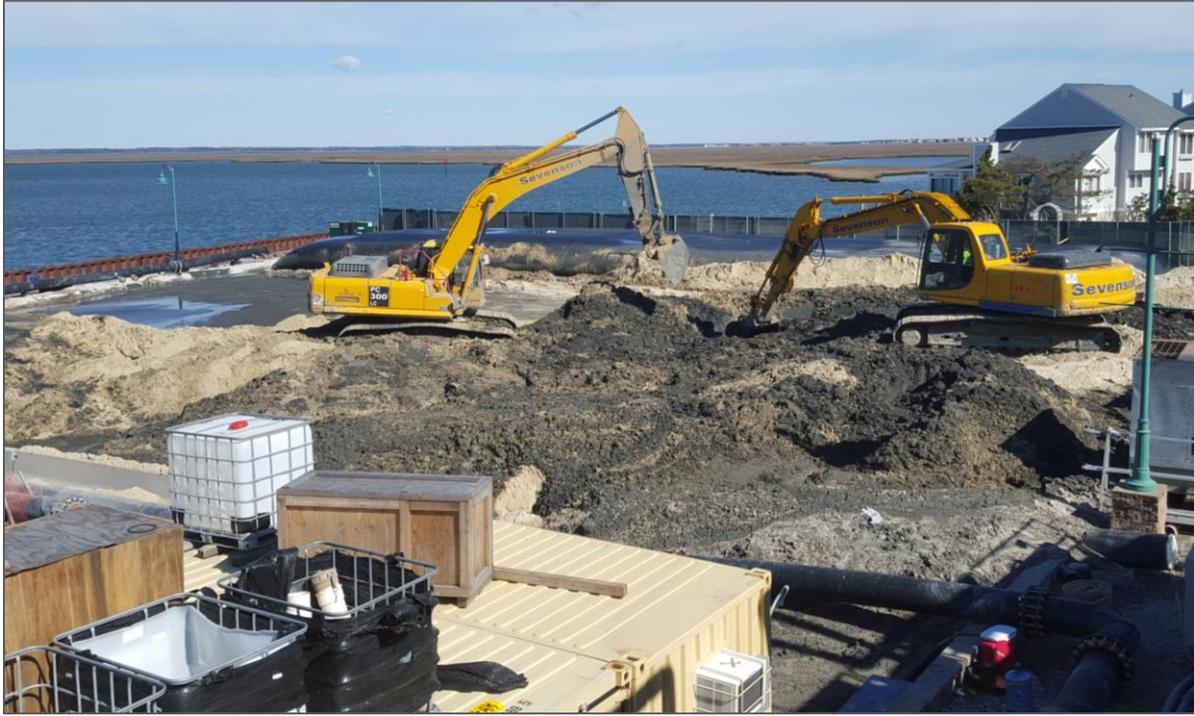
Photograph 5: De-watering Area – Sand blending in progress. (Looking northwest)

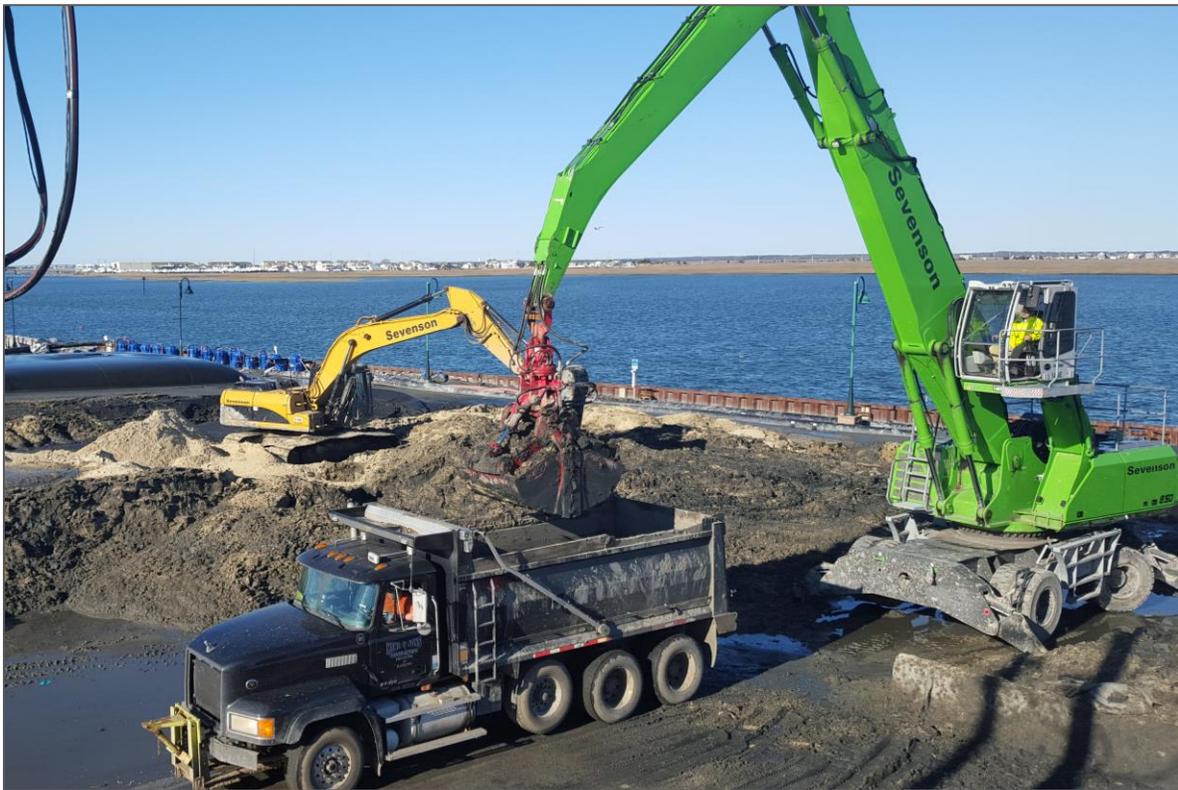
Photograph 6: De-watering Area – Material disposal in progress. (Looking southwest)

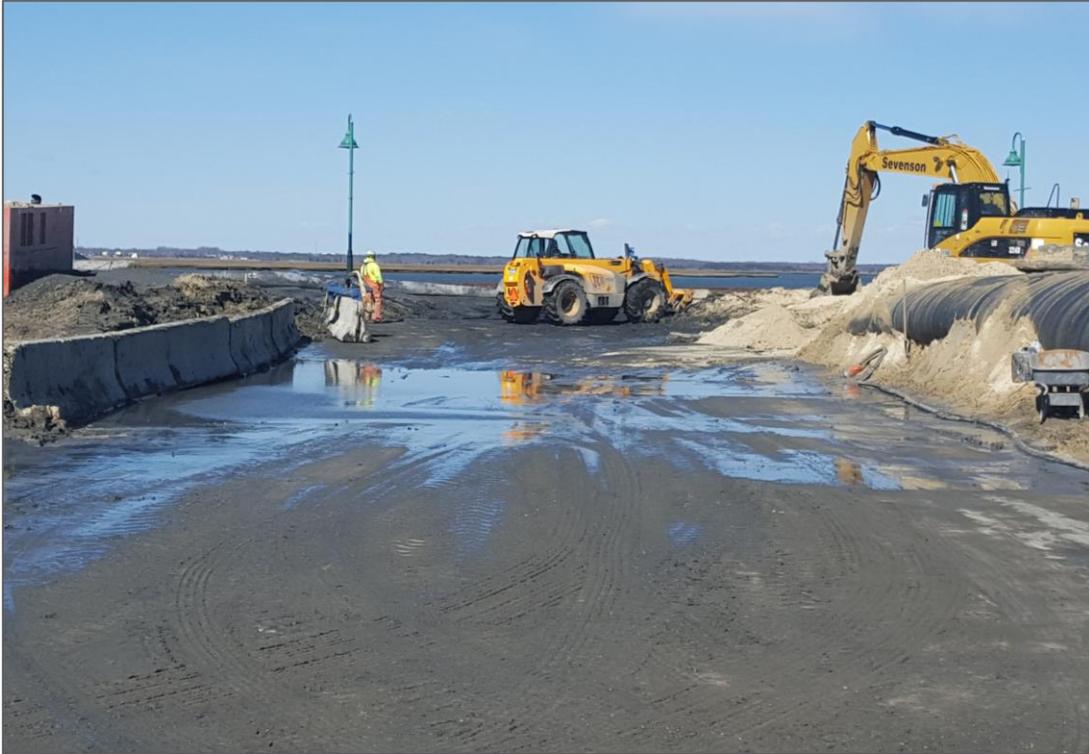
Photograph 7: De-watering Area – Sand blending in progress. (Looking west)

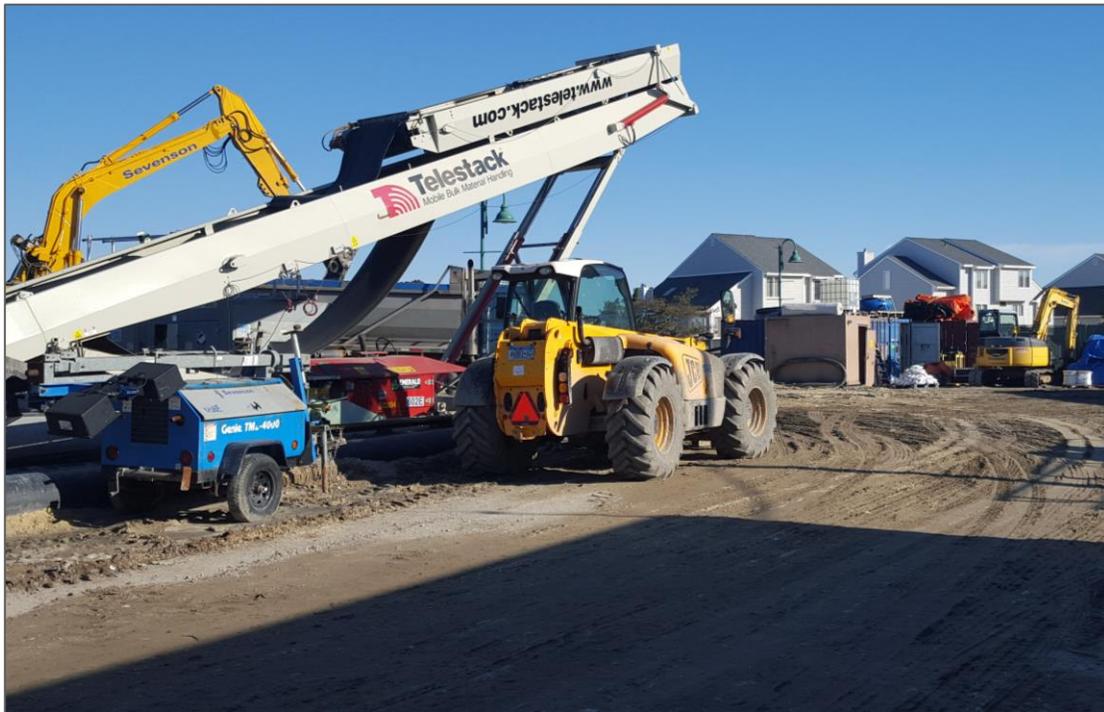
Photograph 8: De-watering Area – Non-operational equipment in stand-by . (Looking north)

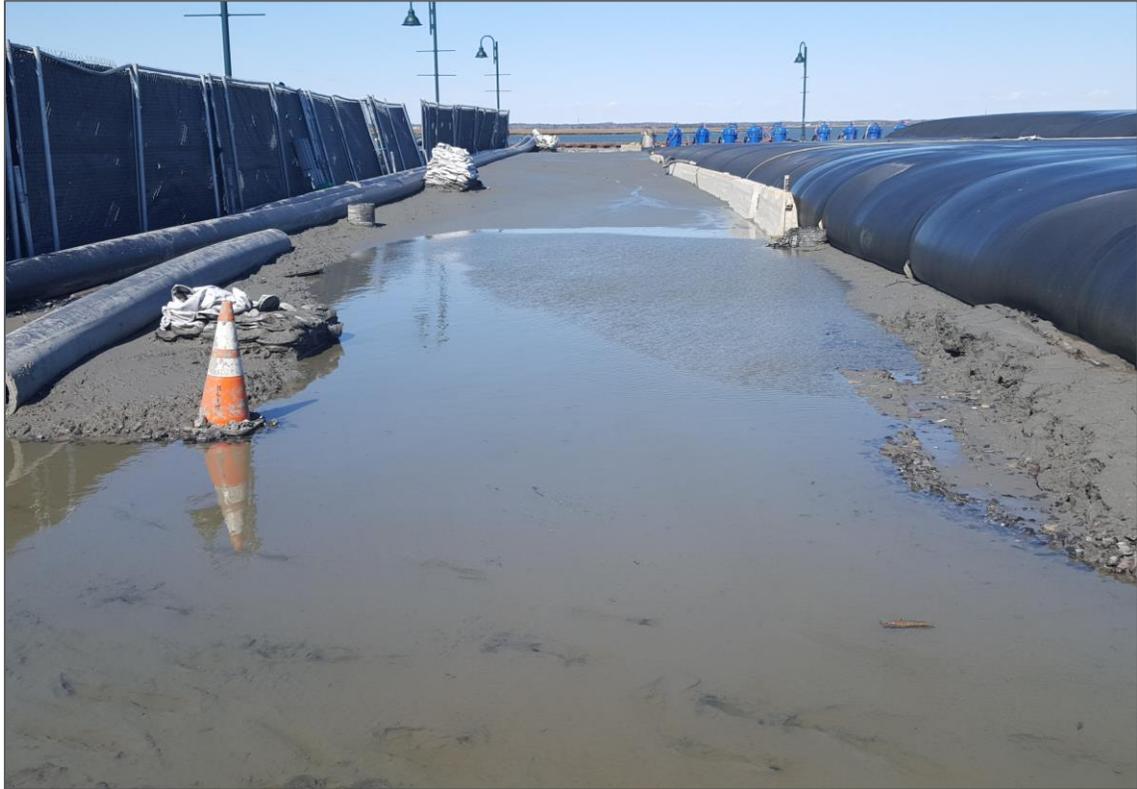
Photograph 9: De-watering Area – Mud/slurry from geotube failure. (Looking west)

Actions to be Taken: Cleanup.

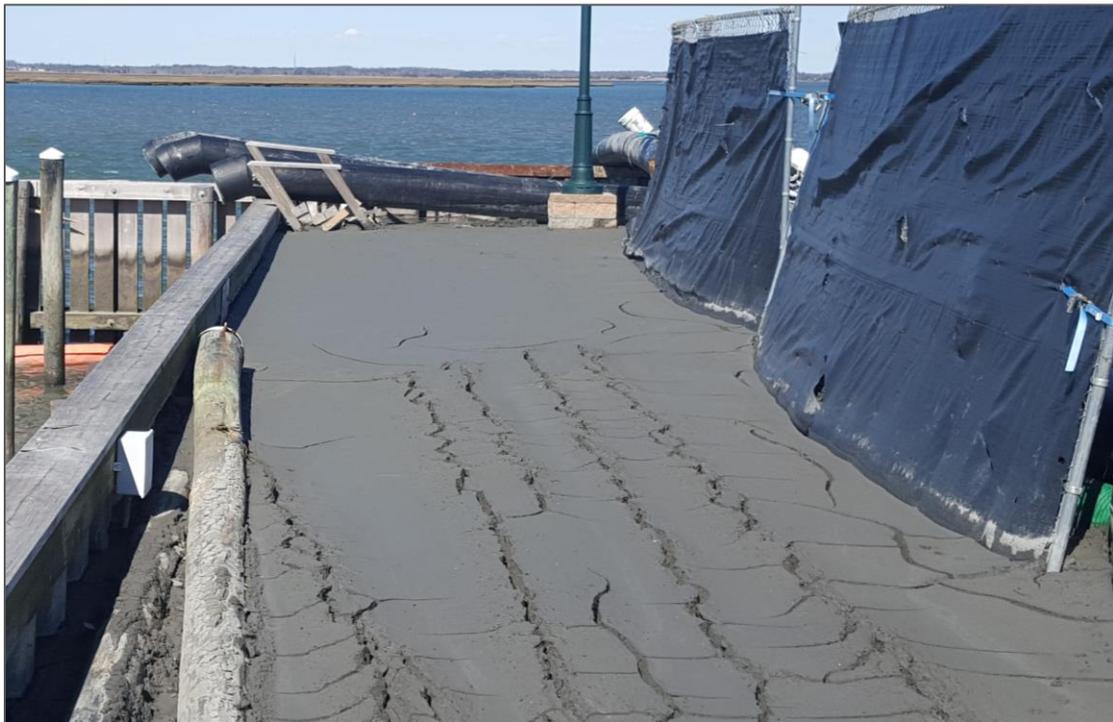
Photograph 10: De-watering Area/North Basin – Discharge pipes, mud/slurry from geotube failure. (Looking west)

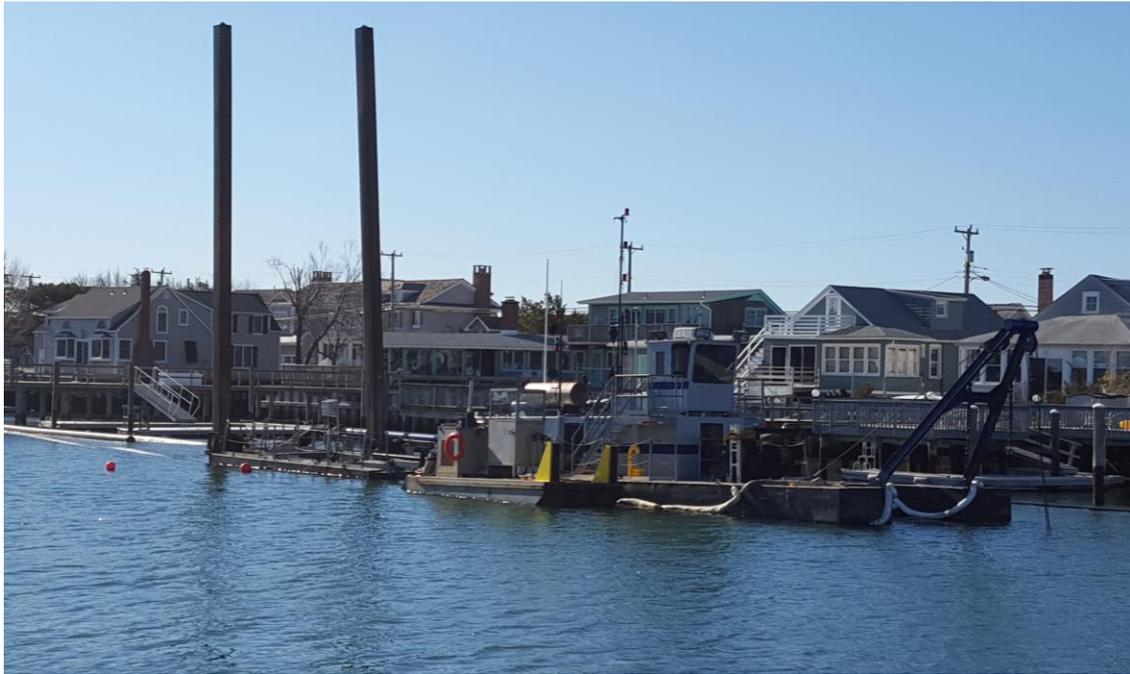
Photograph 7: Stone Harbor – Hydraulic dredge on standby. (Looking south)
