FIELD REPORT

TITLE Stone Harbor Maintenance Dredging
 DATE March 04, 2016
 TO Jill Gougher
 COPY MADN
 FROM BEWI
 PROJECT NO A06772

Project Information

Owner: The Borough of Stone Harbor
Contractor: Severson Environmental Services, Inc.

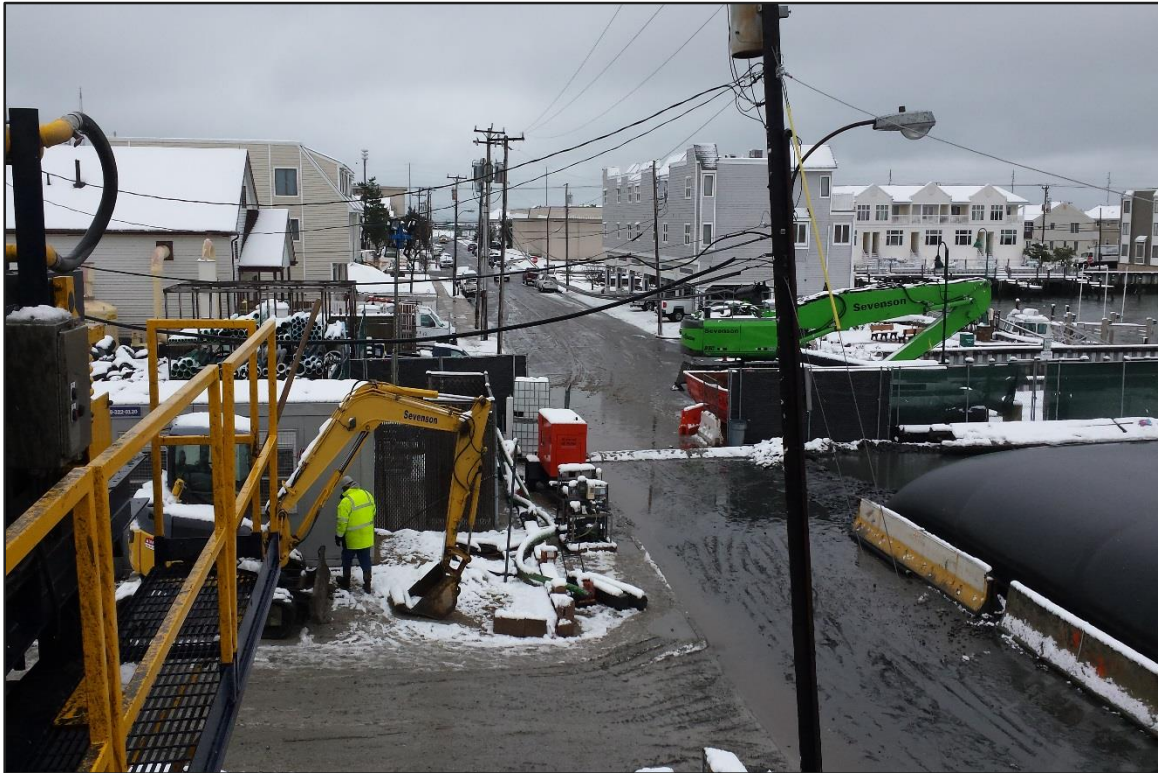
Photograph 1: Site Entrance. (Looking east)

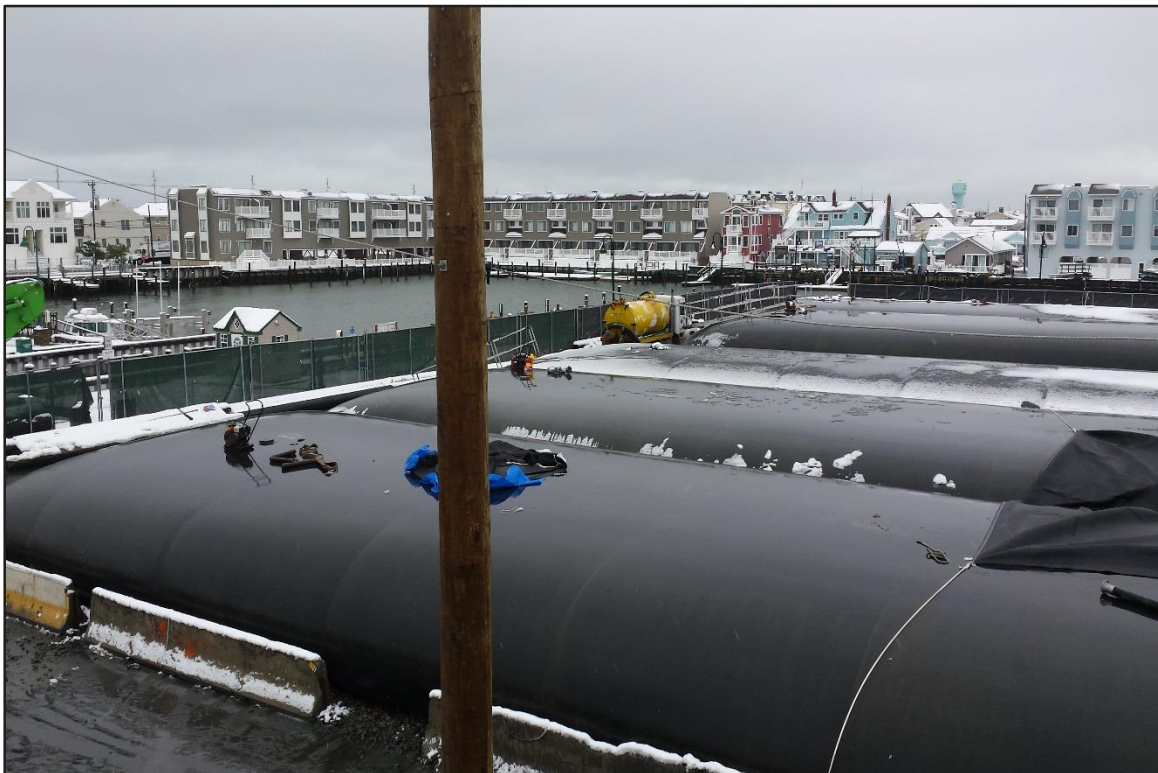
Photograph 2: De-watering Area – Geobags #1-5. (Looking southeast)

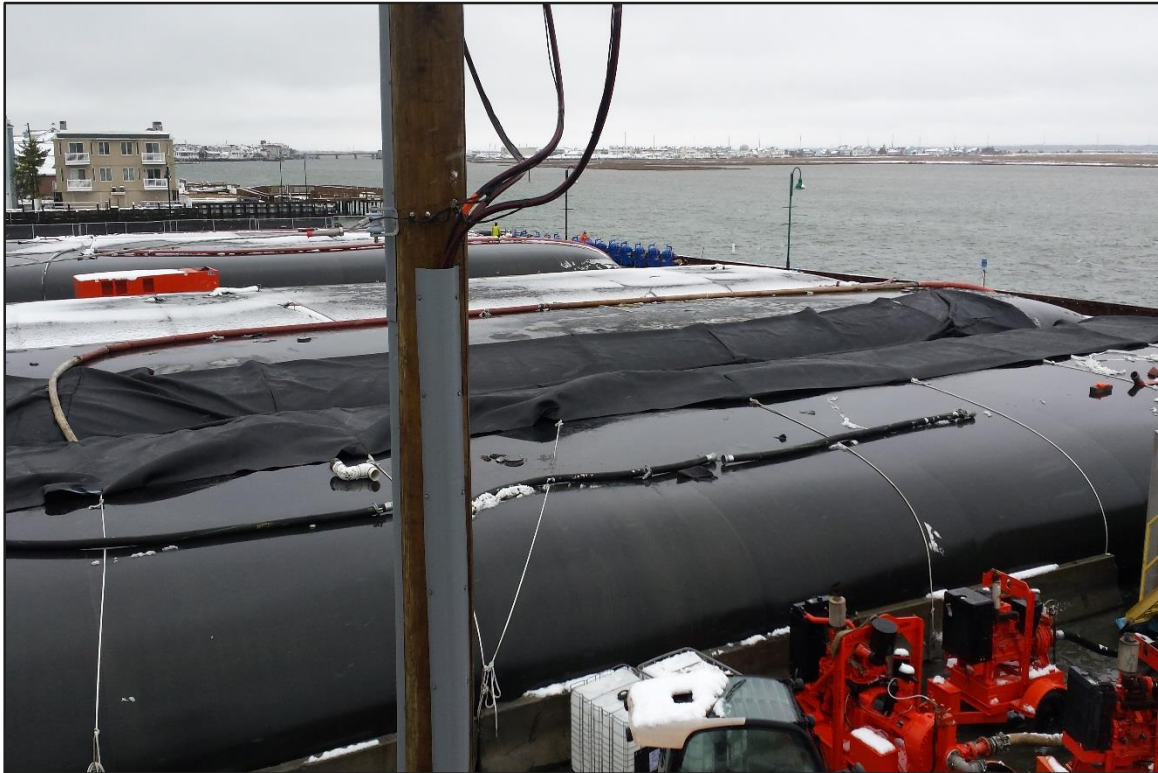
Photograph 3: De-watering Area – Geobags #1-#5 with an additional bag straddling #4-#5. (Looking south)

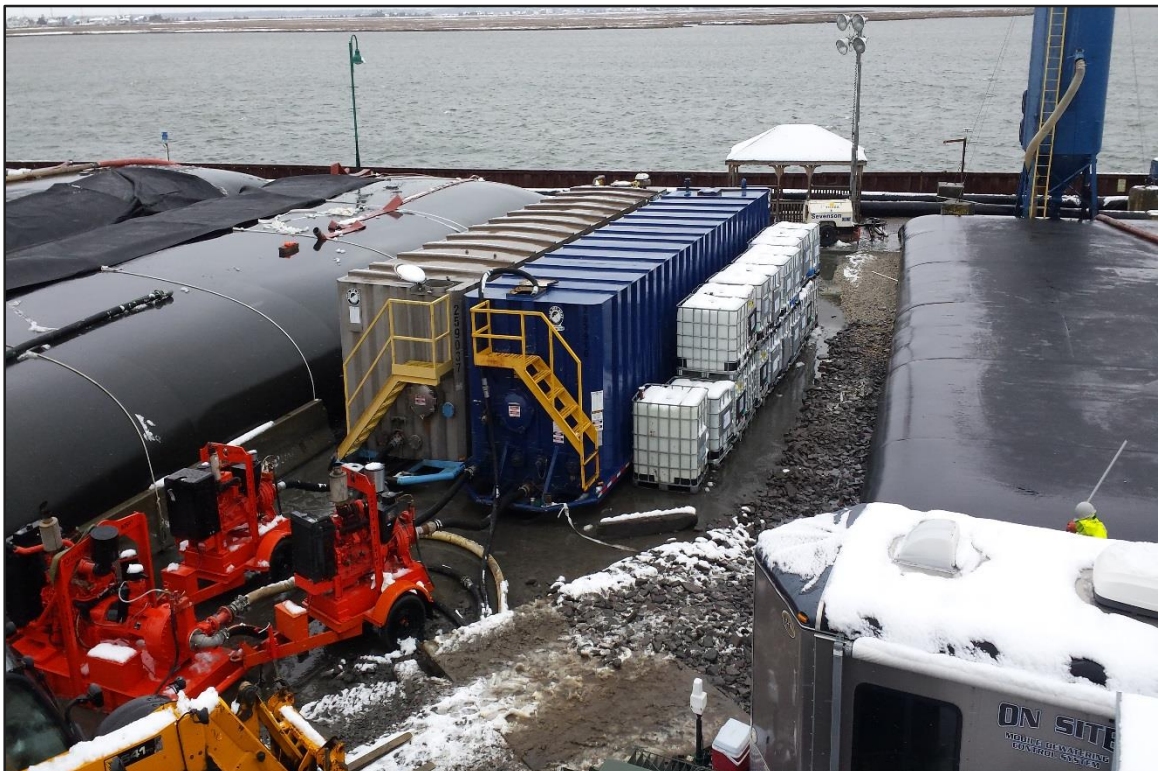
Photograph 4: De-watering Area – Pumping equipment in operation. (Looking west)

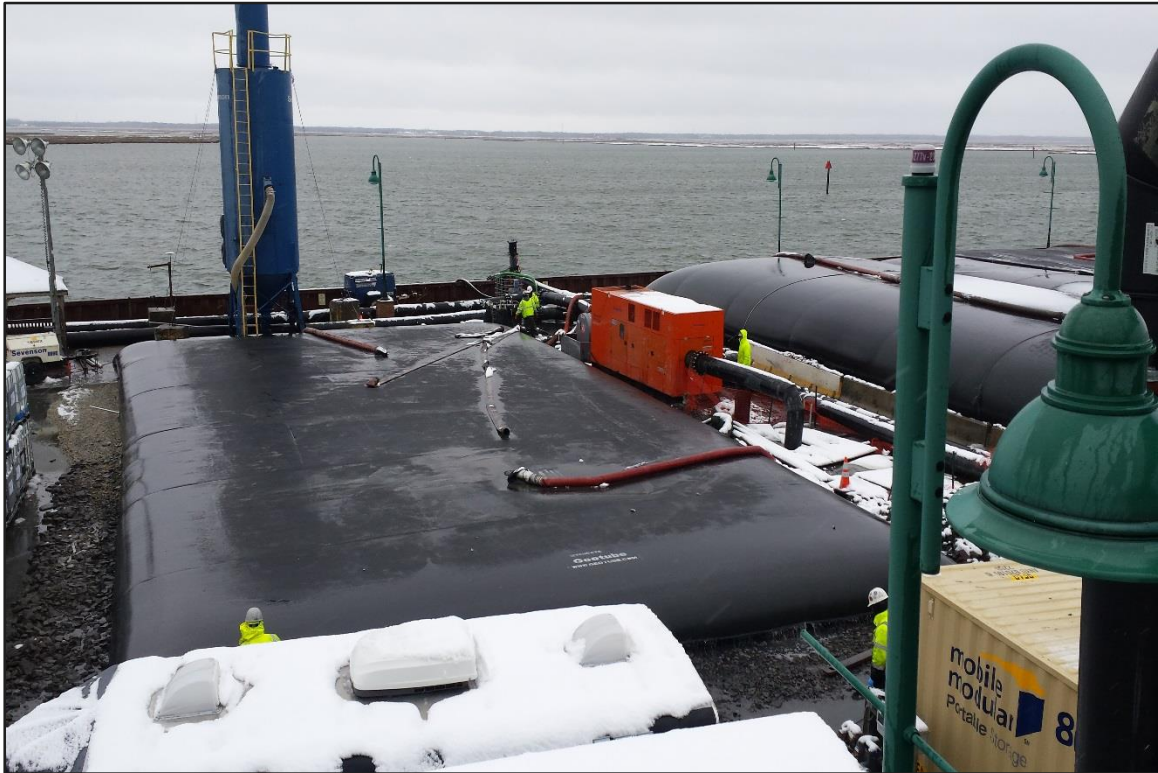
Photograph 5: De-watering Area – New geobag placed between #5 and #6. (Looking west)

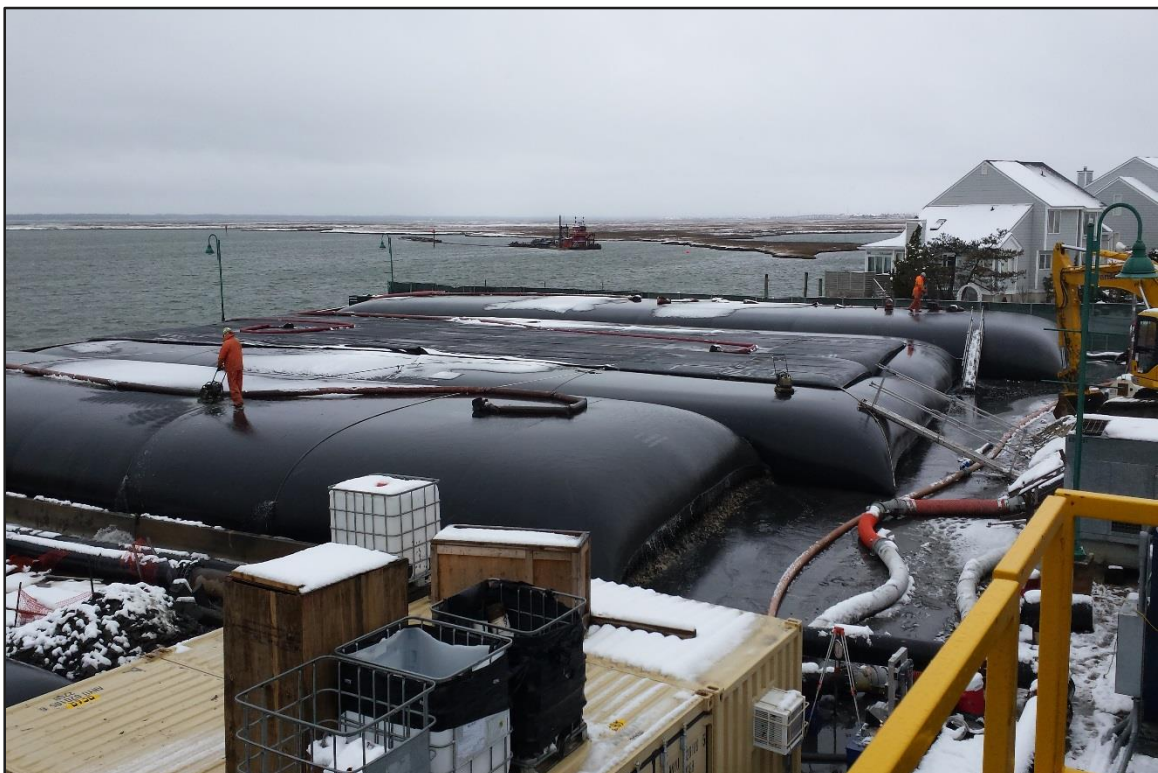
Photograph 6: De-watering Area – Geobags #6-#9 with an additional bag straddling #7-#8. (Looking north)

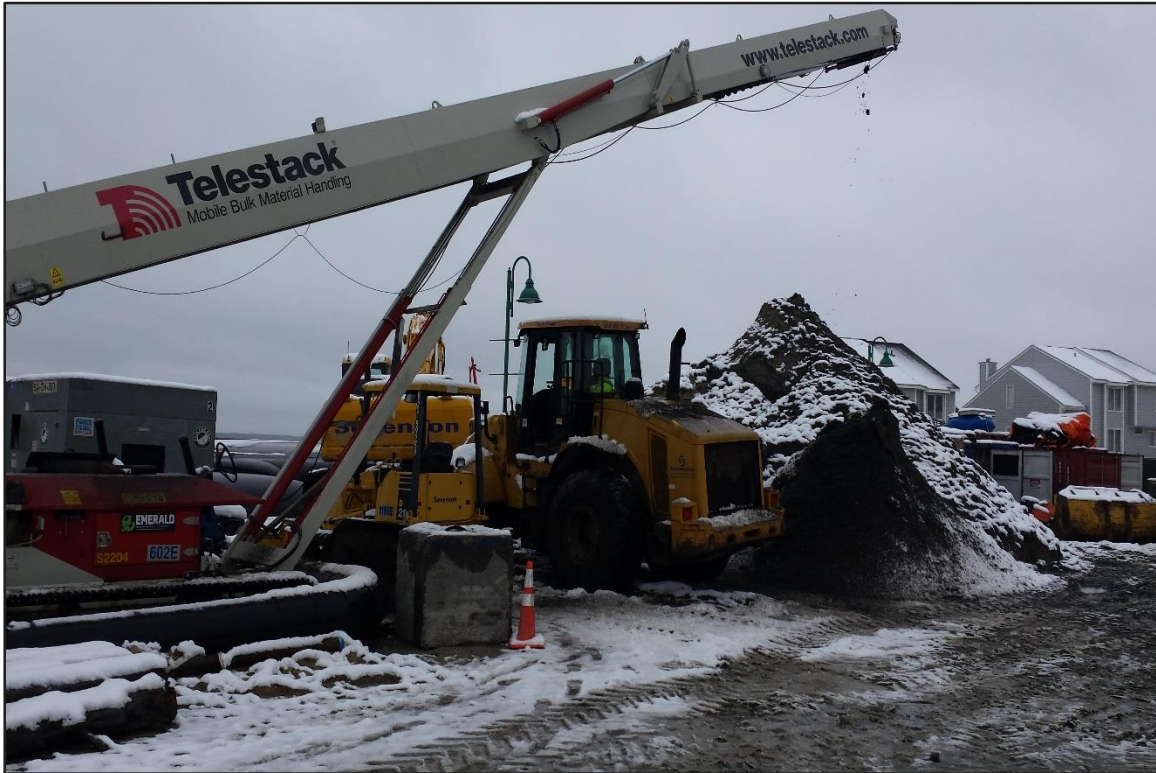
Photograph 7: De-watering Area – De-sanding material and equipment on standby. (Looking northwest)

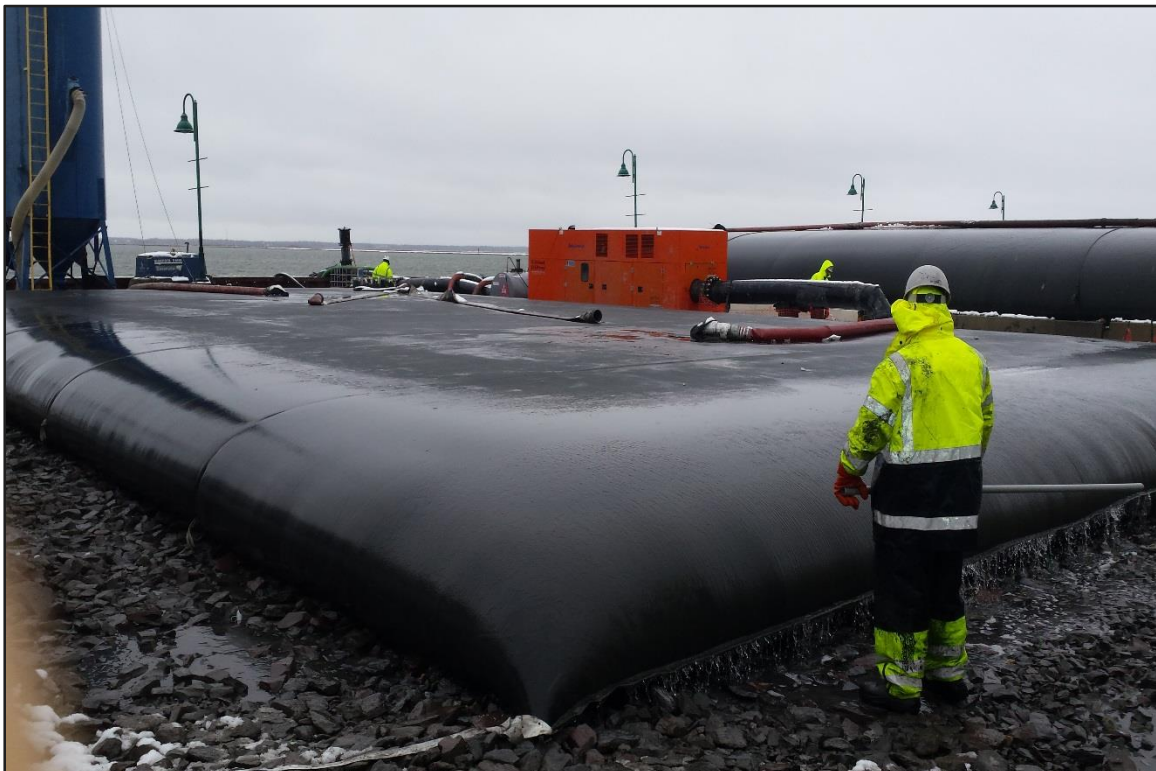
Photograph 8: De-watering Area - New geobag placed between #5 and #6. (Looking west)

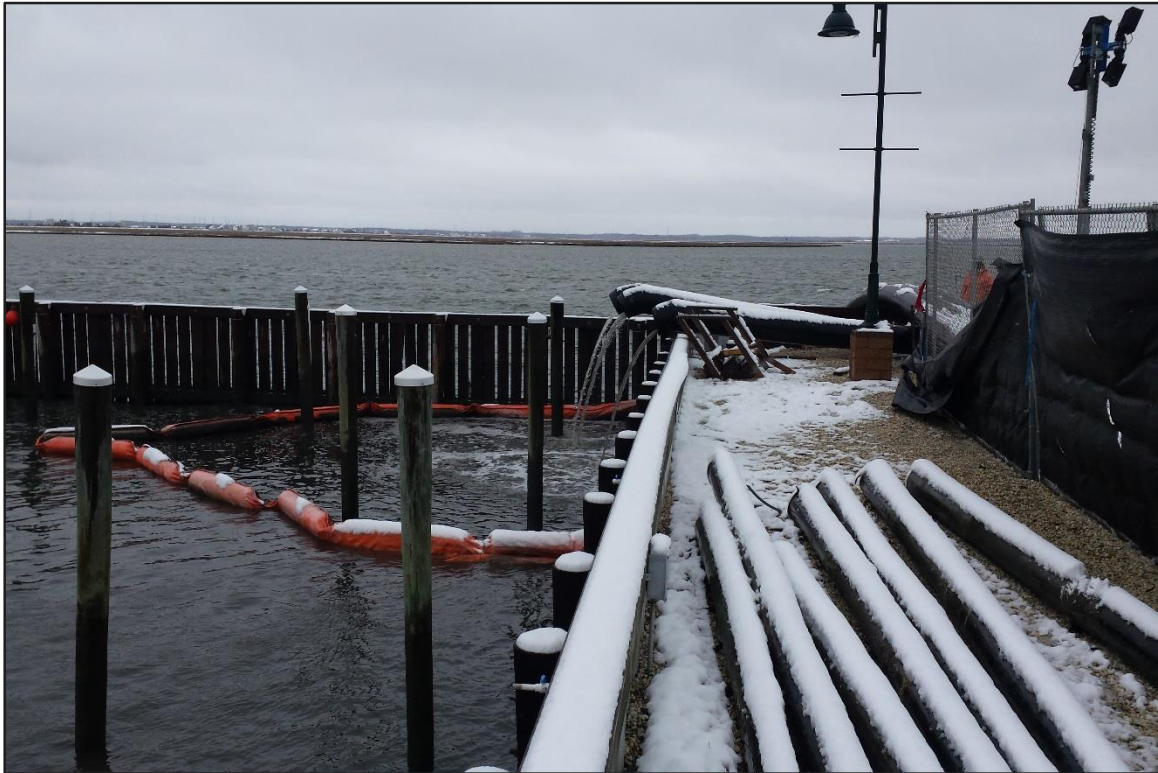
Photograph 9: North Basin/De-watering Area – Discharge pipes. (Looking west)

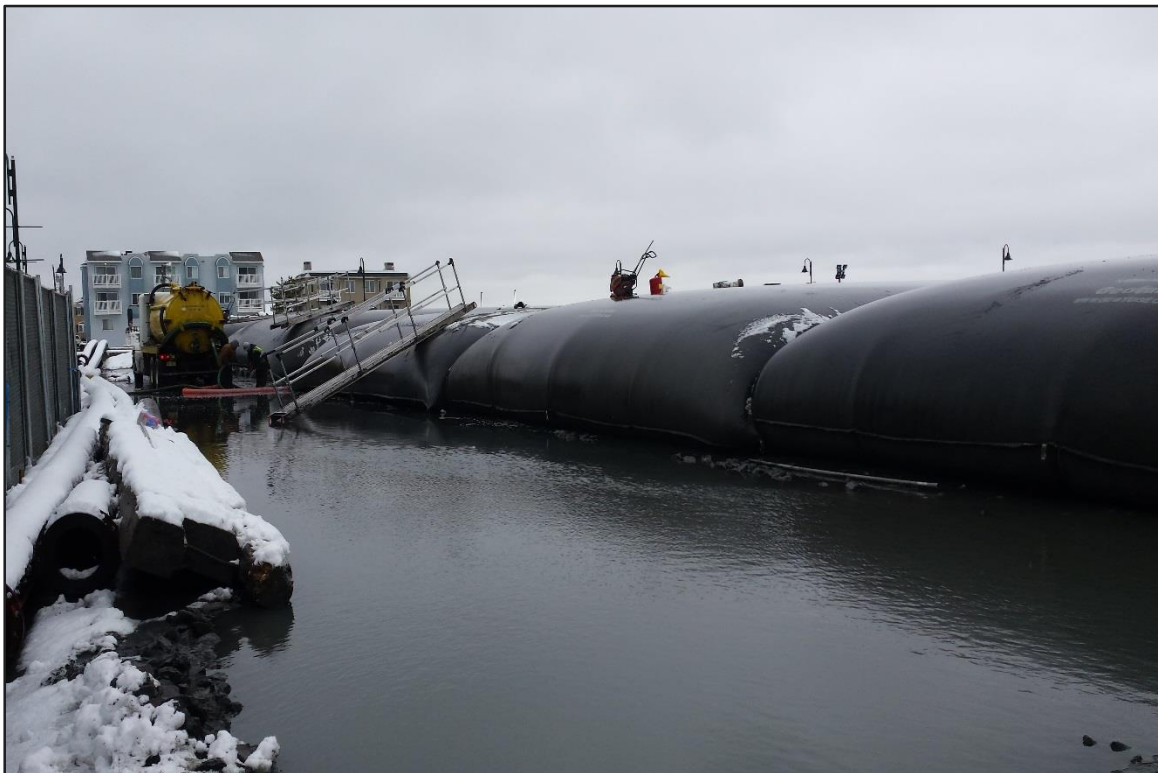
Photograph 10: De-watering Area – Geobags #1-#5. (Looking south)

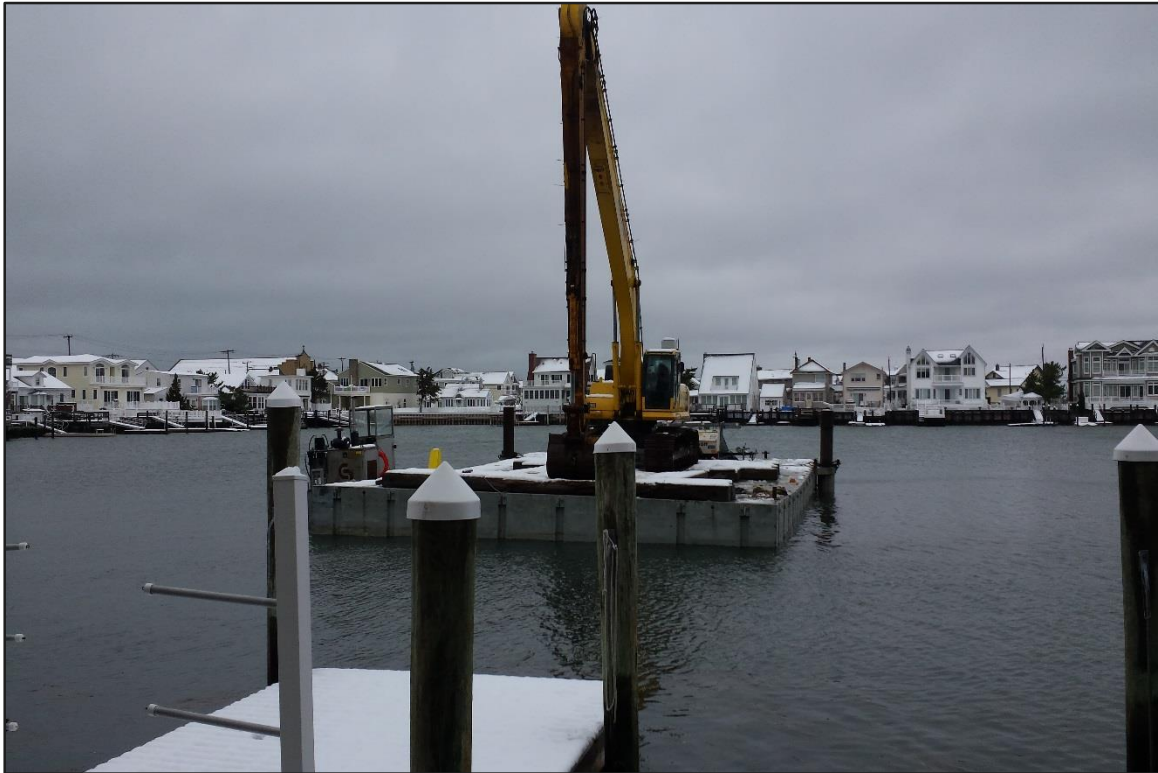
Photograph 11: Shelter Haven – Mechanical Dredge. (Looking south)

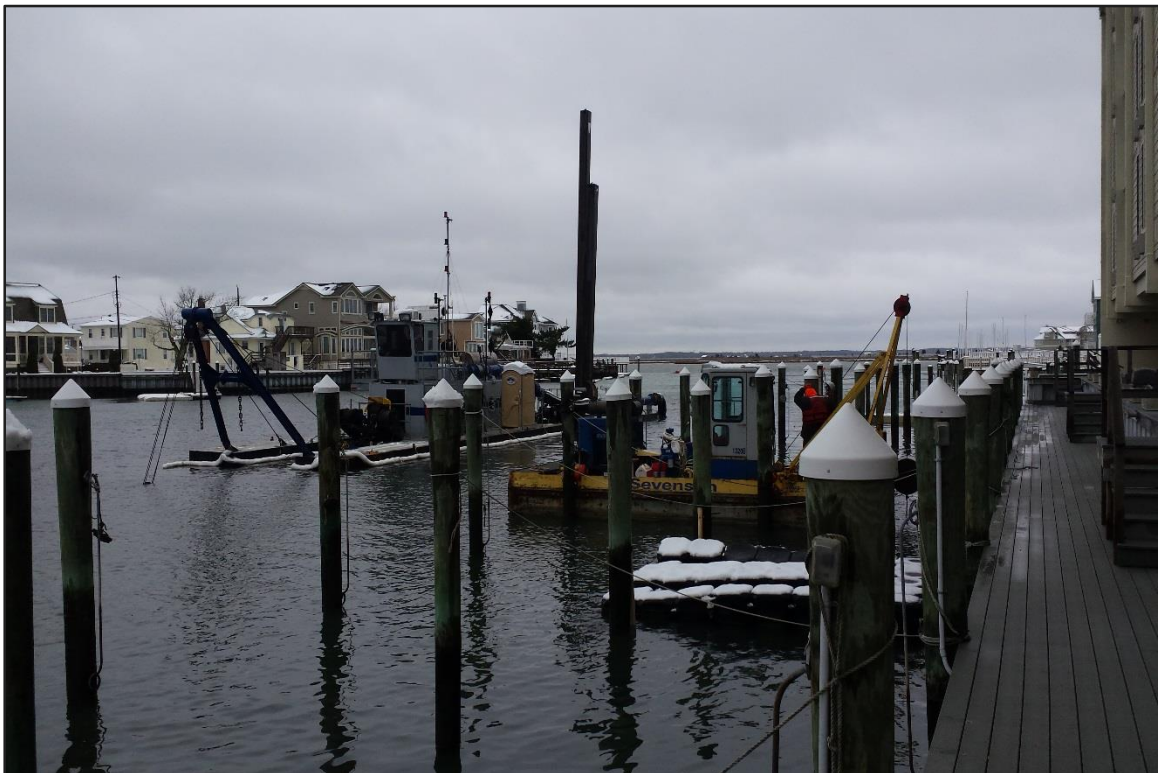
Photograph 12: Shelter Haven – Hydraulic dredge and support boat. (Looking west)
