**SPECIAL SPRING 2018 STORM REPORT ON
THE CONDITION OF THE MUNICIPAL BEACHES FOR
THE BOROUGH OF STONE HARBOR, CAPE MAY COUNTY, NEW JERSEY**

**PREPARED FOR: THE BOROUGH OF STONE HARBOR
9508 SECOND AVENUE
STONE HARBOR, NJ 08247**

**PREPARED BY: THE STOCKTON UNIVERSITY COASTAL RESEARCH CENTER
30 WILSON AVENUE
PORT REPUBLIC, NEW JERSEY 08241**

May 20, 2018

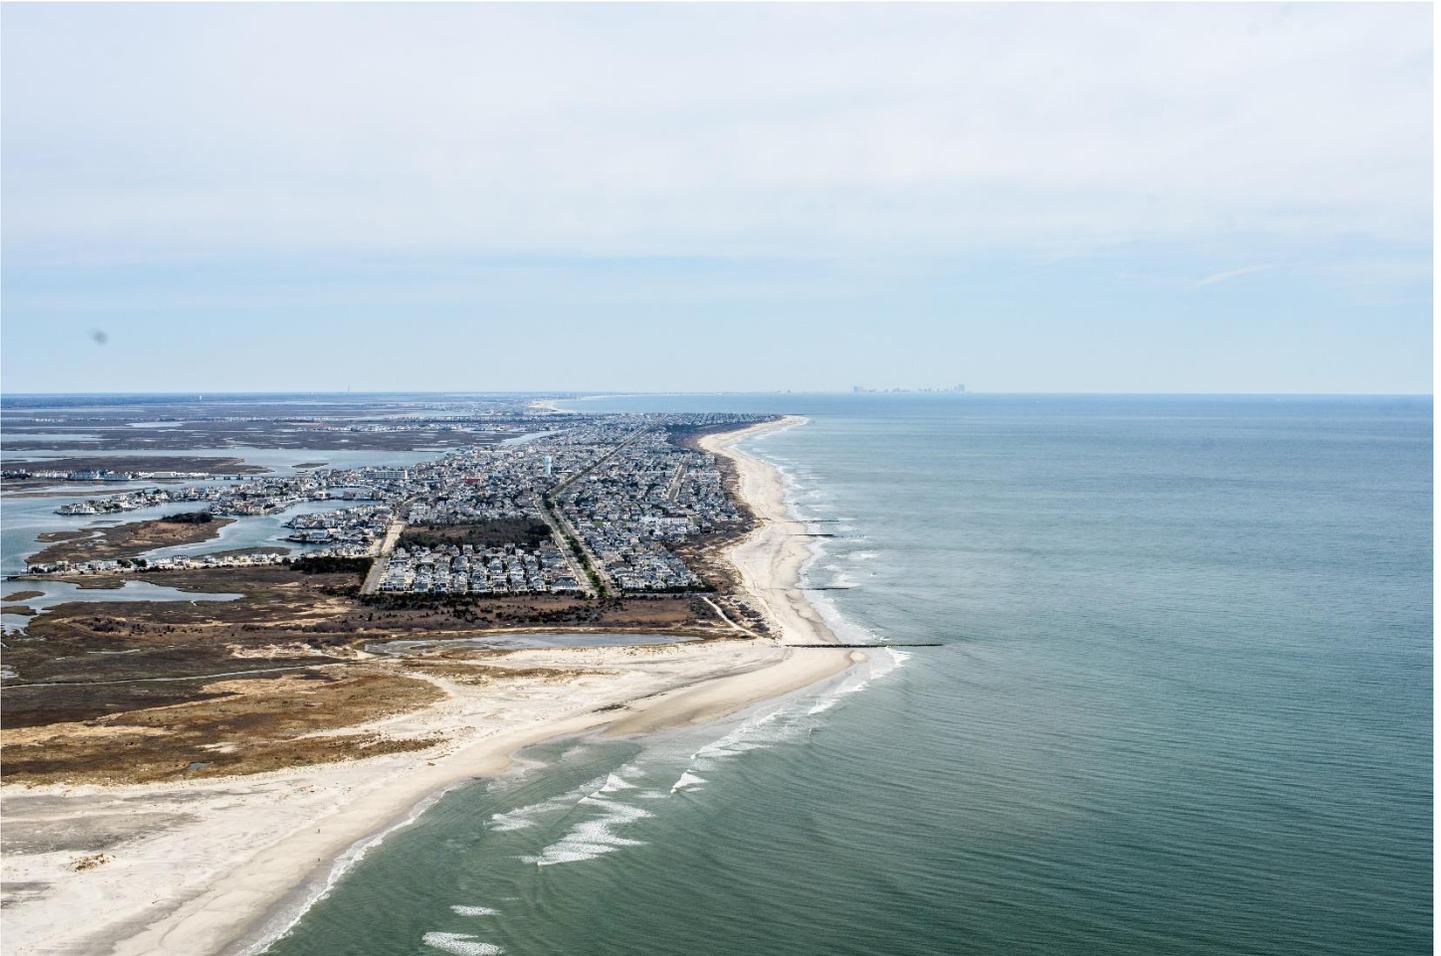
Aerial photograph taken April 21, 2018 showing the view up the beach from Stone Harbor Point beach. Note the new deposit of sand extending south from the terminal groin. This is sand derived from the 2nd Periodic Nourishment Cycle in the Borough's southern section moved beyond the groin by the series of northeast storms in March/April (courtesy Ted Kingston).

The effects can be readily seen in the April 21st picture on the cover showing Stone Harbor beaches from South Point looking north where a deposit several hundred feet wide and about 800 feet long extends at the lower portion of the beach from the 123rd Street groin south into the natural area of South Point. The new sand is a bit more tan in color than the older sediment landward. Its ending point shape at the low tide line is the best evidence of recent deposition.

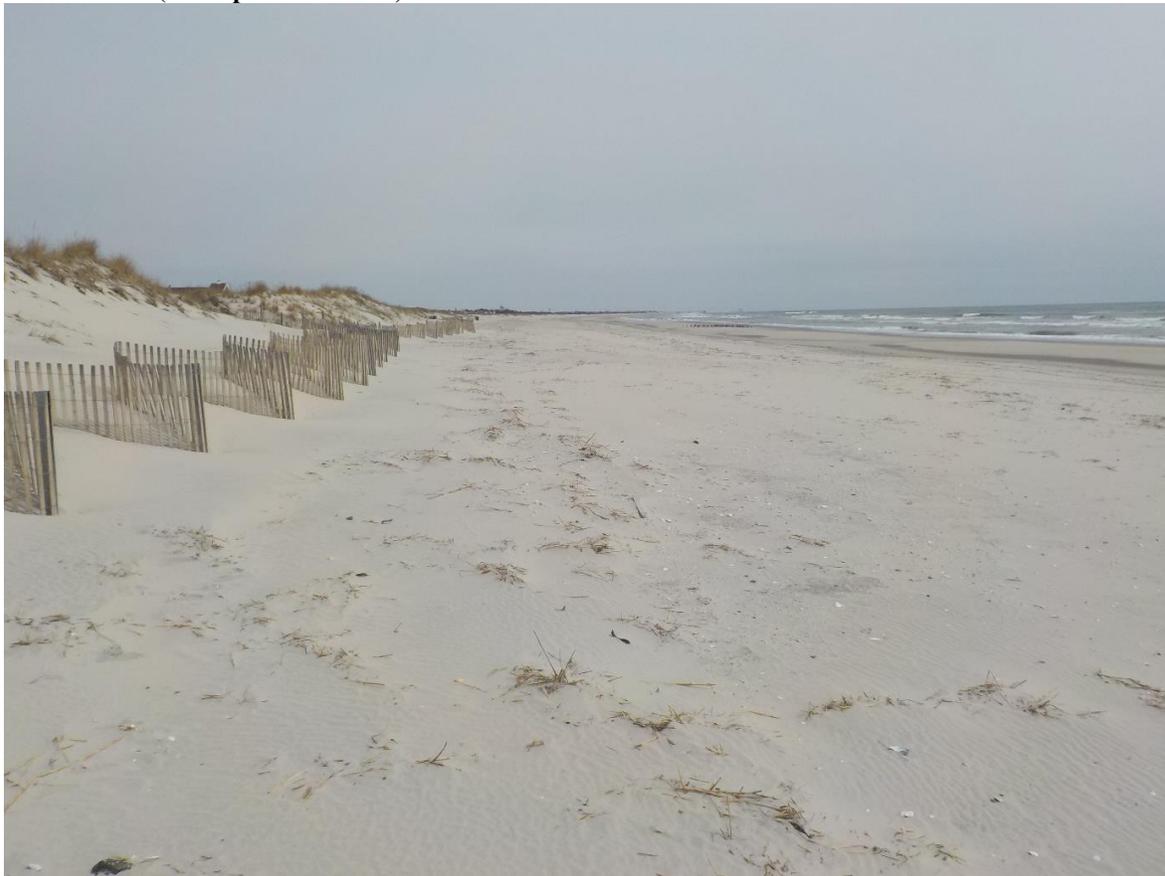
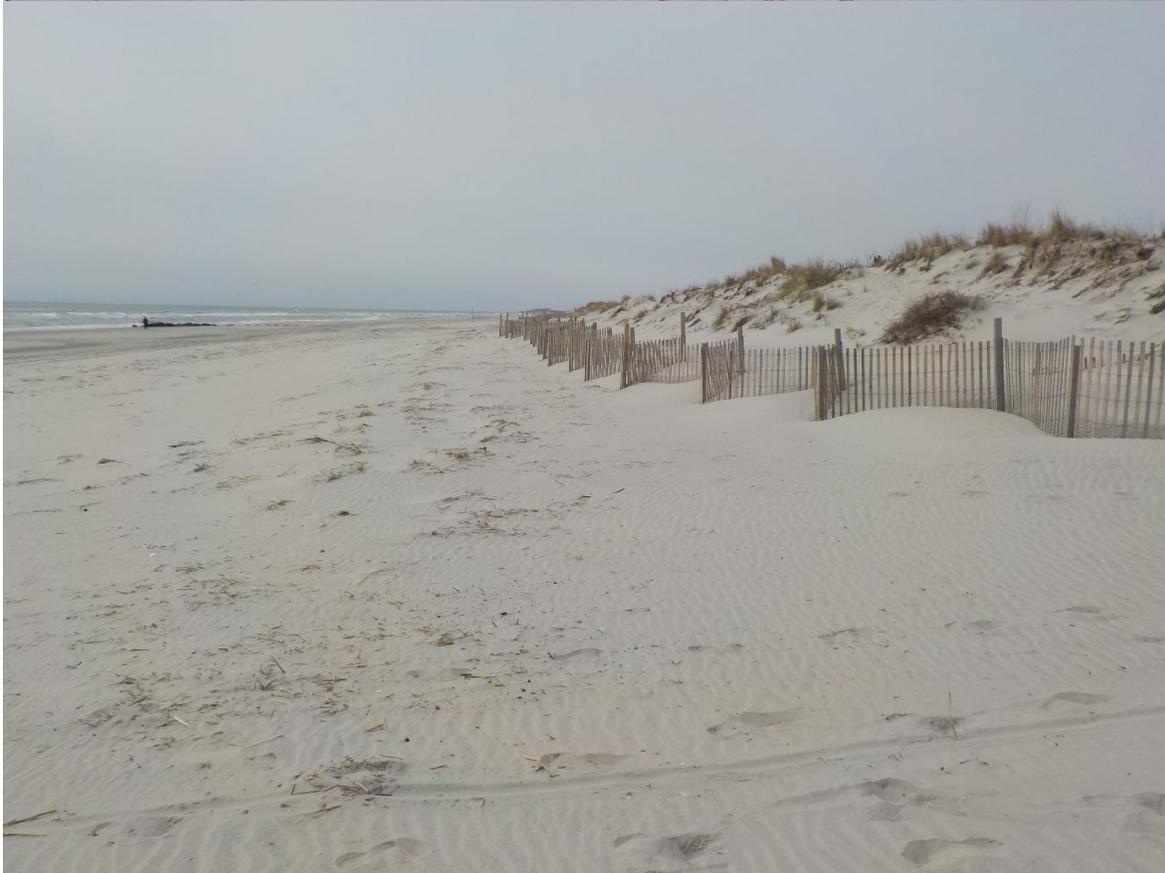
Site SH-82 – 82nd Street (Photoplates 1a & 1b)

Photoplates 1a & b - Photo taken April 9, 2018 after the series of spring northeast storms. Views to the north and south show no dune damage, with plant debris almost at the dune fence on a flat beach surface.

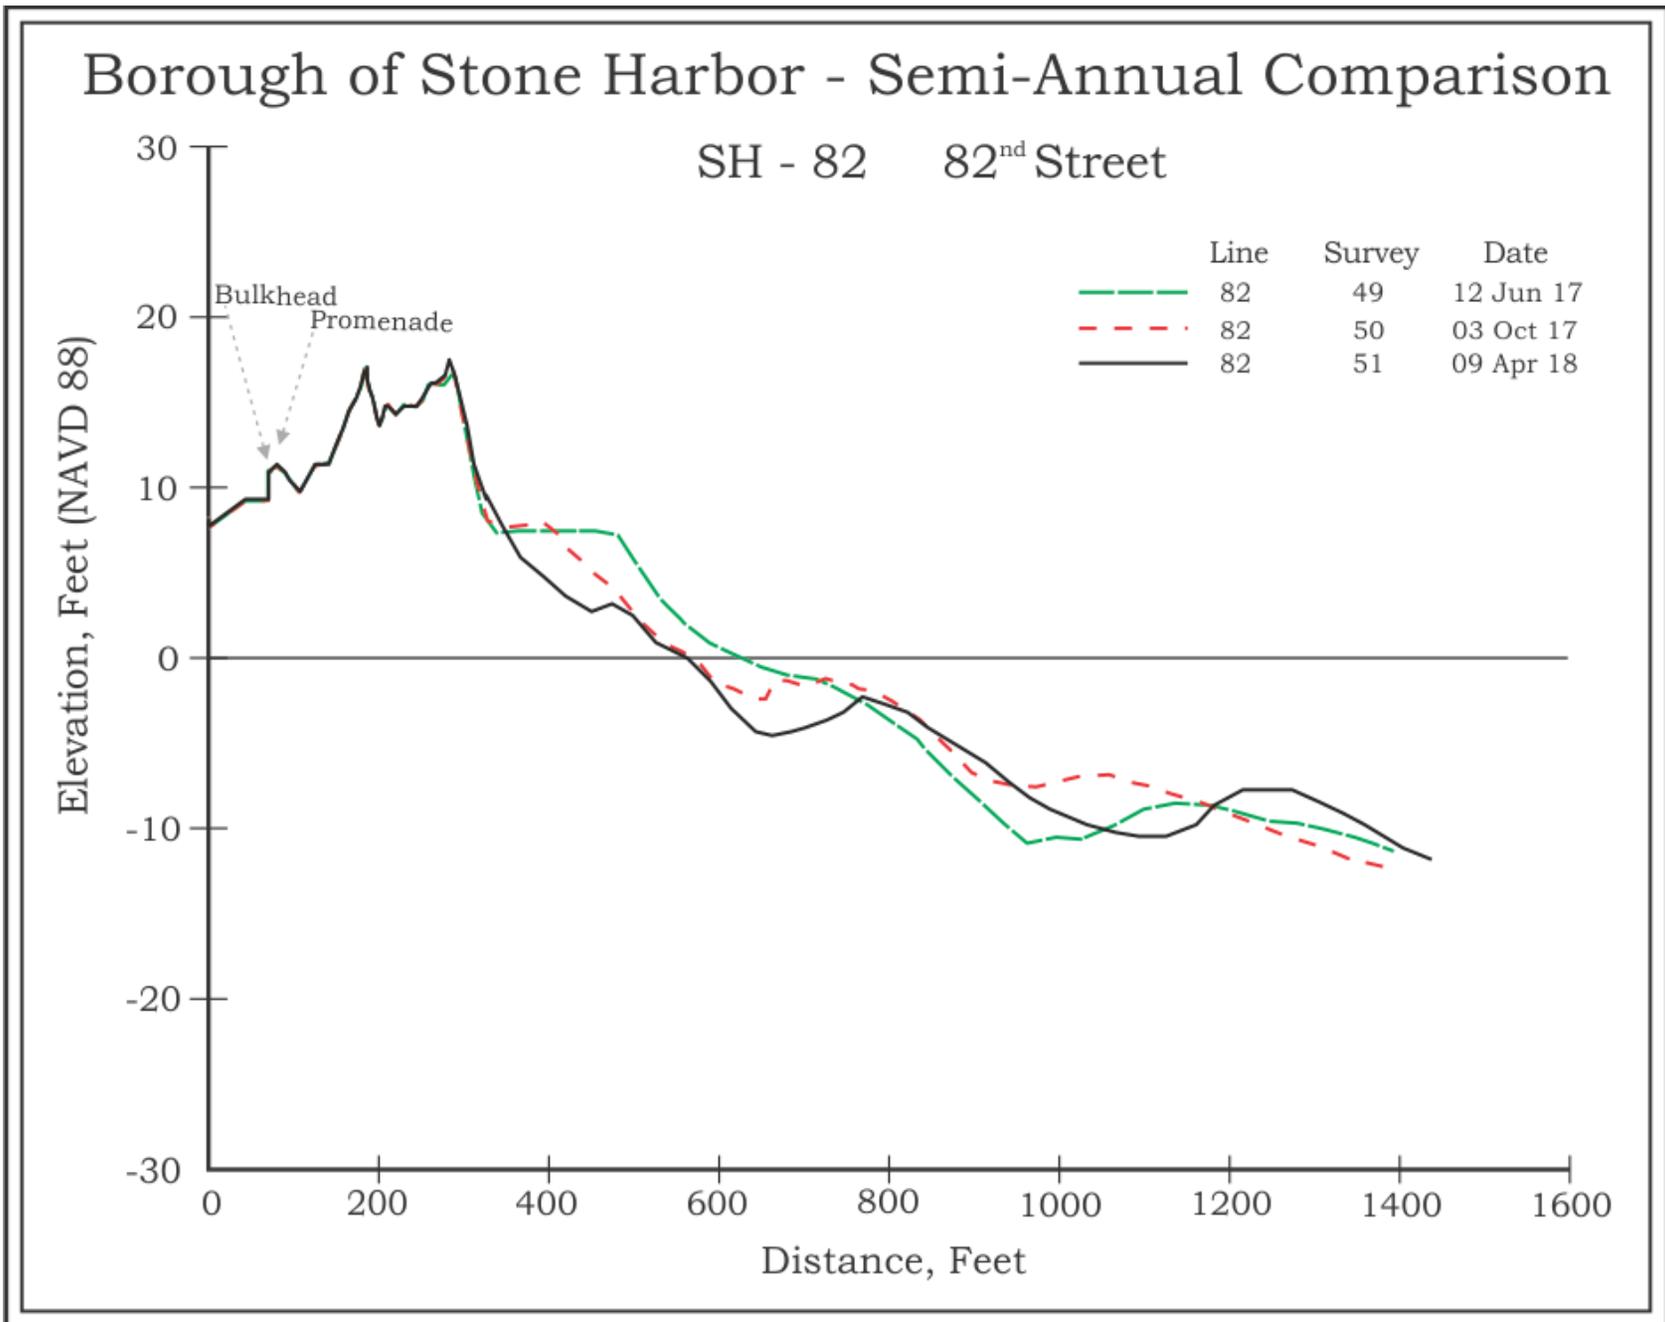
Figure 1. The post beachfill berm was partially eroded by October 2017, and by April 2018 was reduced to a sloping beach into the water. Offshore two bars emerged that did not vertically compensate for the sand lost on the beach. (-24.18 yds³/ft. lost above zero and 3.21 yds³/ft. added below the zero datum).

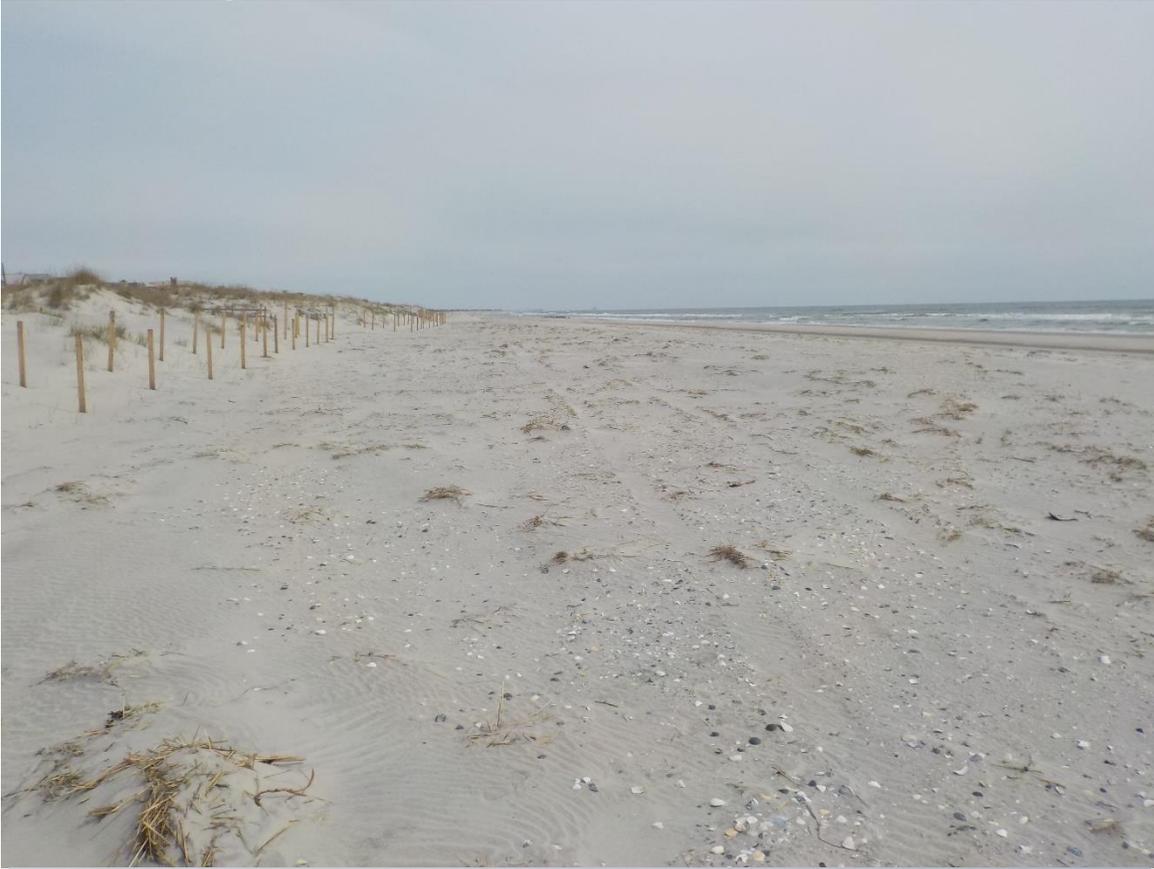
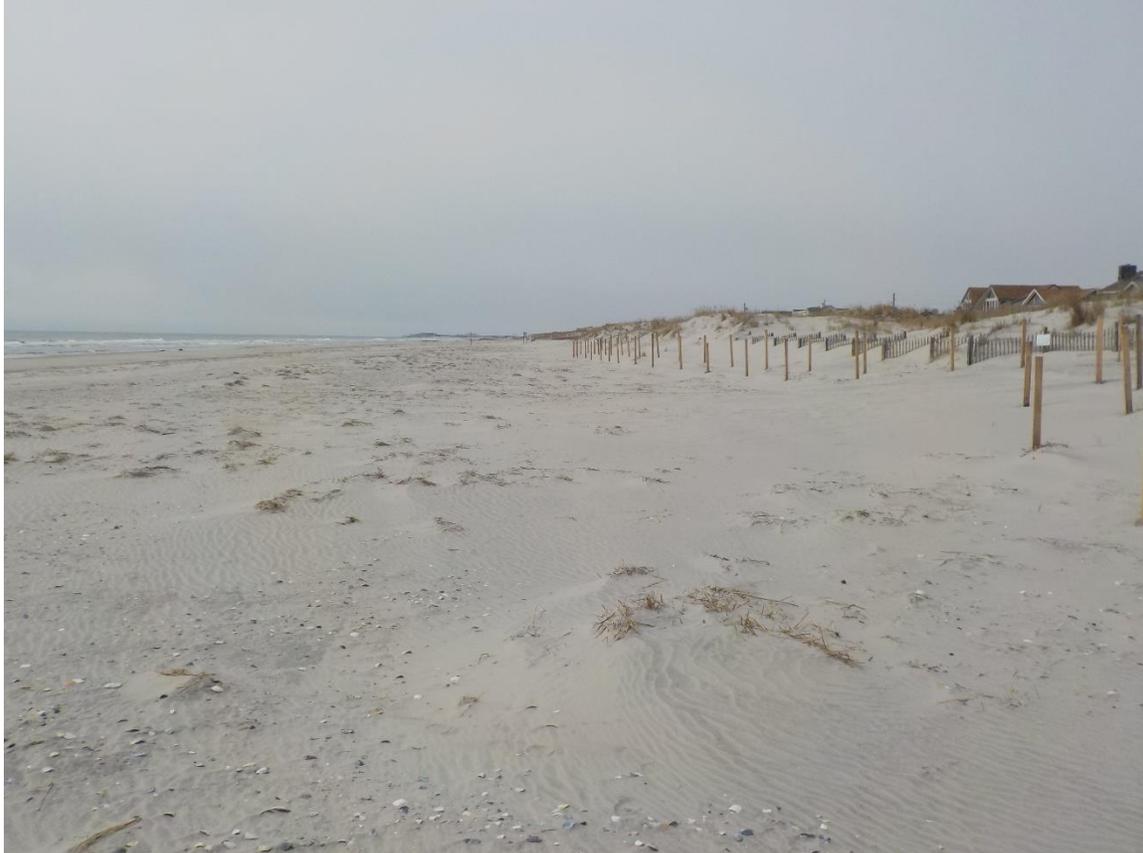
Site SH-90 – 90th Street (Photoplates 2a-2b)

Photoplate 2a & b - Photos taken April 9, 2018 just prior to the final northeast storm April 15th. The plant debris indicates that the waves reached the toe of the dunes, but did no damage. The beach was flattened and sand was added offshore.

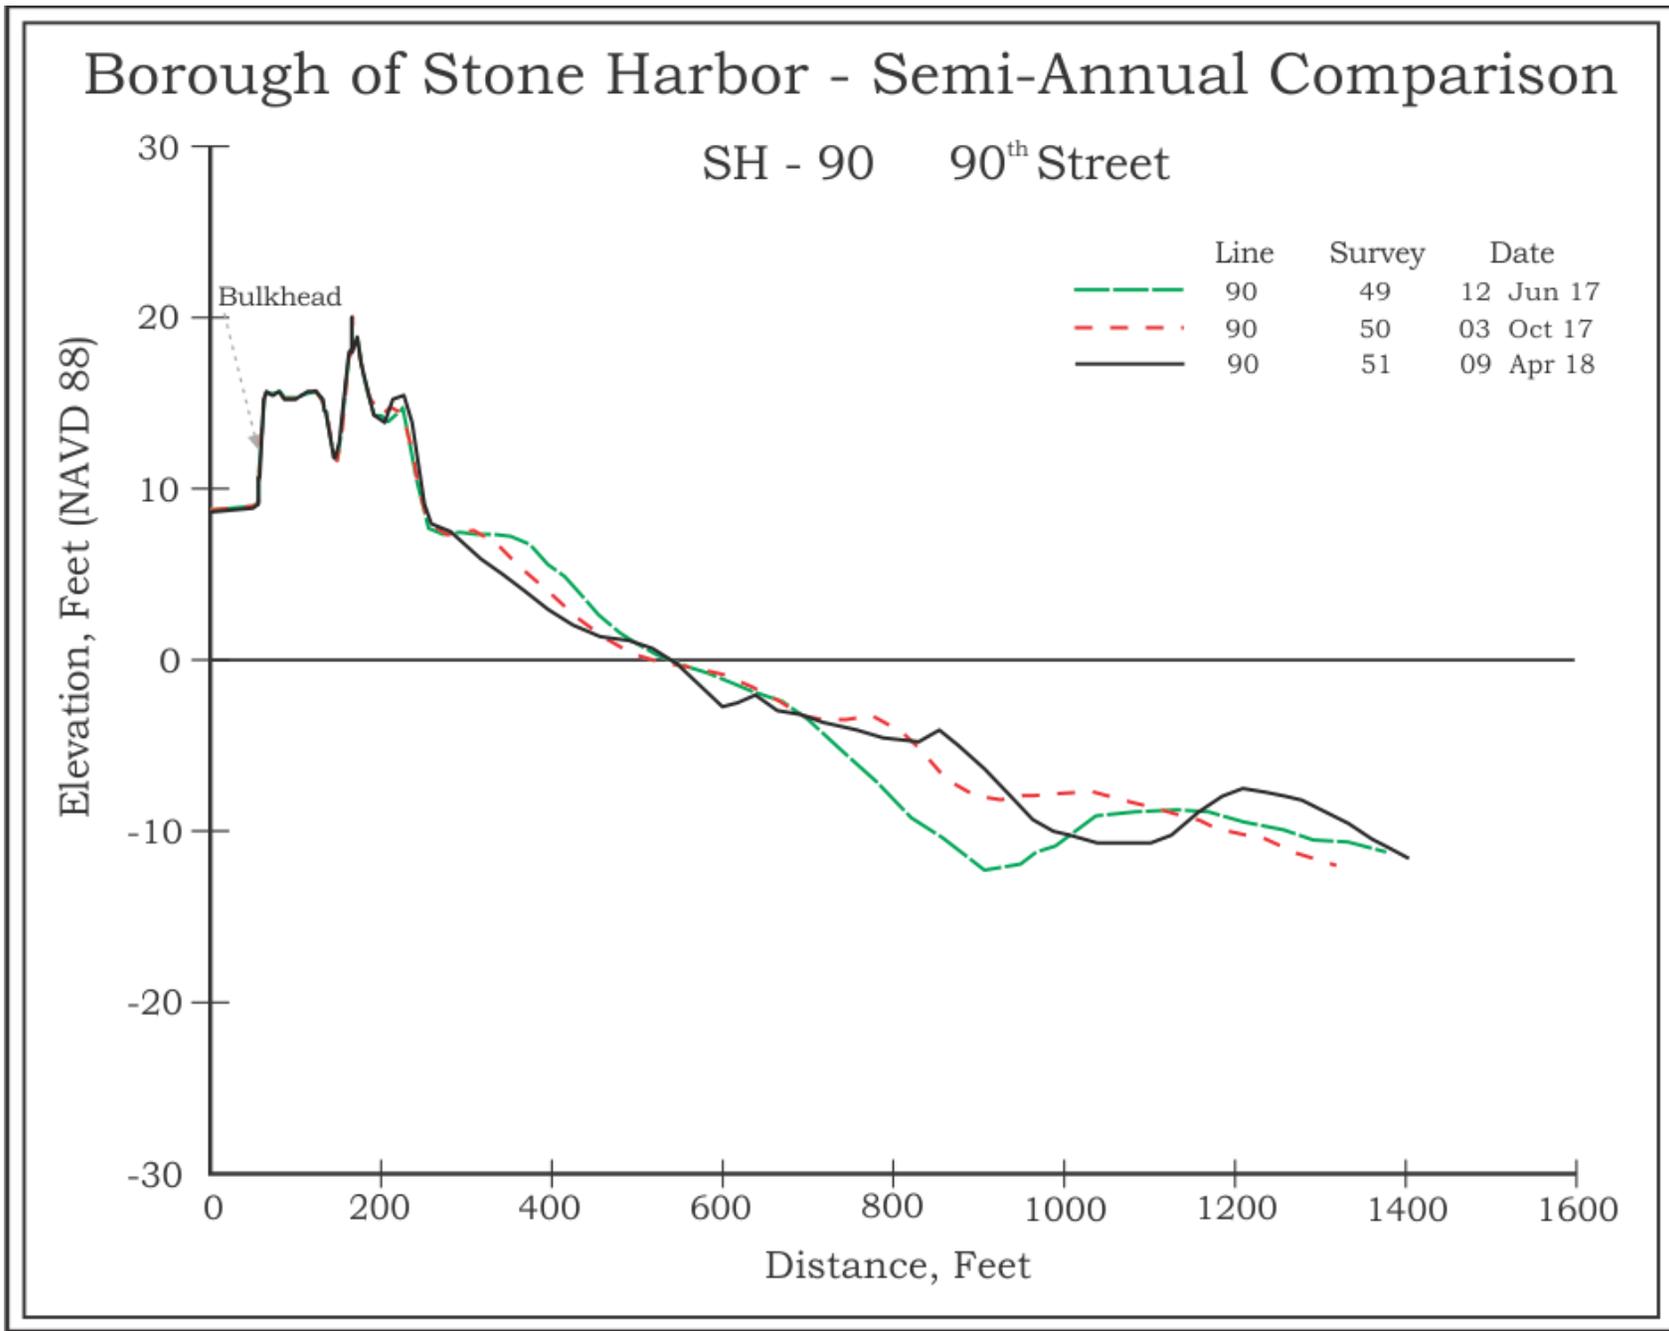
Figure 2. The change on the beach between June and October 2017 was likely the pattern set by the passage of Hurricane Jose Sept. 2017. By April 2018 the beach was flattened into a uniform slope into the water, but offshore a large volume was added close to the beach. Storms took $-10.86 \text{ yds}^3/\text{ft.}$ from the beach while $38.41 \text{ yds}^3/\text{ft.}$ was added below the zero datum elevation. The potential is that sand from the 82nd Street cell moved into this cell.

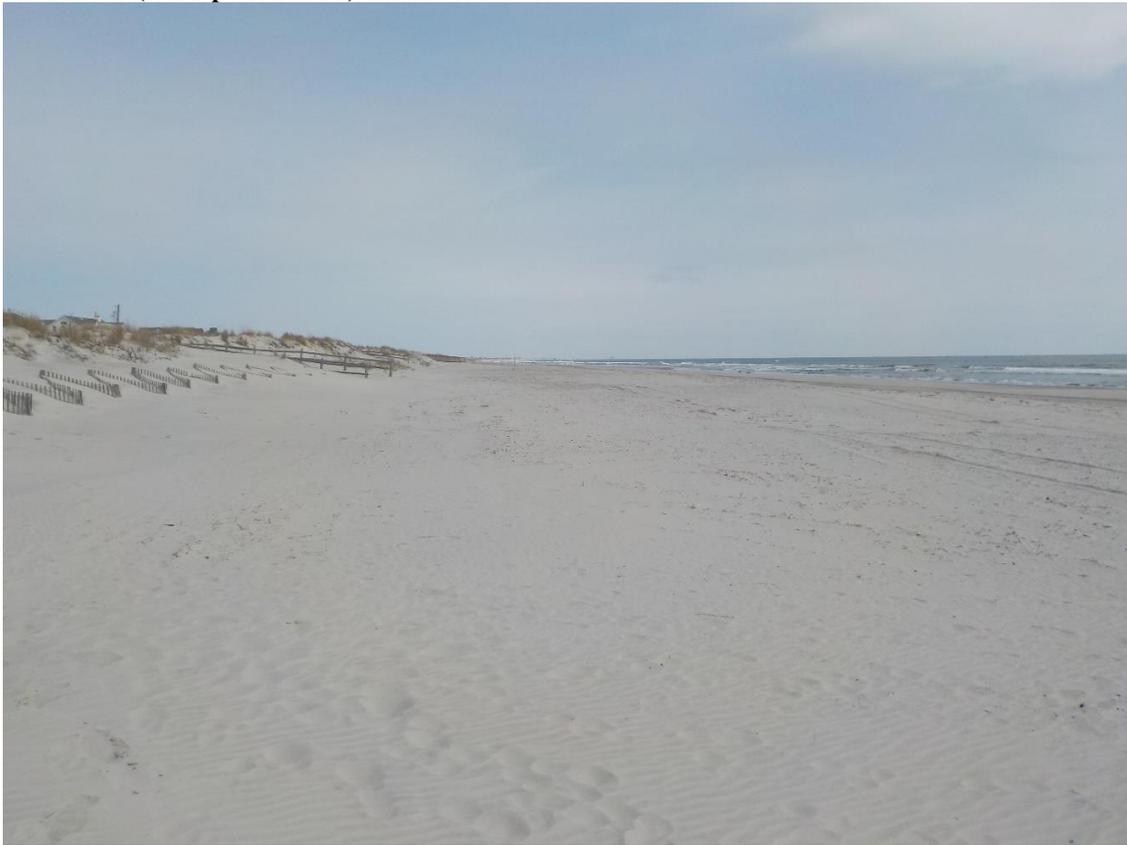
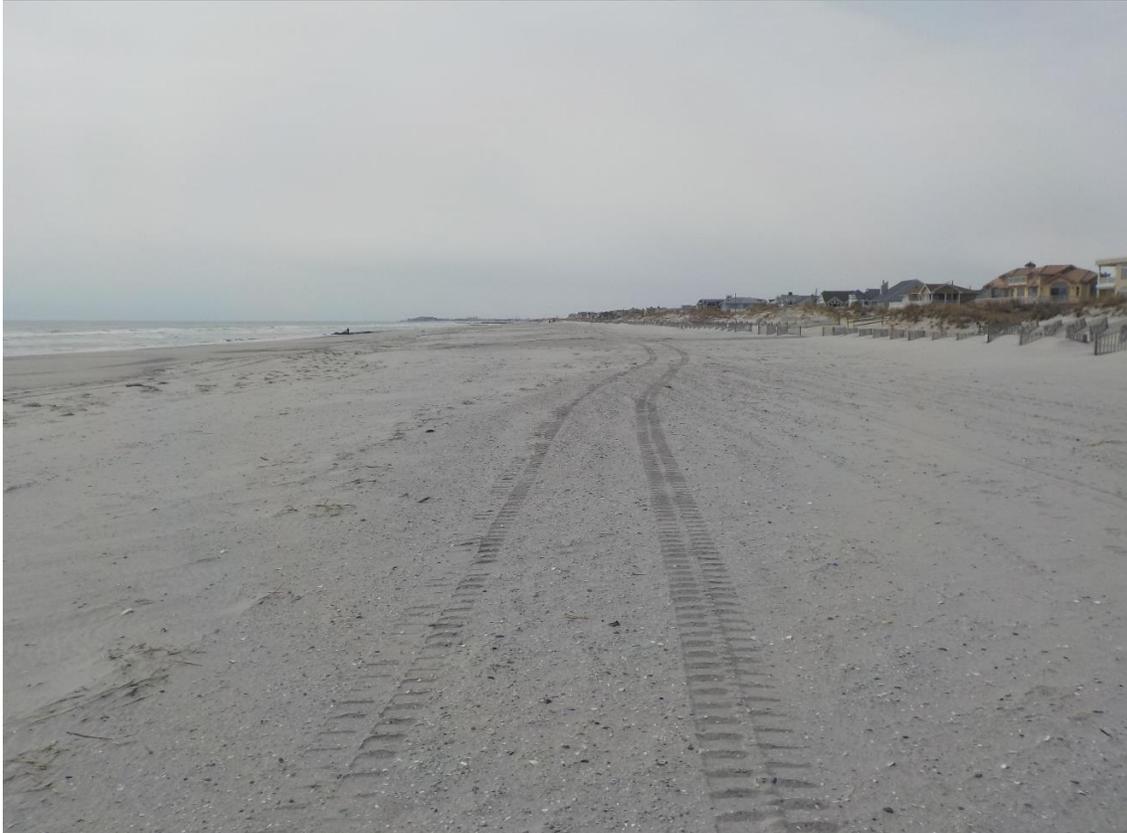
Site SH-95 – 95th Street (Photoplates 3a-3b)

Photoplates 3a & b – The April 9, 2018 photo shows a flat beach with debris within 50 feet of the dune toe, but no dune erosion. The offshore region shows the deposition of sand stripped off the upper beach.

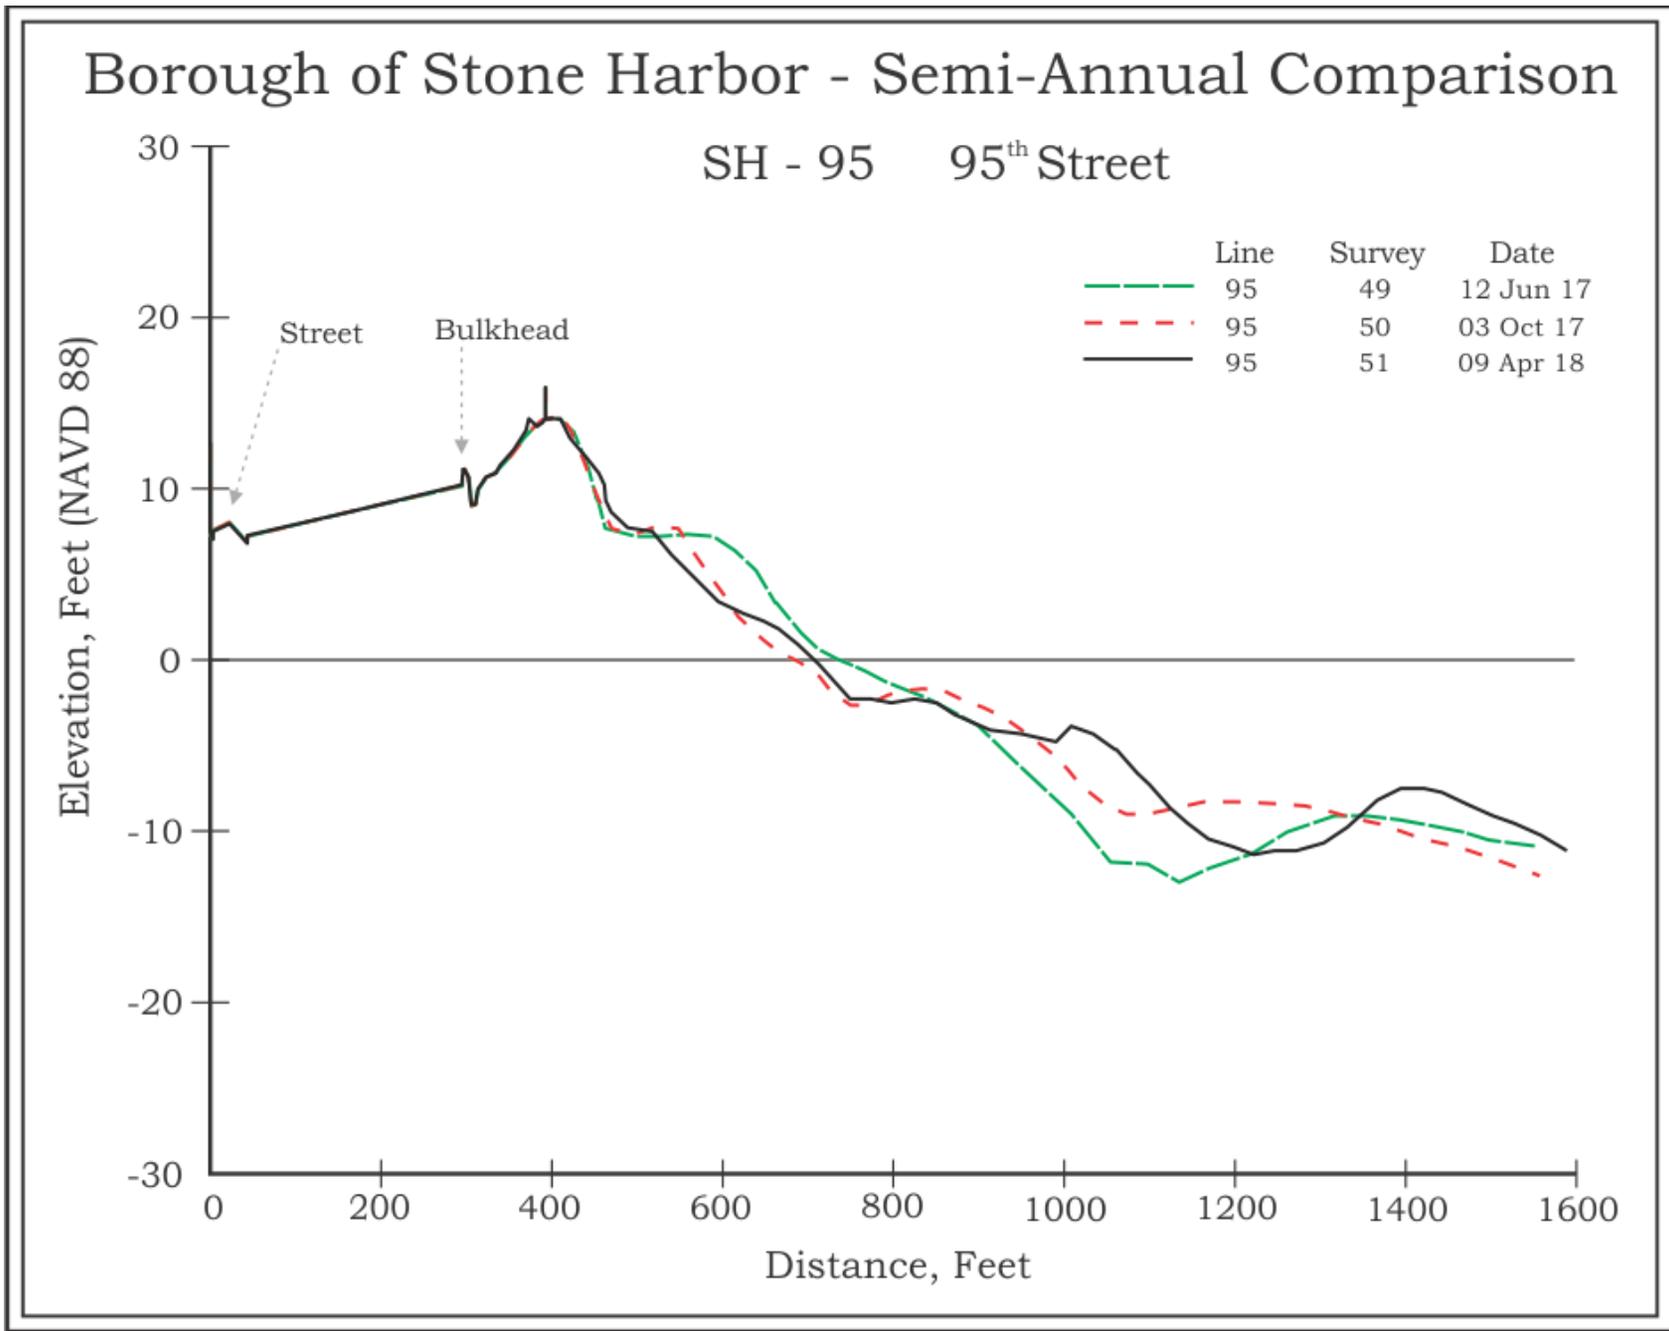
Figure 3. The post-beachfill berm was reduced by half by the time of the October 2017 survey. Further erosion took half of what remained. Offshore sand was deposited close to the beach as well as in a bar well offshore (-12.56 yds³/ft. sand lost above the datum, and 40.94 yds³/ft. gained offshore below zero elevation).

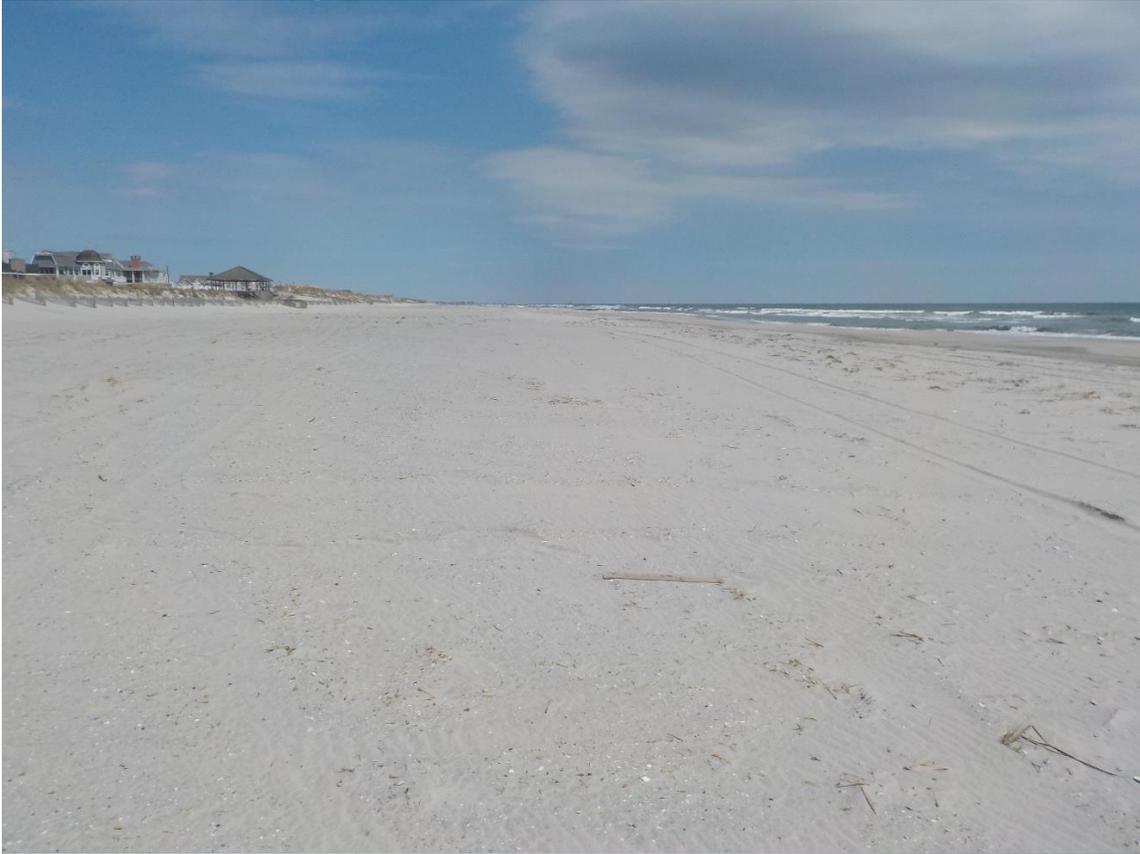
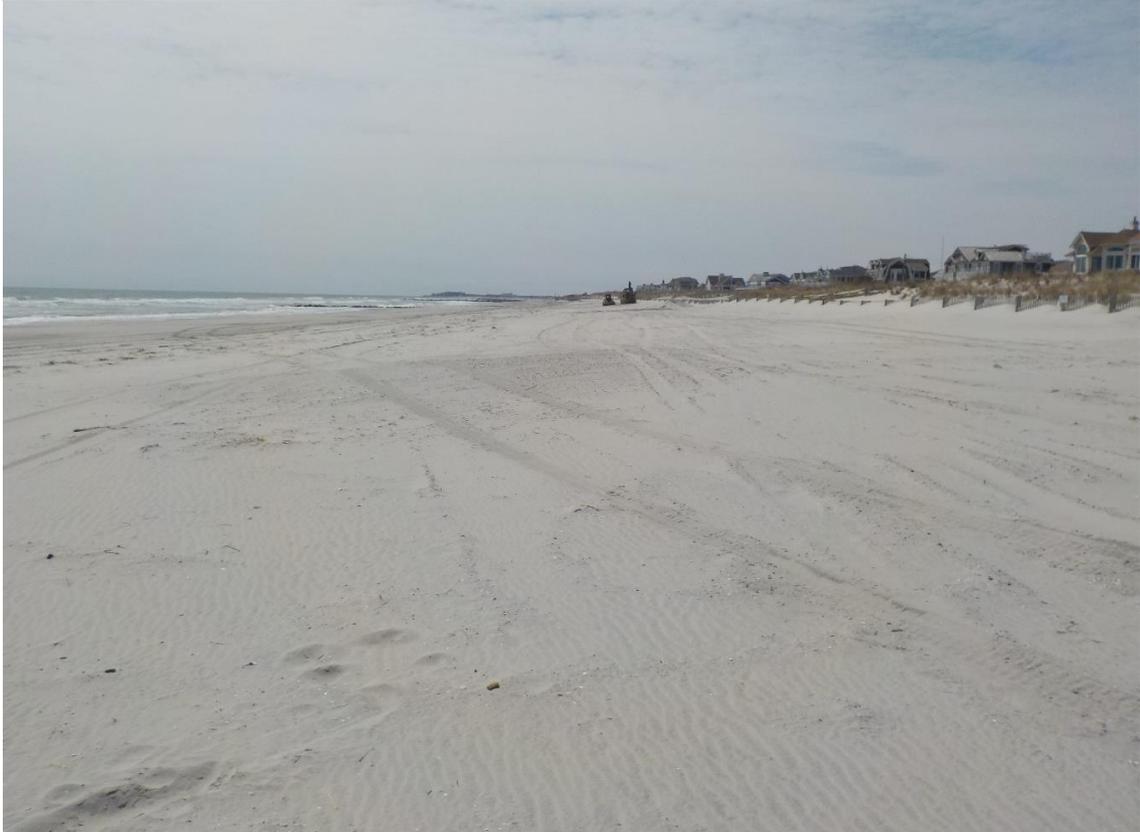
Photoplate 4a & b - Photo taken April 9, 2018 shows that the beach at 103rd Street was unaffected within 100 feet of the dune toe. No dune erosion, but the beach was badly flattened at the berm without significant sand deposited offshore.

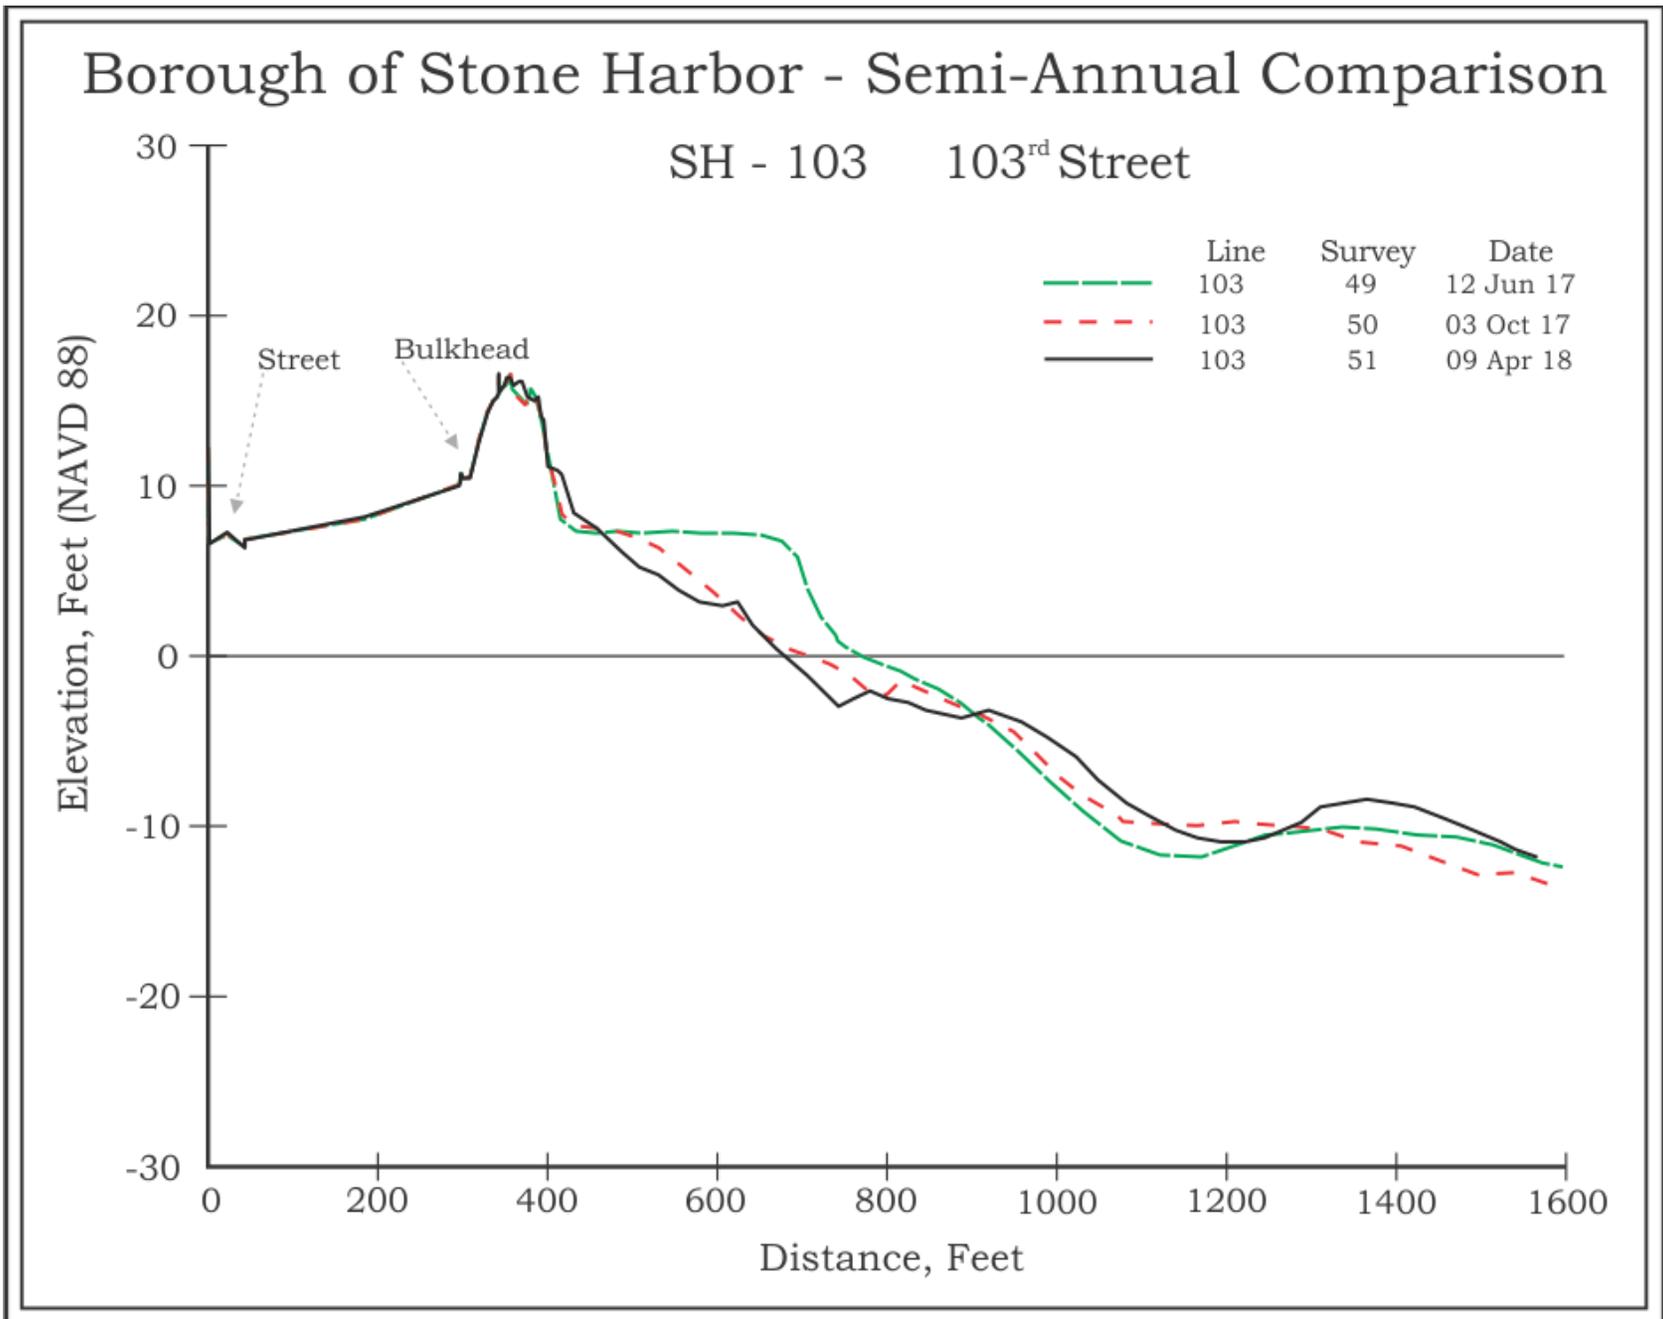
Figure 4. The post-beachfill berm was severely eroded by October 2017 and further pushed landward by April 2018. Offshore sand accumulated as a pair of bars, one close to the beach and one well offshore. The beach sand volume loss was 34.24 yds³/ft. while 18.86 yds³/ft. was added offshore.

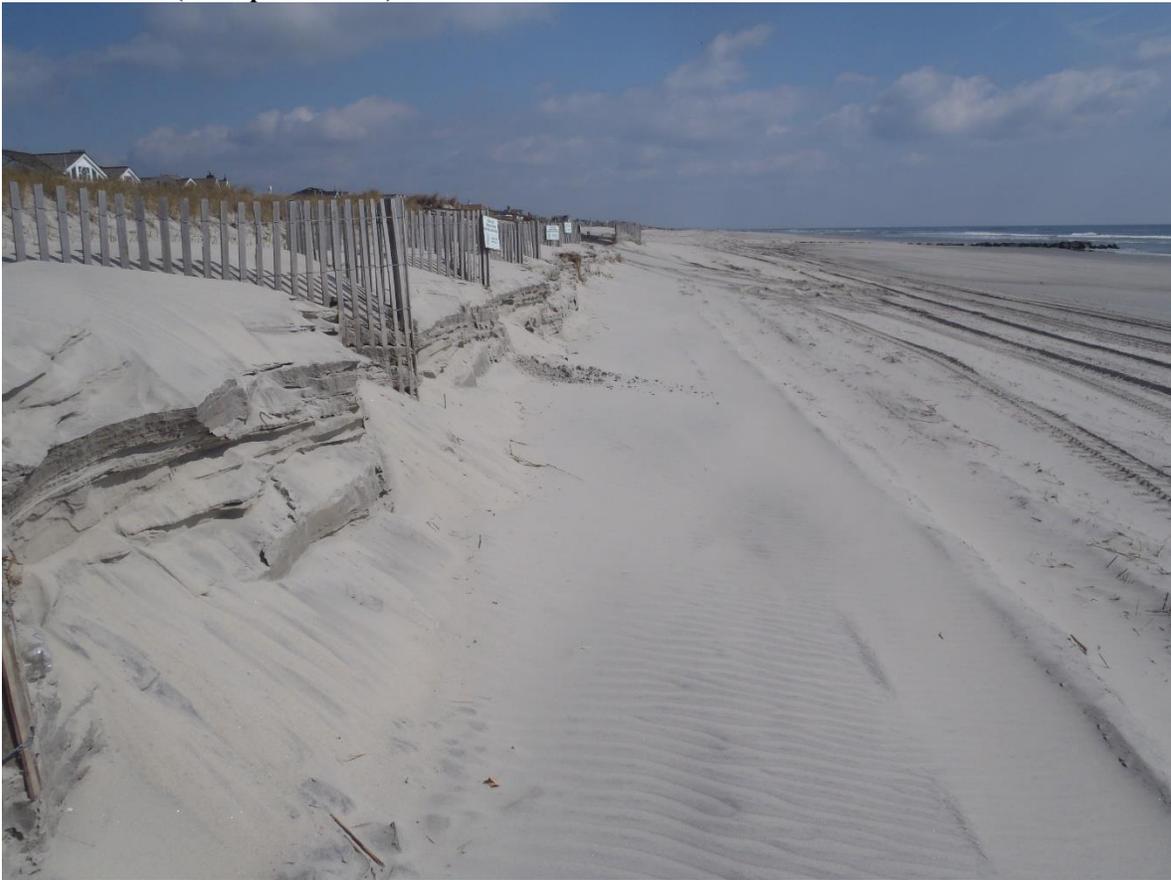
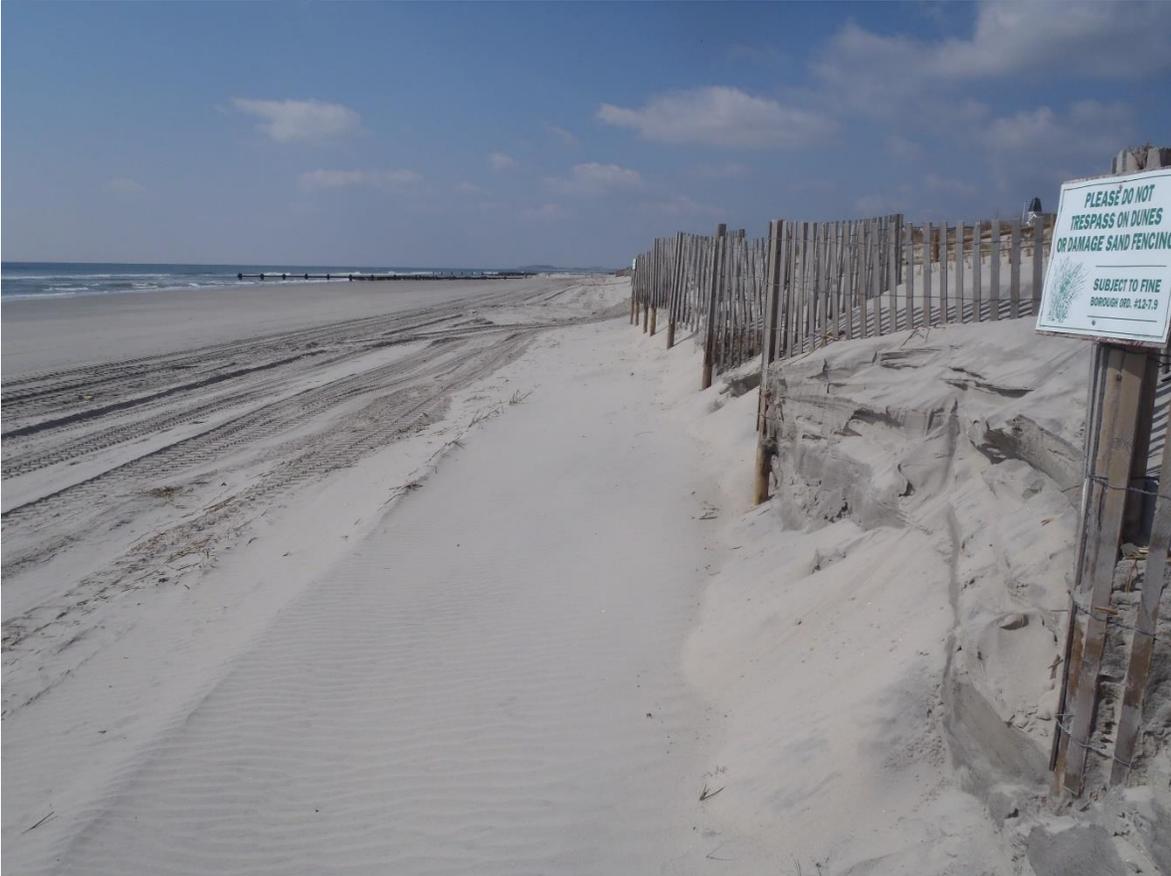
Site SH-108 – 108th Street (Photoplates 5a-5b)

Photoplates 5a & b – The photo taken April 10, 2018 is in sharp contrast with those four sites to the north. Here the dune toe was eroded to the fence installation compromising some fence sections. The beach is very flat and much narrower than in June or October 2017.

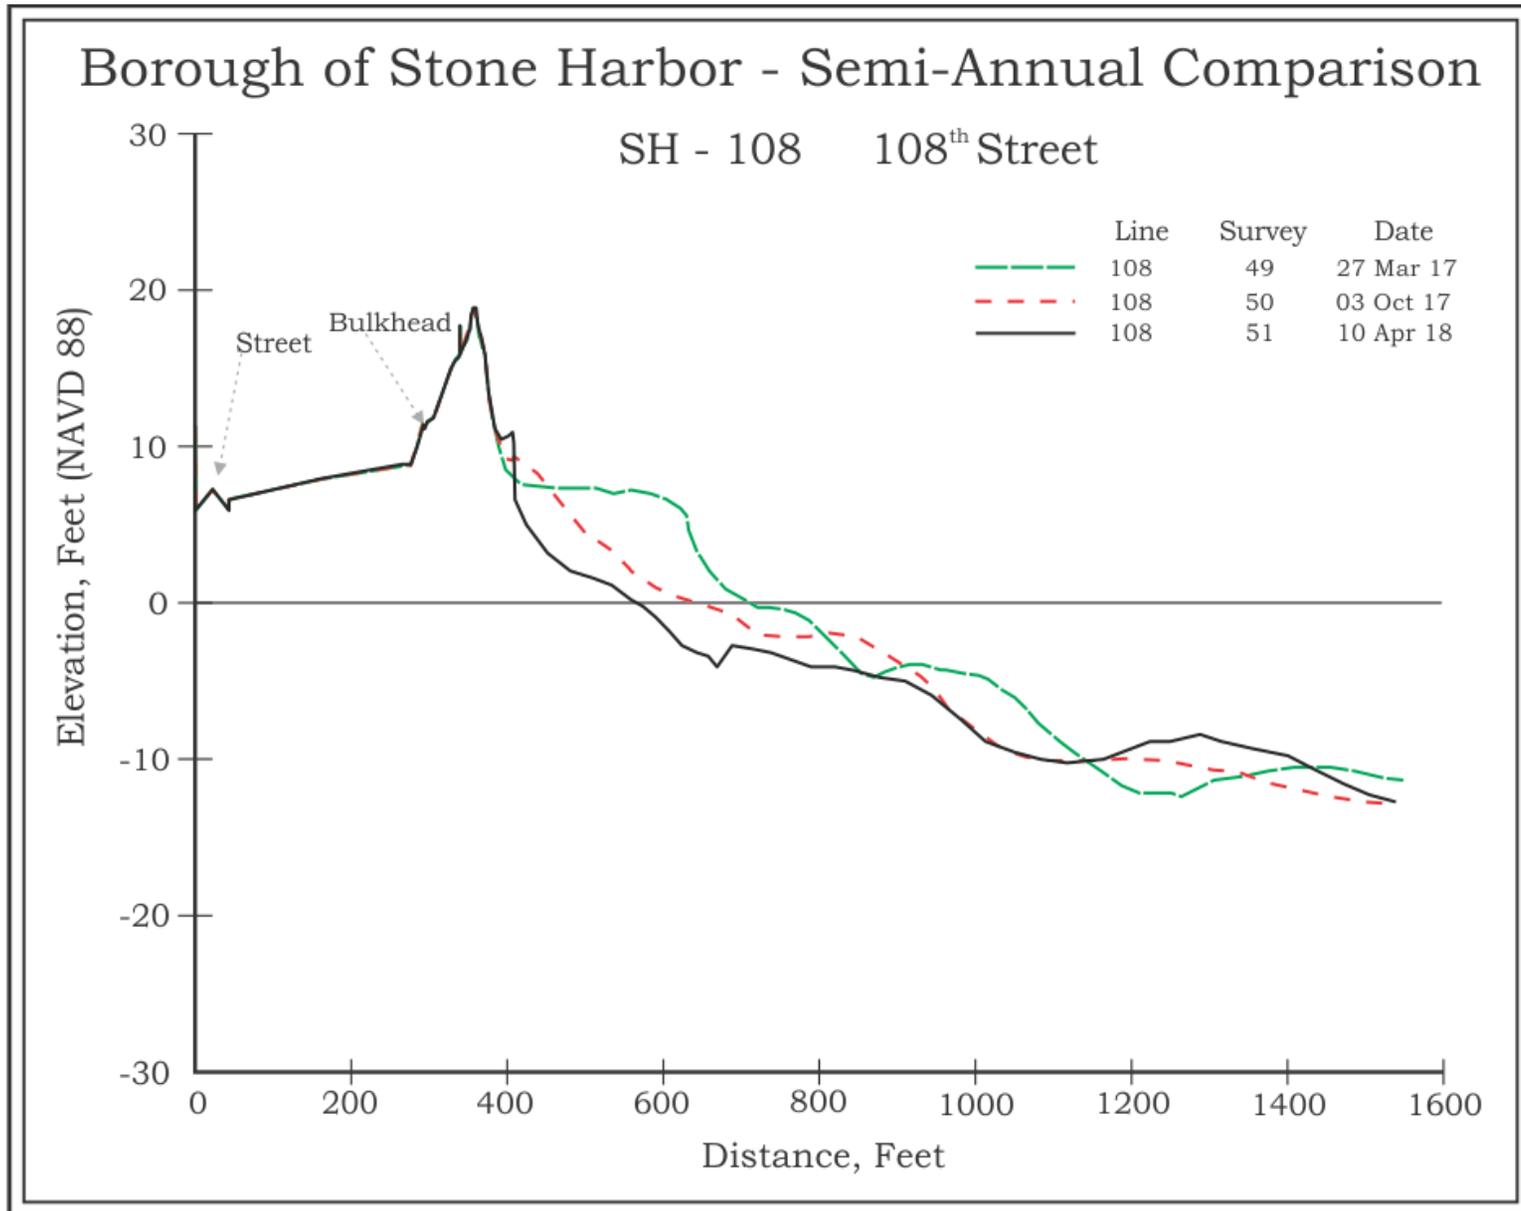
Figure 5. The storm damage was extensive at 108th Street in comparison to those sites to the north. This and 123rd Street cell were the two most heavily impacted by the storms since the beach was repaired. Between March and October 2017, the as-built berm was eroded substantially and sand piled offshore. The total change including the past winter was a beach sand volume loss of 47.89 yds³/ft. while the offshore region lost 28.75 yds³/ft. yielding the 76.74 yds³/ft. in combined losses.
