**SPECIAL SPRING 2018 STORM REPORT ON
THE CONDITION OF THE MUNICIPAL BEACHES FOR
THE BOROUGH OF STONE HARBOR, CAPE MAY COUNTY, NEW JERSEY**

**PREPARED FOR: THE BOROUGH OF STONE HARBOR
9508 SECOND AVENUE
STONE HARBOR, NJ 08247**

**PREPARED BY: THE STOCKTON UNIVERSITY COASTAL RESEARCH CENTER
30 WILSON AVENUE
PORT REPUBLIC, NEW JERSEY 08241**

May 20, 2018

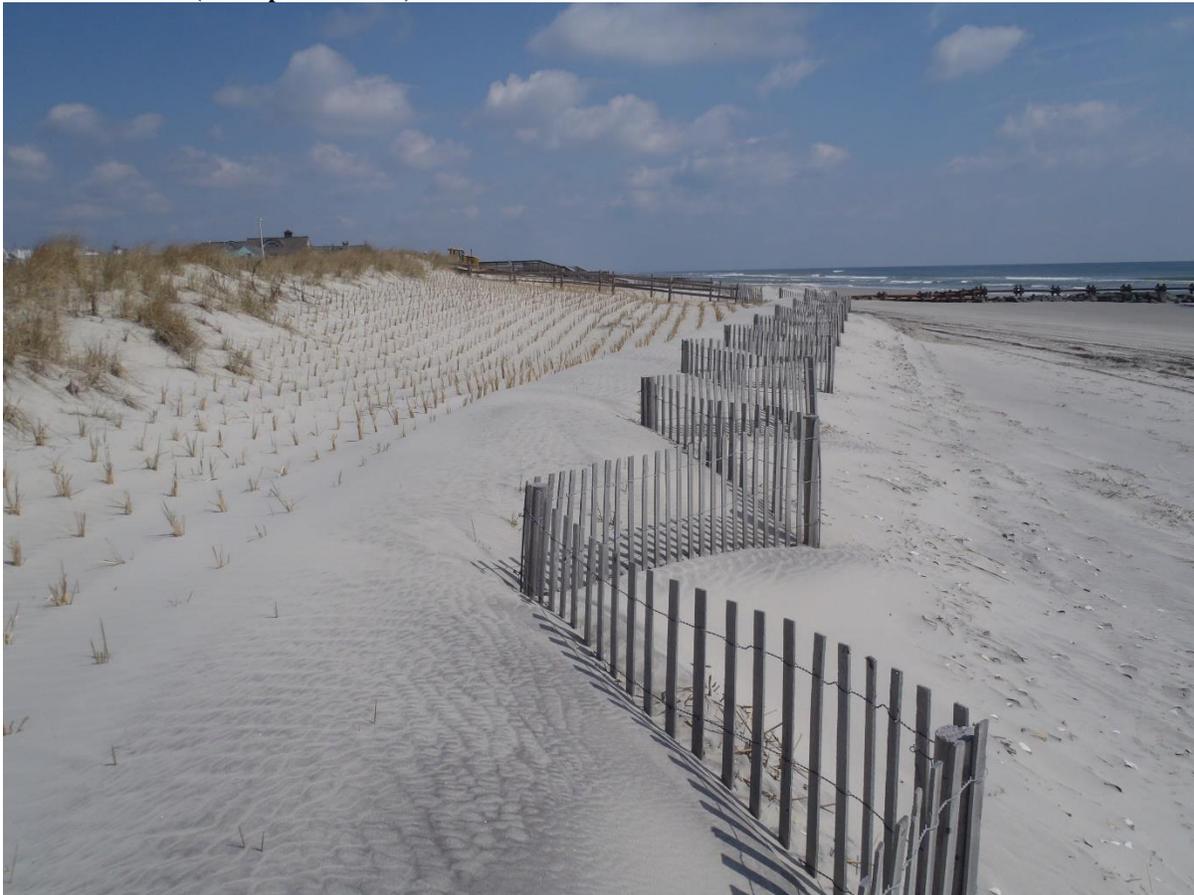
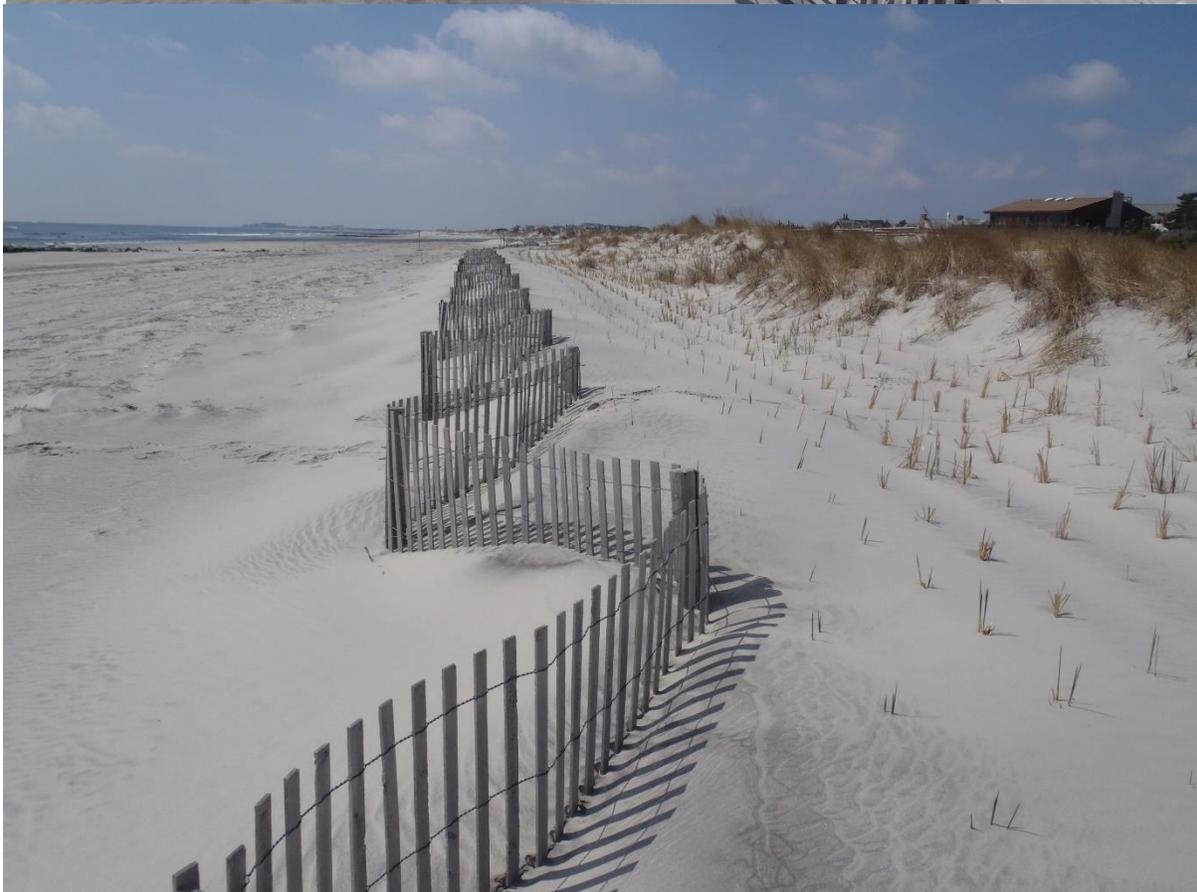
Site SH-112 – 112th Street (Photoplates 6a-6b)

Photoplates 6 a & b - Photos taken April 10, 2018 show that the storms did not reach or damage the dunes at 112th Street. Plant debris did accumulate on the dune toe slope and the beach became narrower.

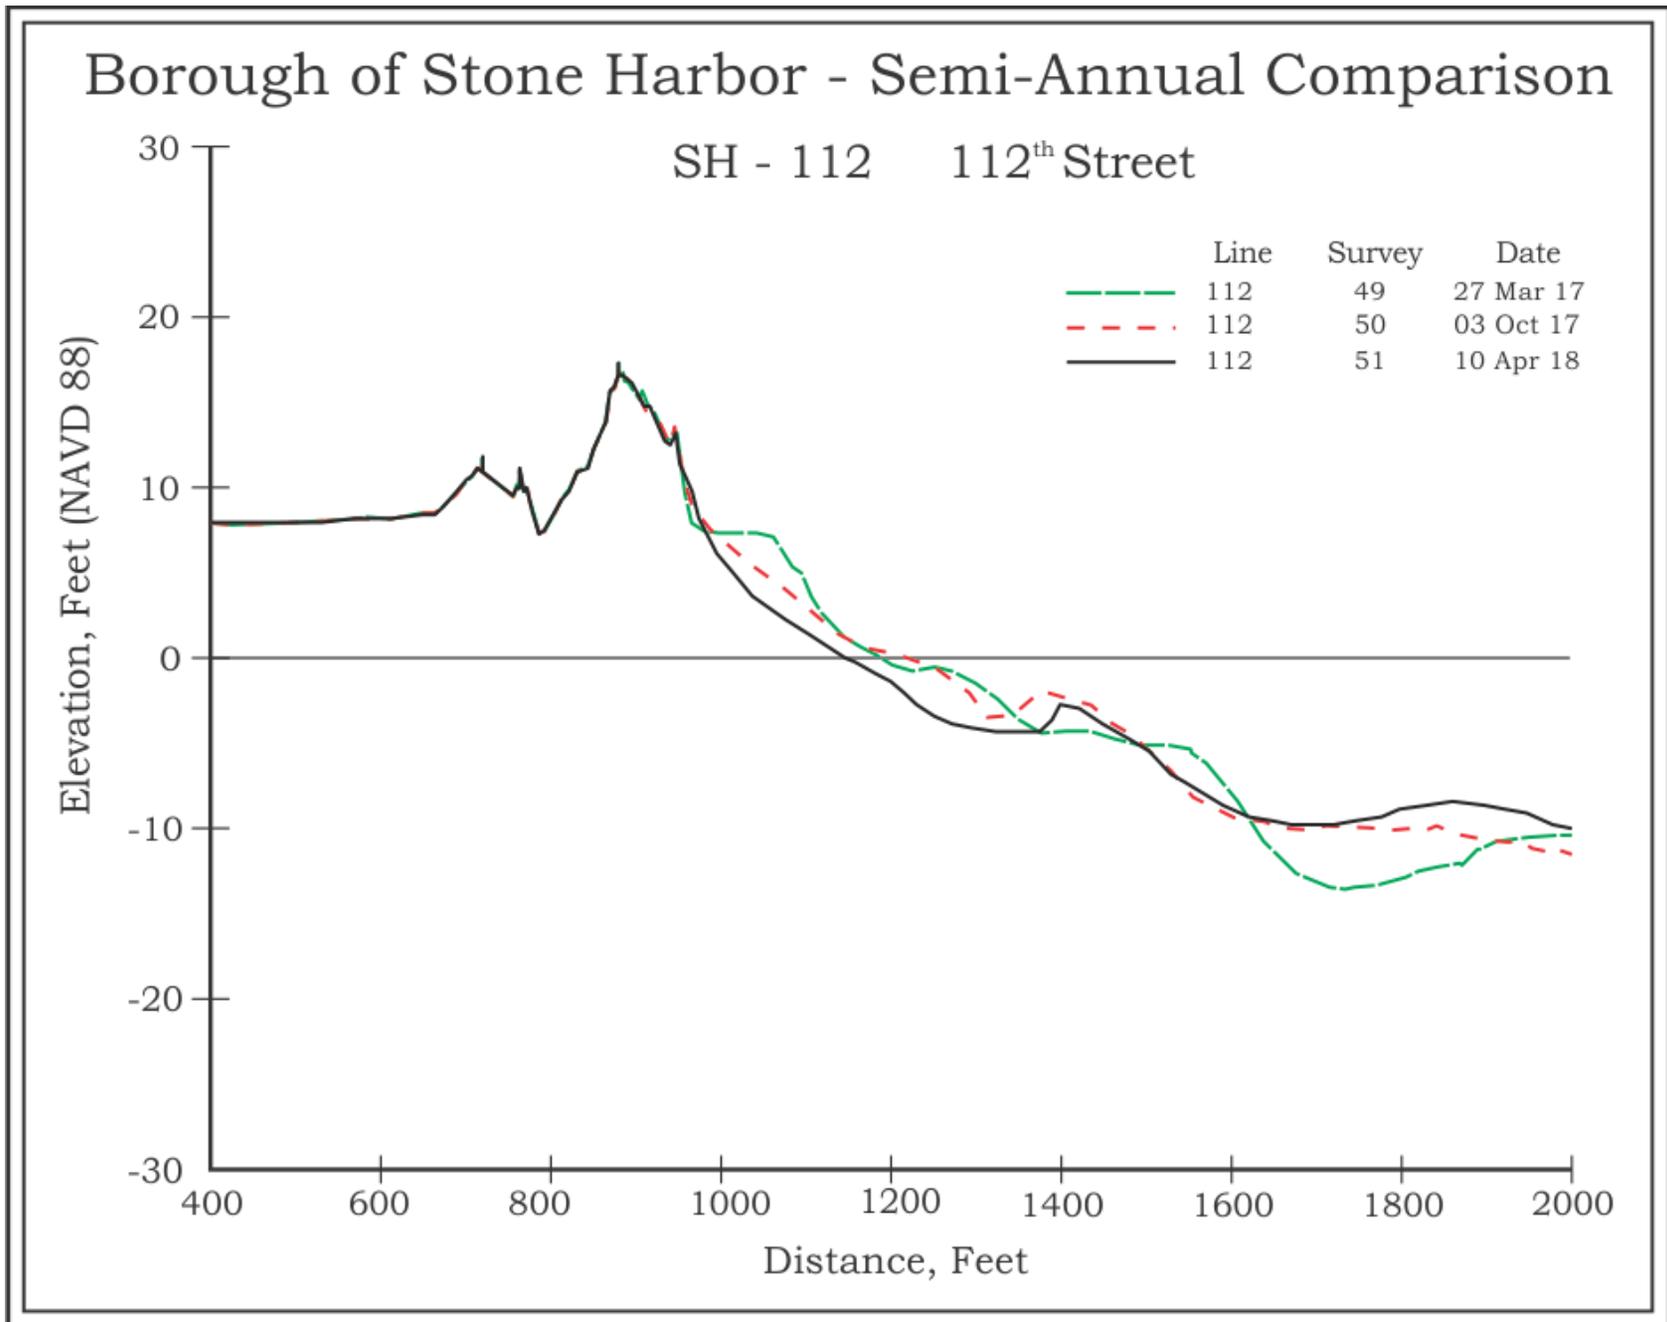
Figure 6. The profiles at 112th Street show the loss of the as-built berm by October 2017 with sand transferred offshore. The winter storms flattened the beach slope into a uniform concave-up curve into the water where offshore bars dominated. The sand loss above the zero datum was 16.06 yds³/ft. while below the datum, the offshore gained 15.82 yds³/ft.

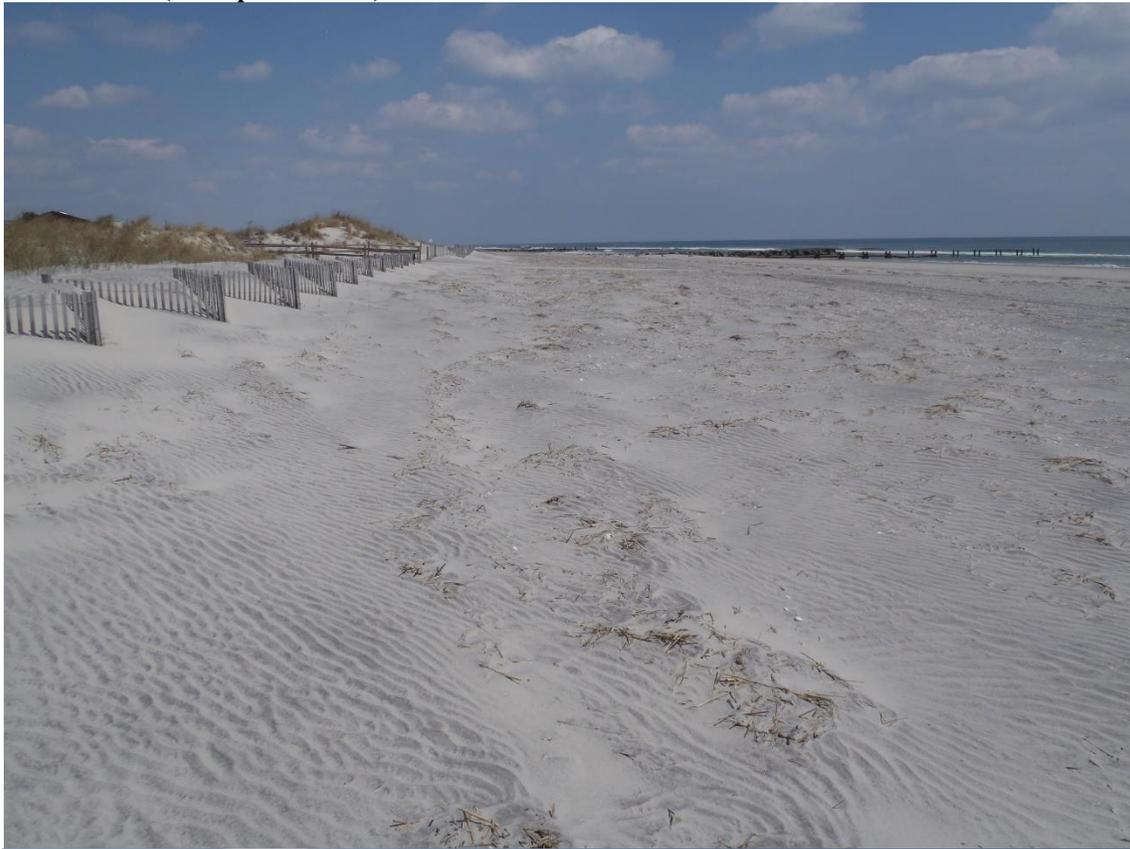
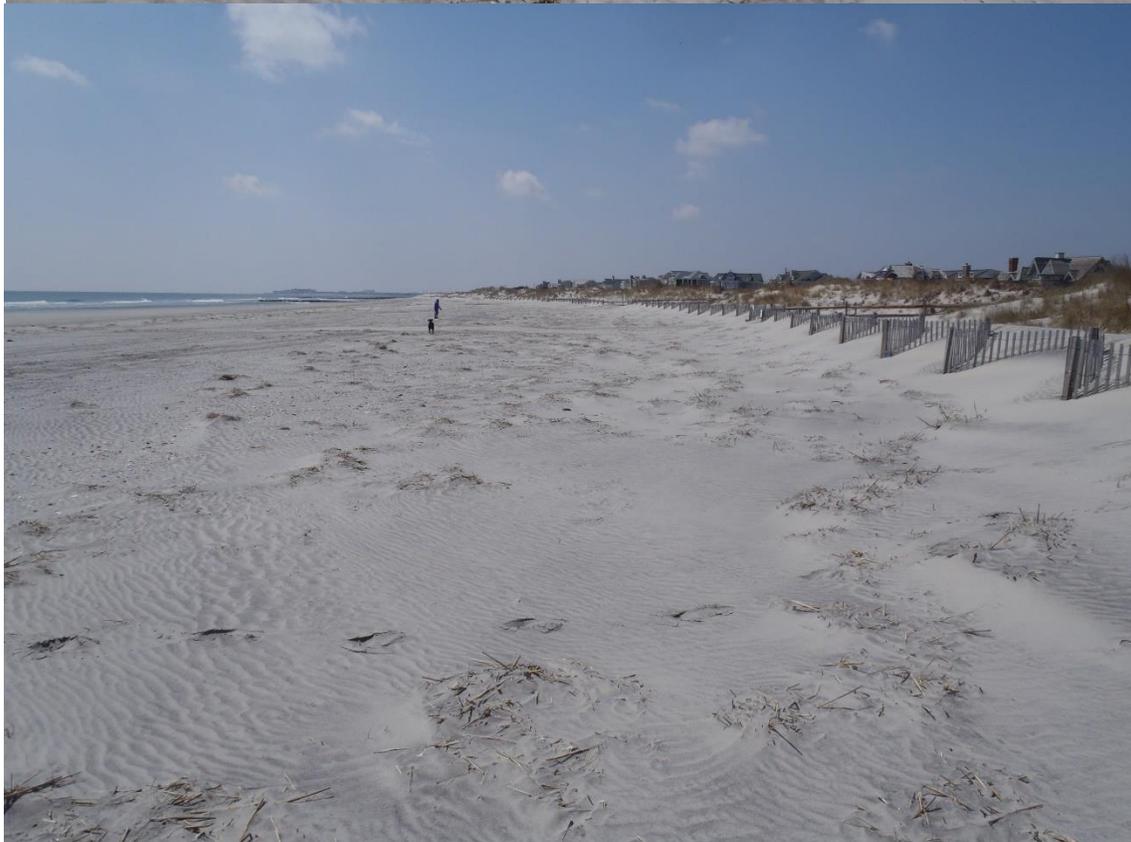
Site SH-116 – 116th Street (Photoplates 7a-7b)

Photoplates 7a & b – Photos taken April 10, 2018 show a wide beach with storm debris up to the dune fencing, but no dune damage. The series of storms moved sand to this location adding to a generally wider beach.

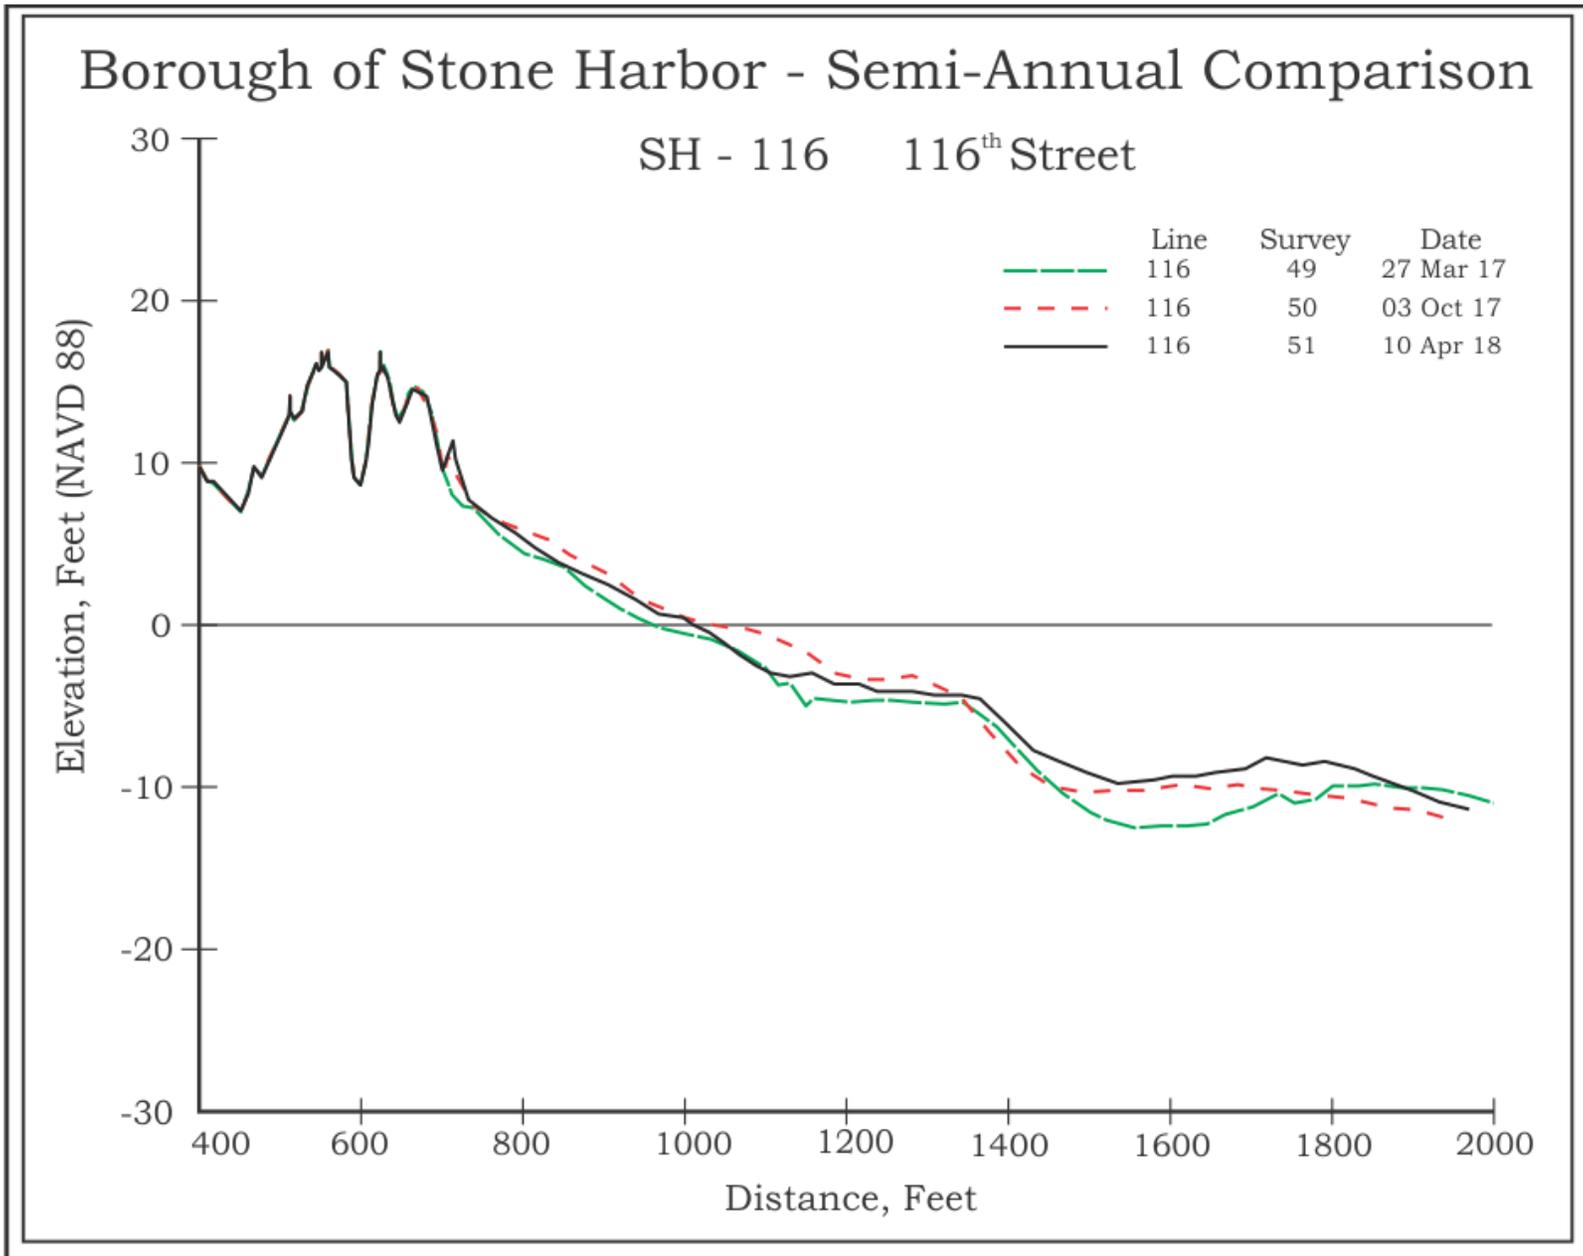
Figure 7. The 116th Street location was the anomaly of the eight sites where the sand gains far exceeded any other location both above and below the datum. Above the datum the beach gained 8.37 yds³/ft. and 45.40 yds³/ft. below zero elevation. The shoreline advanced 49 feet as well indicating specific sand deposition at this site.

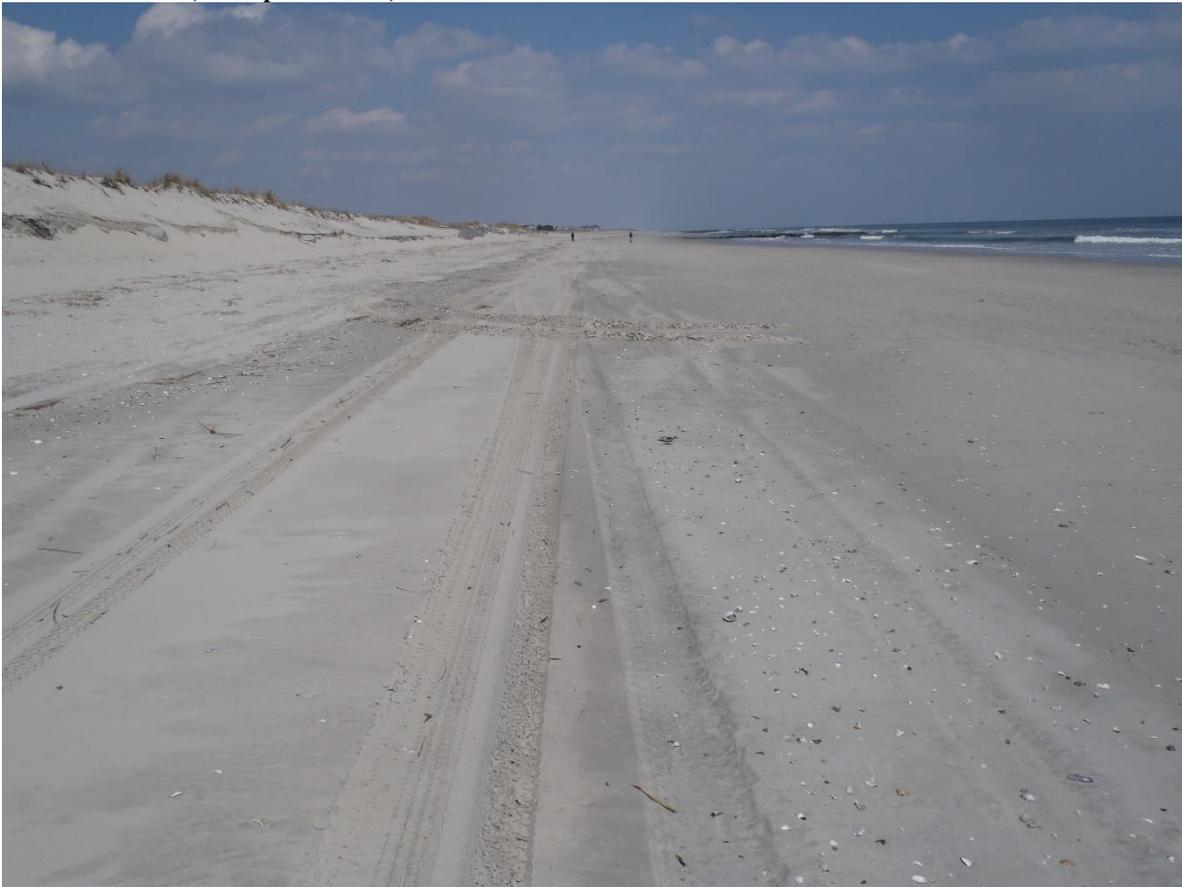
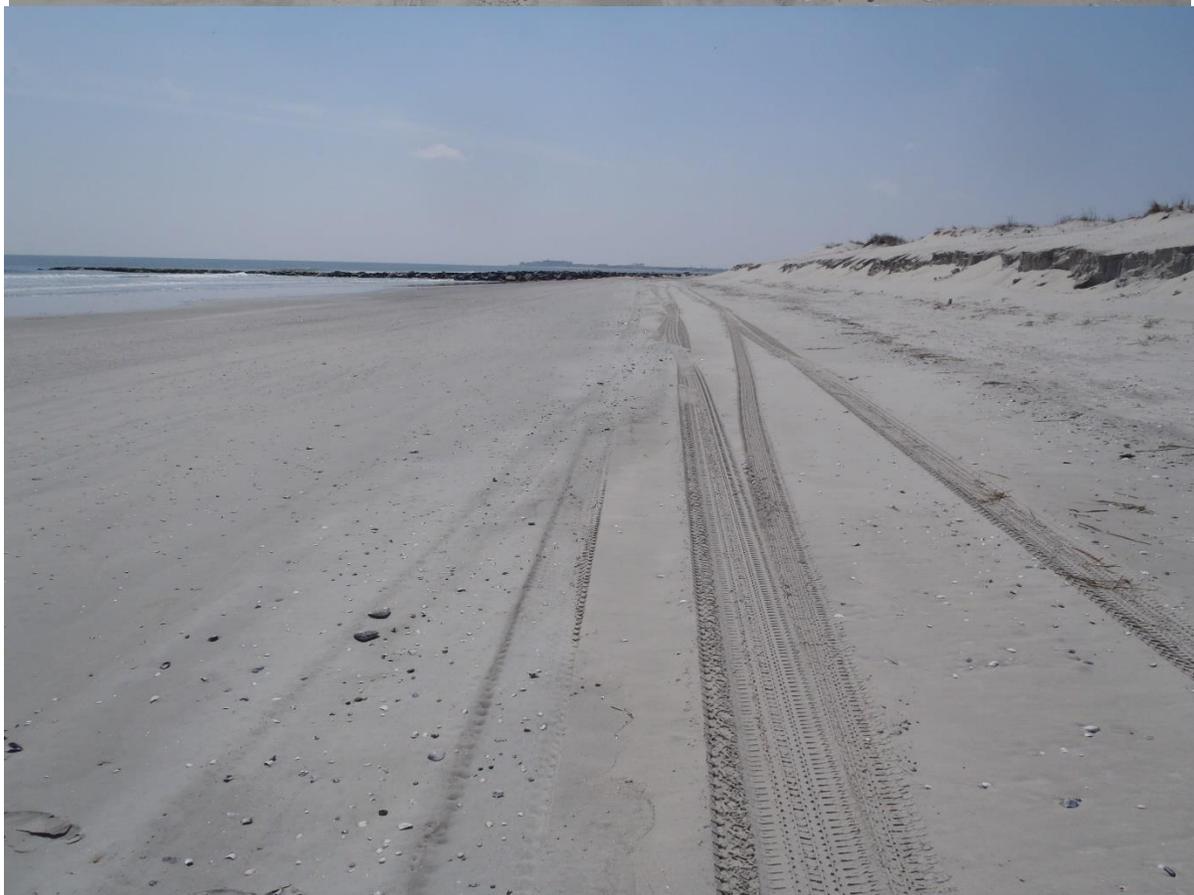
Site SH-123 – 123rd Street (Photoplate 8a-8b)

Photoplates 8a & b – Photos taken April 10, 2018 showing storm damage to the dune toe where sand was removed and the beach was flattened to the point where high tide reaches the dunes.

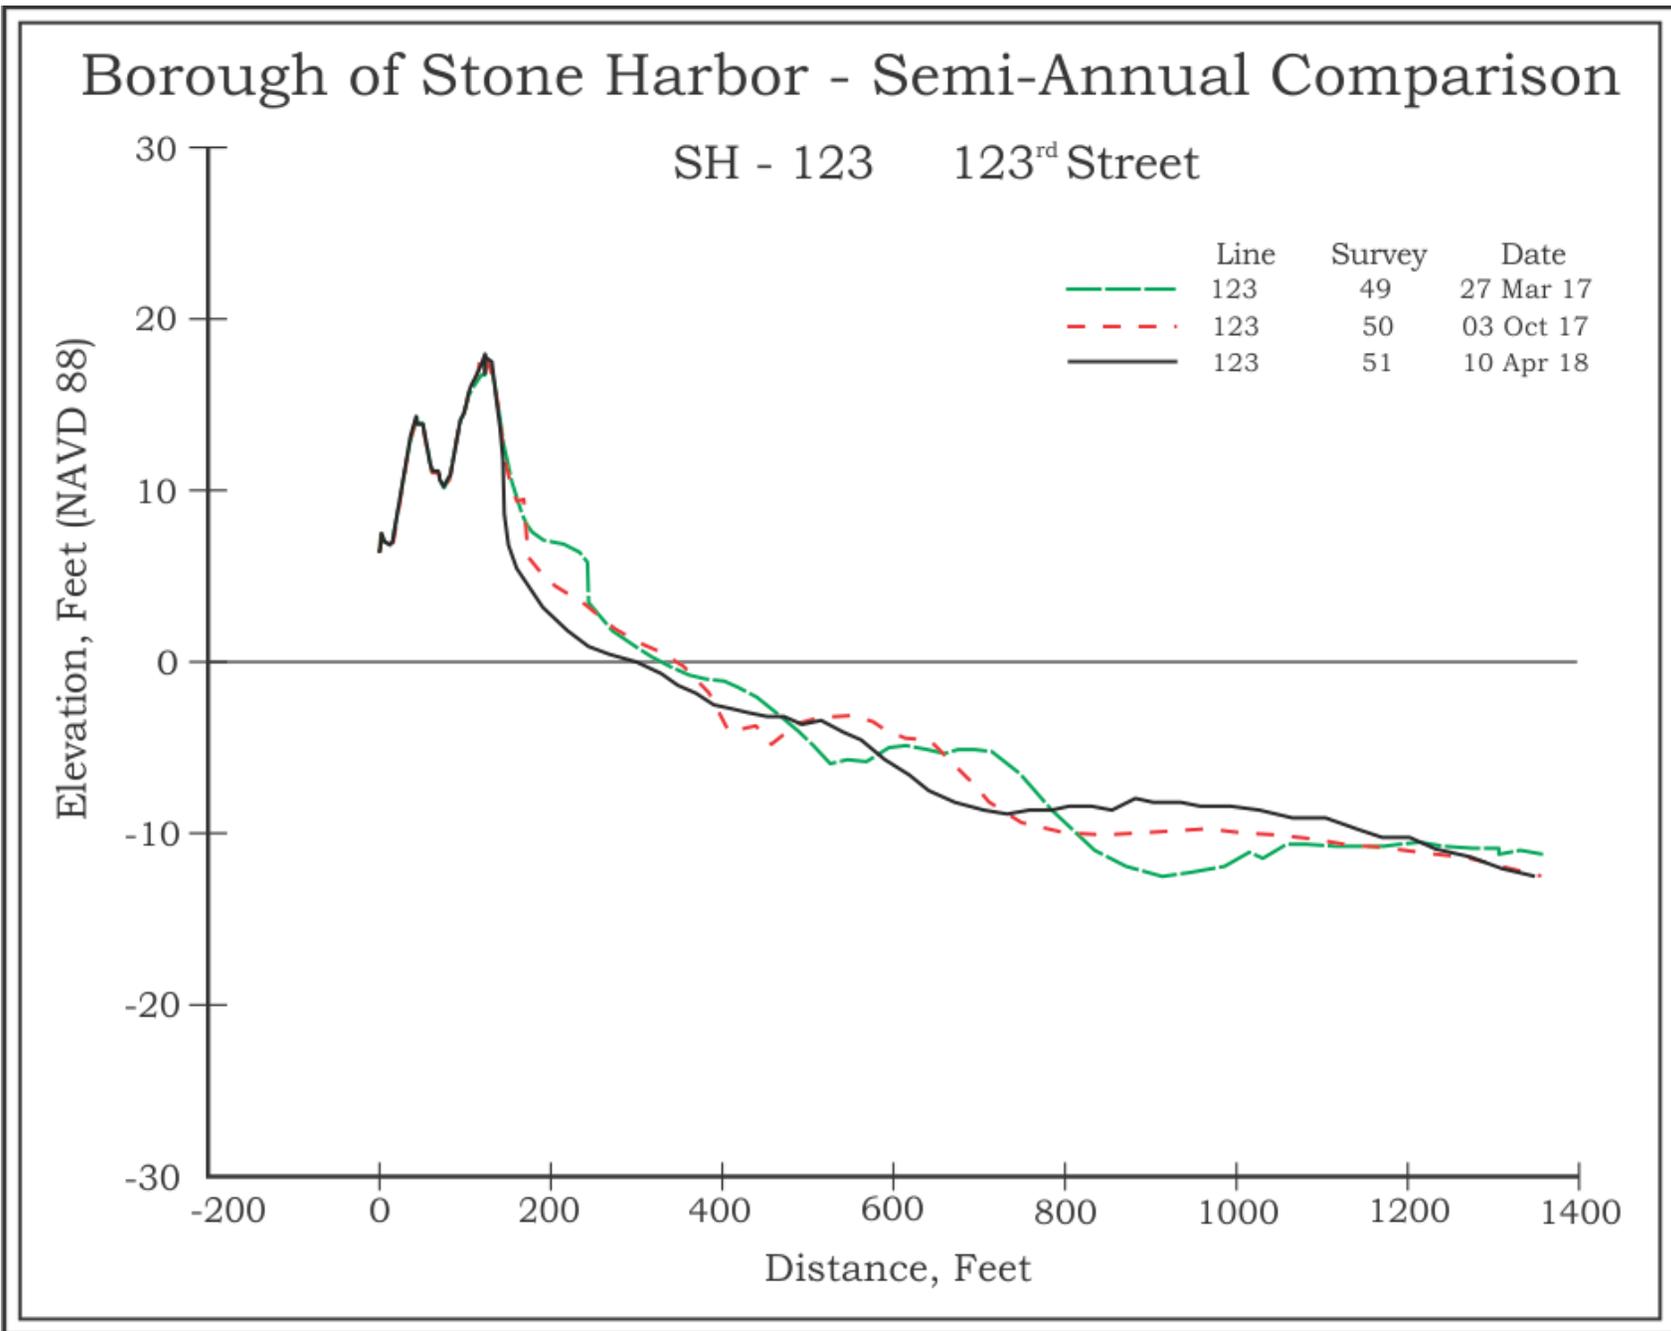
Figure 8. 123rd Street was the second of two where the dune was eroded generating a scarp in the dune toe. The beach was reduced in steps by half in October 2017 and to a concave-up storm beach by April 10, 2018. Sand redistribution removed 19.40 yds³/ft. in sand volume on the beach and took 3.78 yds³/ft. offshore. Bar redistribution was extreme among the three surveys.
