The Coastal Research Center

The spring 2020 municipal oceanfront beach survey was completed on April 15<sup>th</sup> and 16<sup>th</sup> at the eight established sites in Stone Harbor. The Stockton University Coastal Research Center (CRC) completed the first of two scheduled seasonal surveys for 2020. Semi-annual shoreline and sand volume changes were calculated between survey #55 (conducted in October 2019) and survey #56 to determine changes over the 2019 to 2020 winter season and review changes to the Corps project on the Borough beaches. This spring has been perhaps, the most storm-free since the beginning of the 21<sup>st</sup> Century. Storms did occur, but seemed to pass northwest of the region, moving across the country directly into New England and from there, out to sea. Minor periods of northeast weather did occur, but limited to wind velocities under 25 MPH. March 23, 2020 was the single noted northeaster thus far in 2020. The spring has seen extensive periods of southeast winds which generate northerly sand transport. The trend is evident on the cross sections as small ridges of sand have appeared in the nearby offshore region that usually migrate onto the beach as th

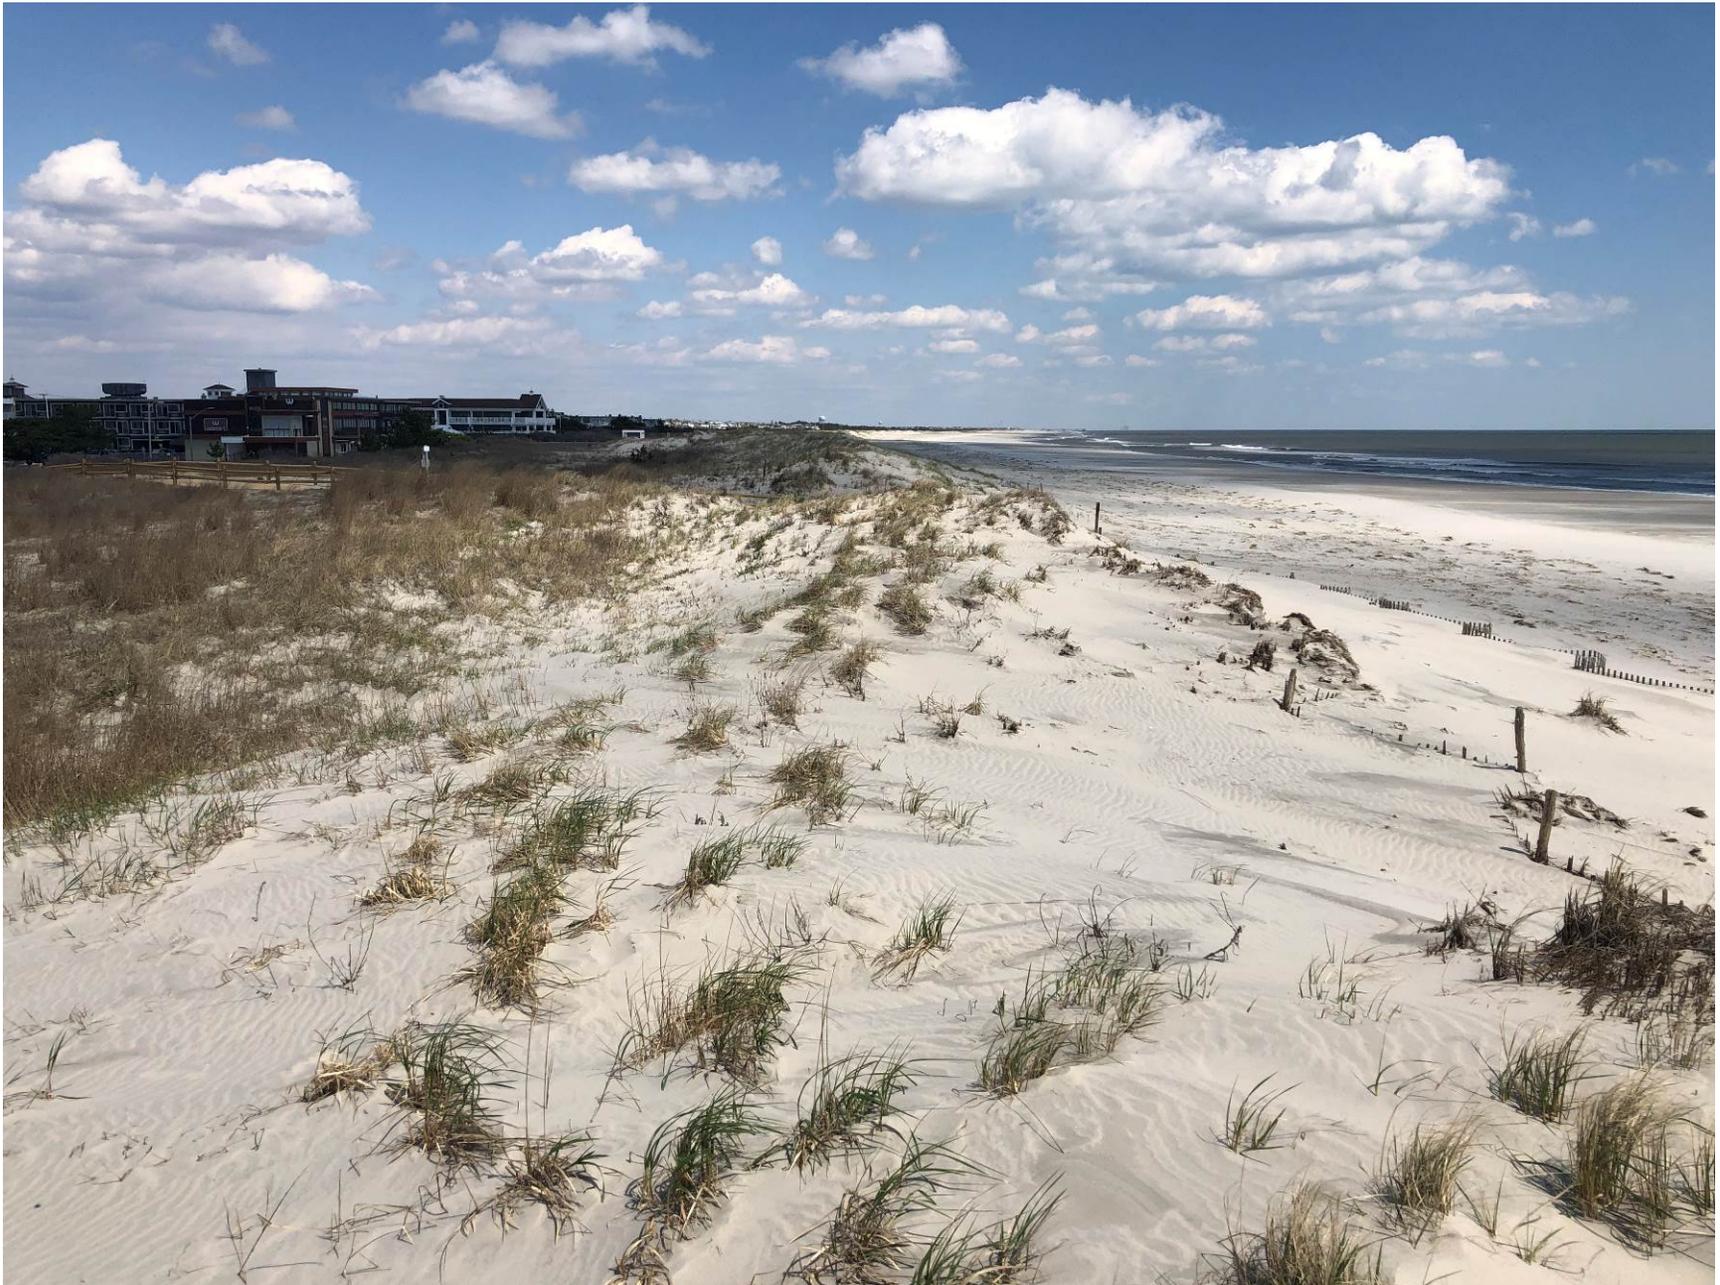
**SH-82**, located at 82<sup>nd</sup> Street, this beach received sand later in 2017 derived from Townsend’s Inlet. This April 16, 2020 view shows the sand accumulated at the dune fencing over the past 2 winters and a wide beach looking north towards Avalon.

**Figure 1. View to the north at 82<sup>nd</sup> Street. The photo was taken on April 16, 2020. The beach width remains sufficient to absorb wave activity without the new fence installed following the 2017 USACE work being eroded. This fence row is nearly buried with wind deposited sand.**

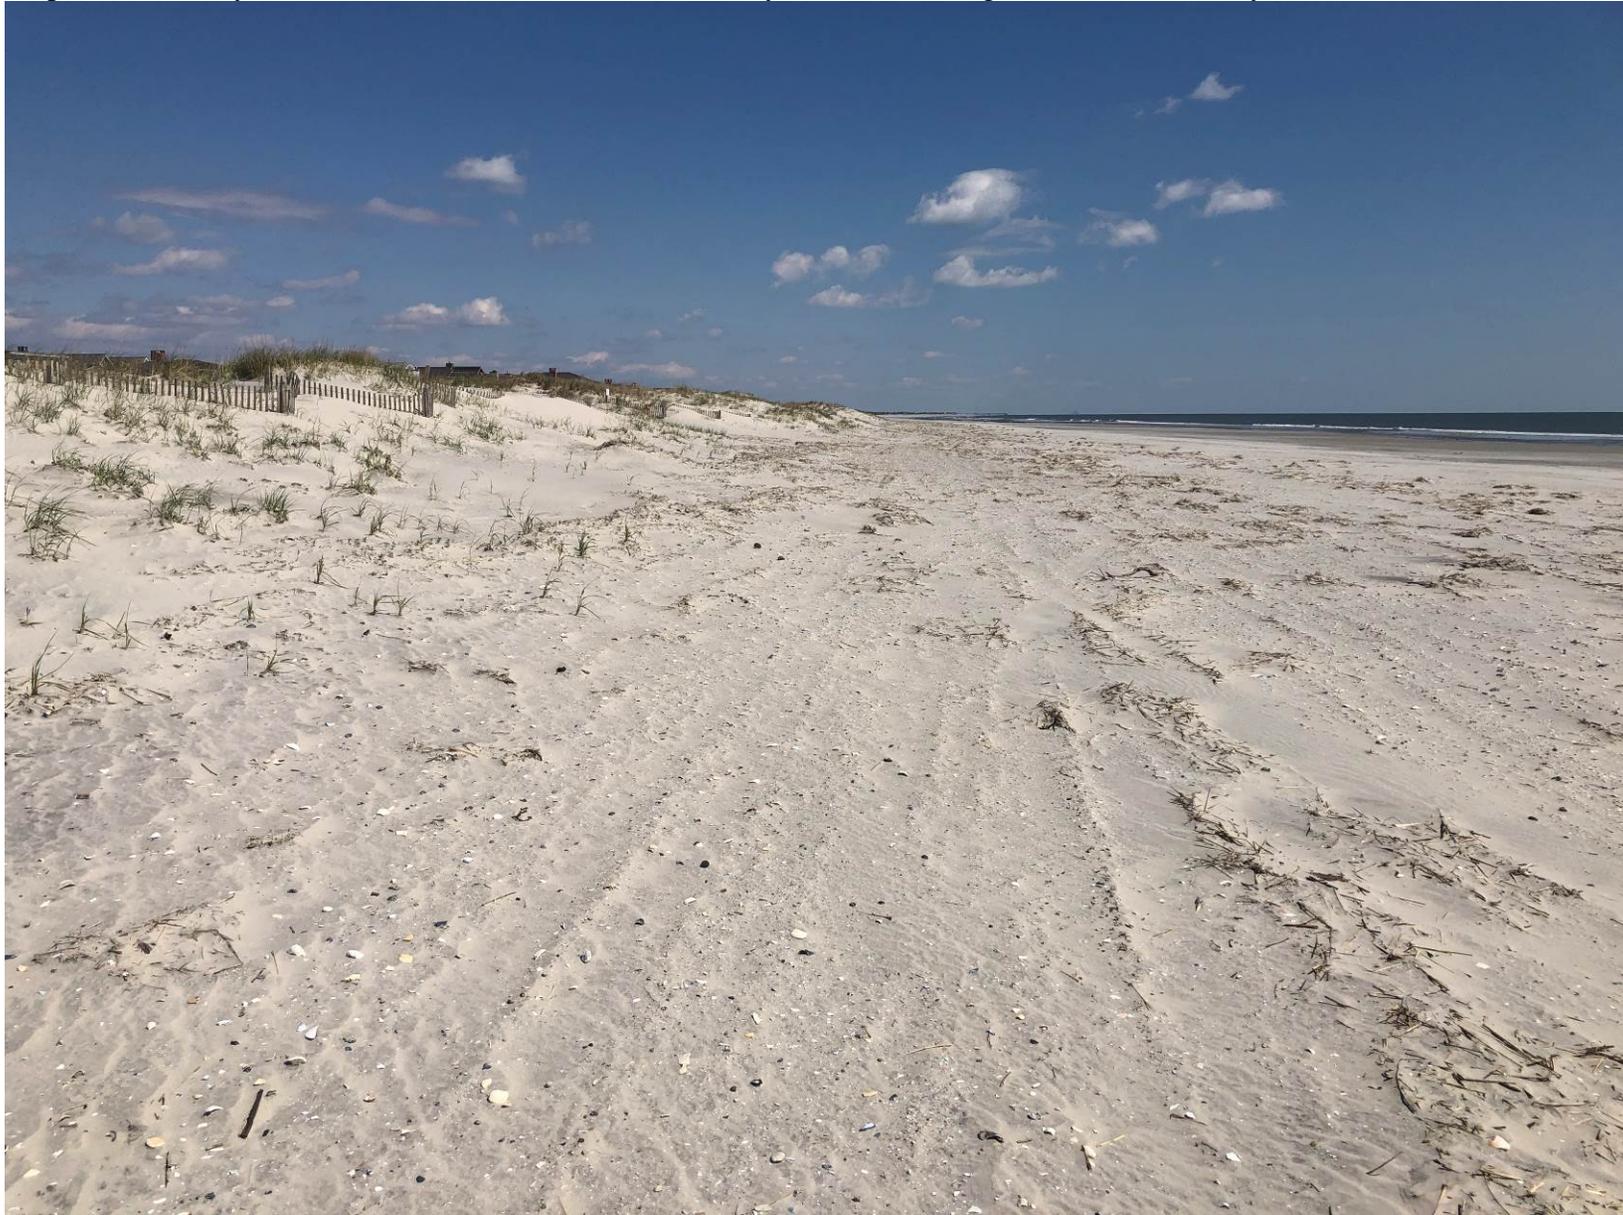
**SH-90**, located at 90<sup>th</sup> Street this beach also received sand during spring of 2017 adding 44.63 yds<sup>3</sup>/ft. The beach width sustained the dune's seaward slopes without any erosion. Storm debris does cover the dry beach indicating some winter activity.

**Figure 2.** View to the north taken from the foredune toe on April 16, 2020. The dry beach width absorbed the winter wave activity as evidenced by the multiple rows of grass debris. The dune toe remains undamaged by erosion.

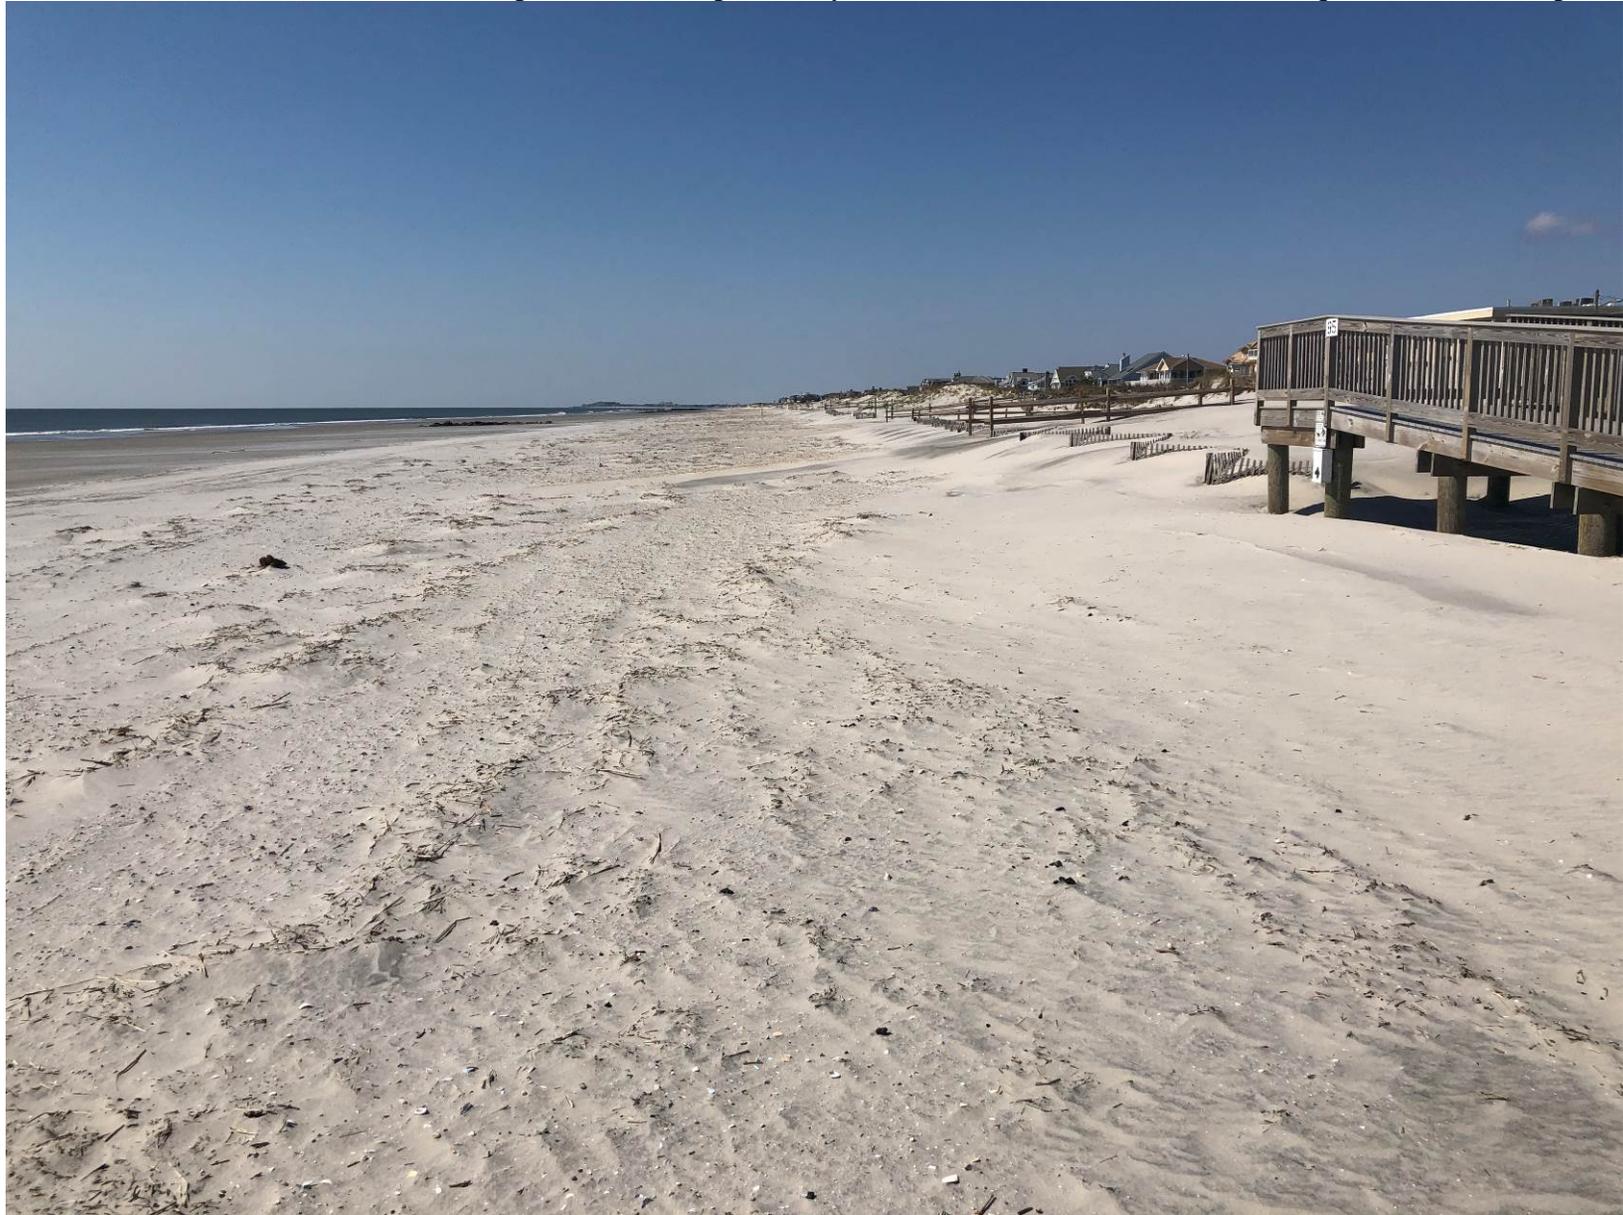
**SH-95**, located at 95<sup>th</sup> Street this site received sand by June 12, 2017, providing a 99-foot wider beach as 53.73 yds<sup>3</sup>/ft. were placed above the zero elevation. The beach remains in decent shape with sand deposited by the wind in the dunes in substantial quantities over the past 2 years.

**Figure 3.** This foredune toe view to the south taken April 16, 2020 and shows the handicapped access ramp with extensive sand accumulation at the fencing to the south. The beach width remains at a suitable level to allow considerable recreational space in 2020.

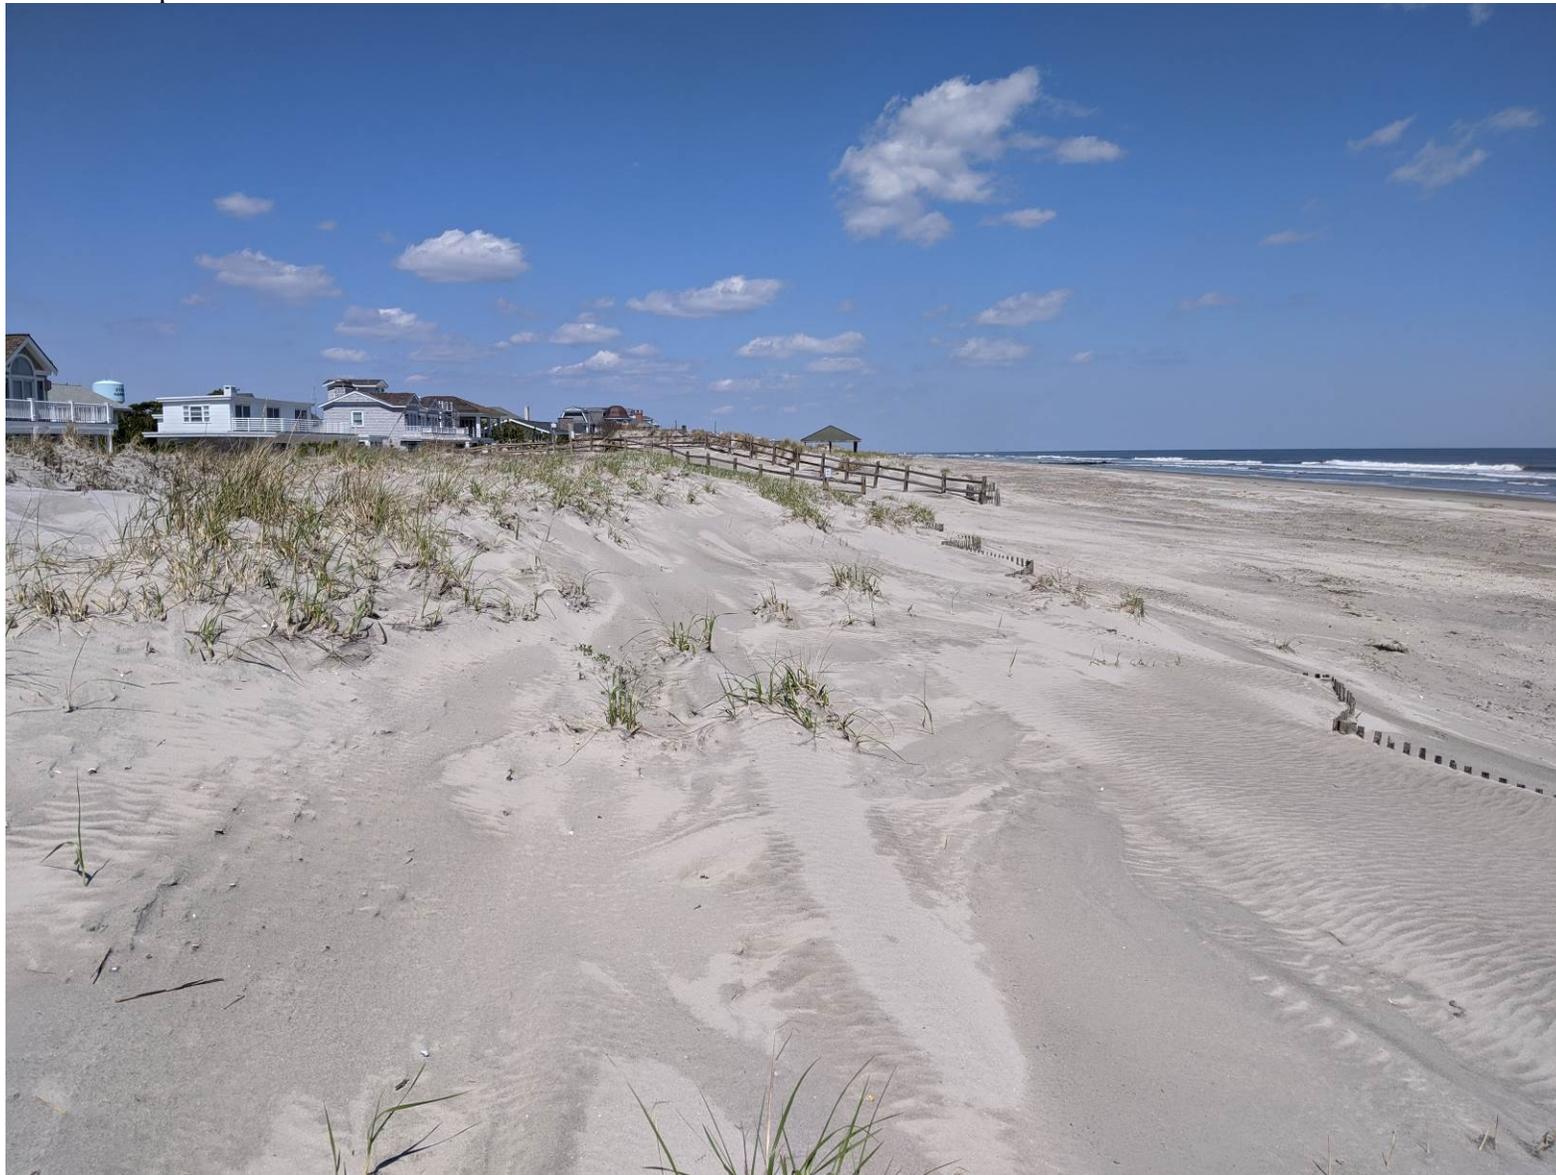
**SH-103**, the 103<sup>rd</sup> Street beach gained sand at the dune fencing burying the most recently placed row of fencing (2017). The beach width remained sufficient to protect the dunes from erosion as well.

**Figure 4.** View to the north at 103<sup>rd</sup> Street taken April 15, 2020. The extensive sand deposition around the 2017 fence installation has buried the fence. The site retained the wider beach and saw no dune damage this past winter.

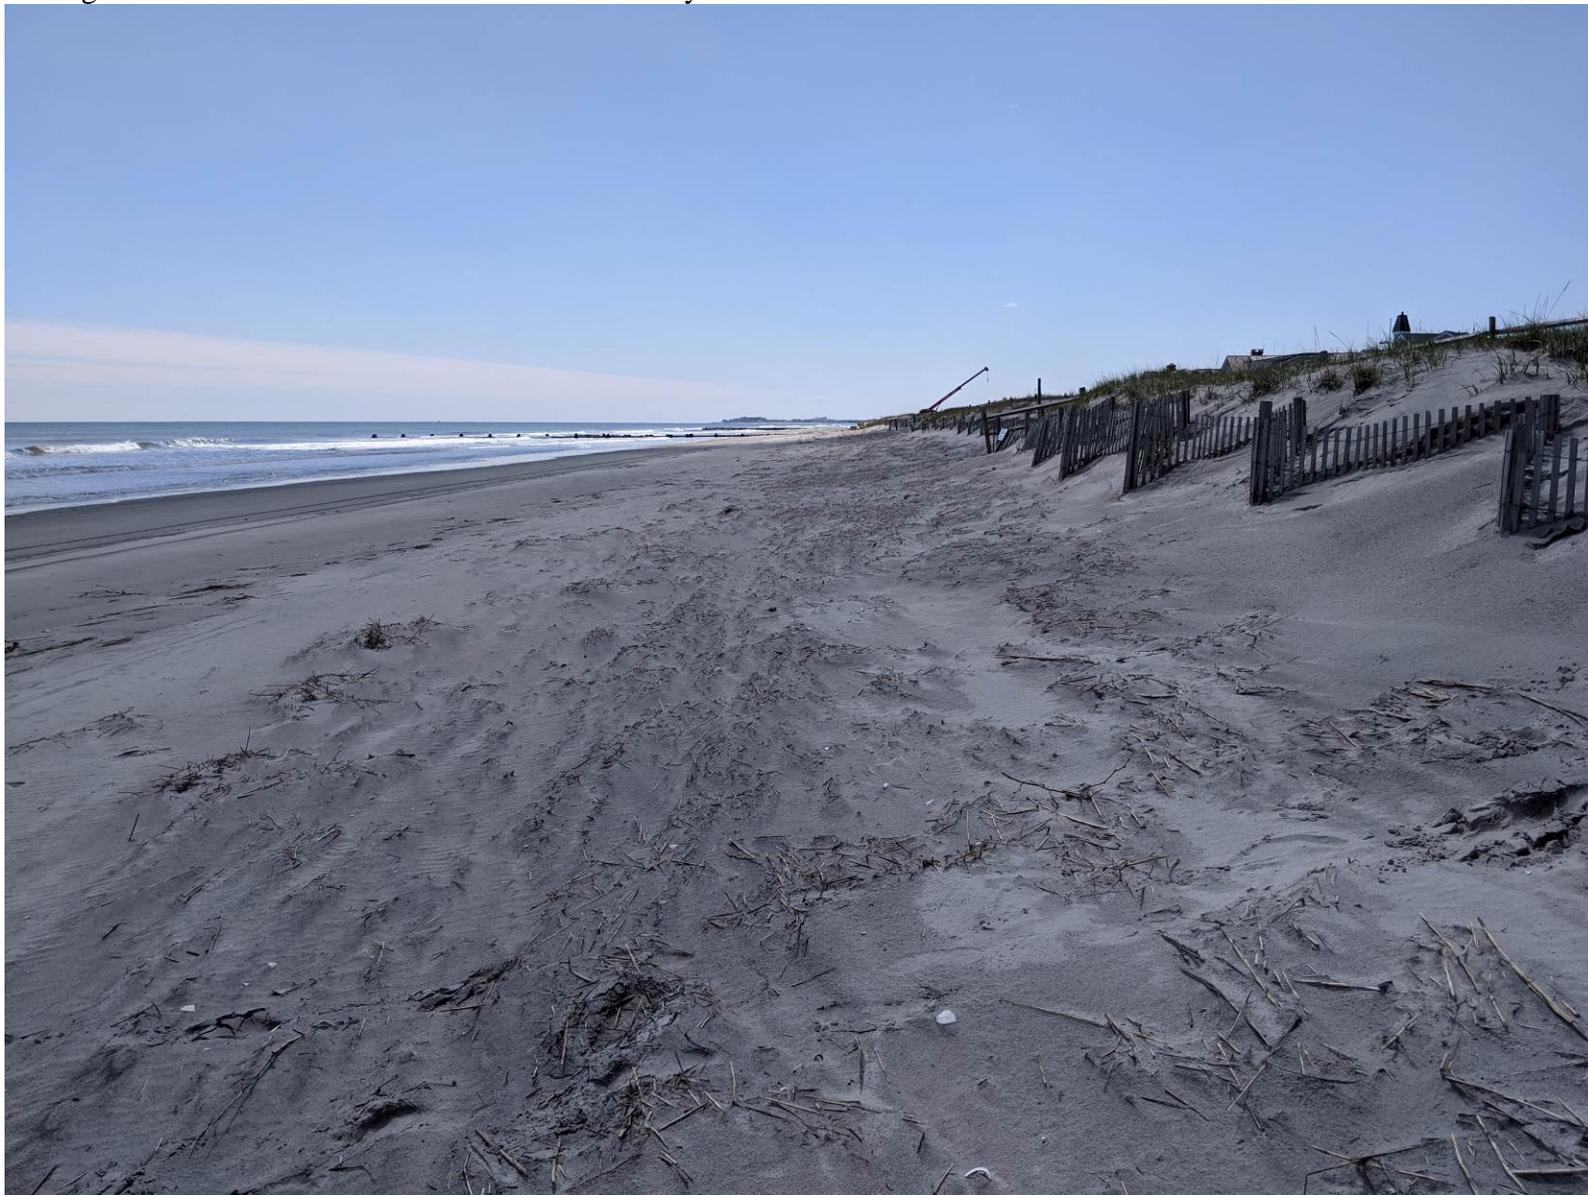
**SH-108**, the project beach at 108<sup>th</sup> Street was restored by March 27, 2017. Since the project, the dunes have been brushed by wave erosion, but largely undamaged. The beach width has declined considerably since 2017.

**Figure 5.** View to the south taken on April 15, 2020. At this site, the wave-deposited debris reached to the seaward dune toe this past winter. The beach is narrow, but with a gentle slope seaward. The dunes escaped erosion thus far as the seasons begin to change over to summer wave conditions.

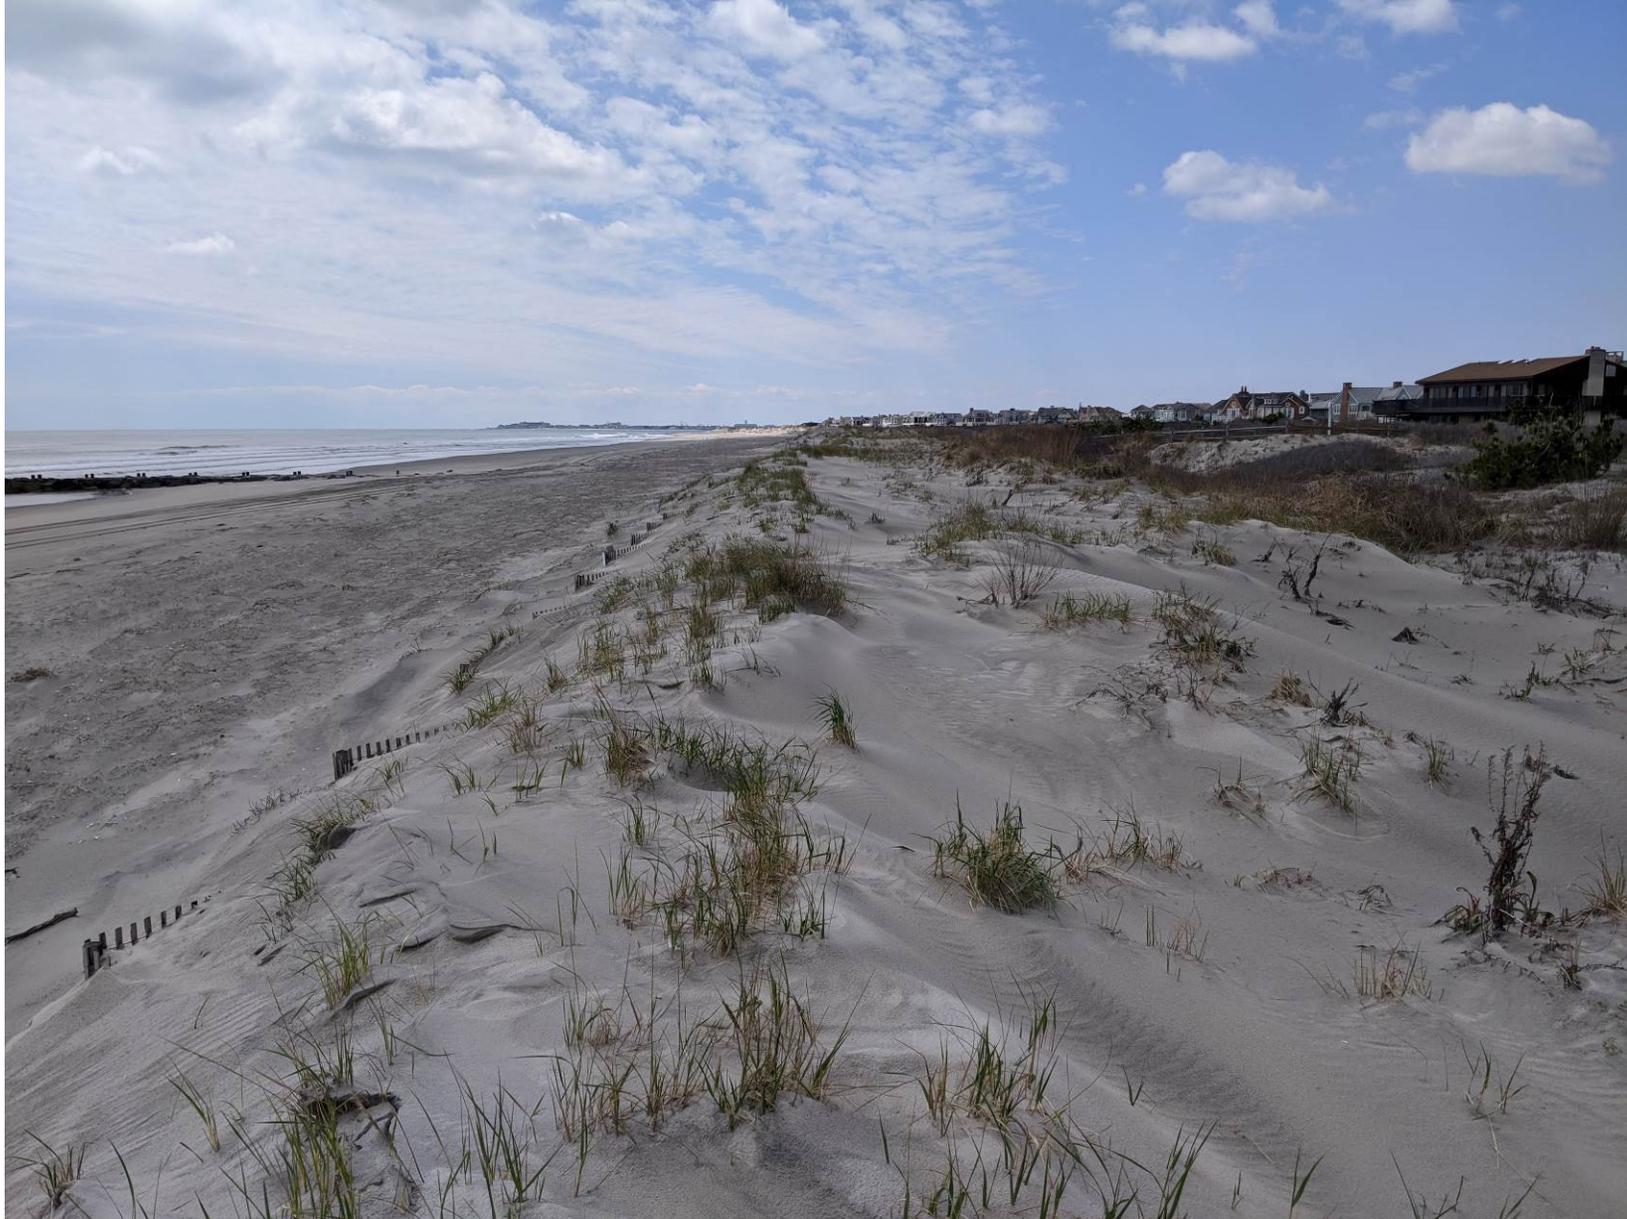
**SH-112.** The 112<sup>th</sup> Street beach re-nourishment was completed by March 27, 2017. The new fencing is all but buried by April 2020 and the beach width remains excellent.

**Figure 6.** View to the south taken April 15, 2020 along the foredune crest. Wind deposition is universally present where the 2017 fence installation is buried and lobes of sand deposited by the wind extend from almost every plant cluster. A wider beach also is present at this location.

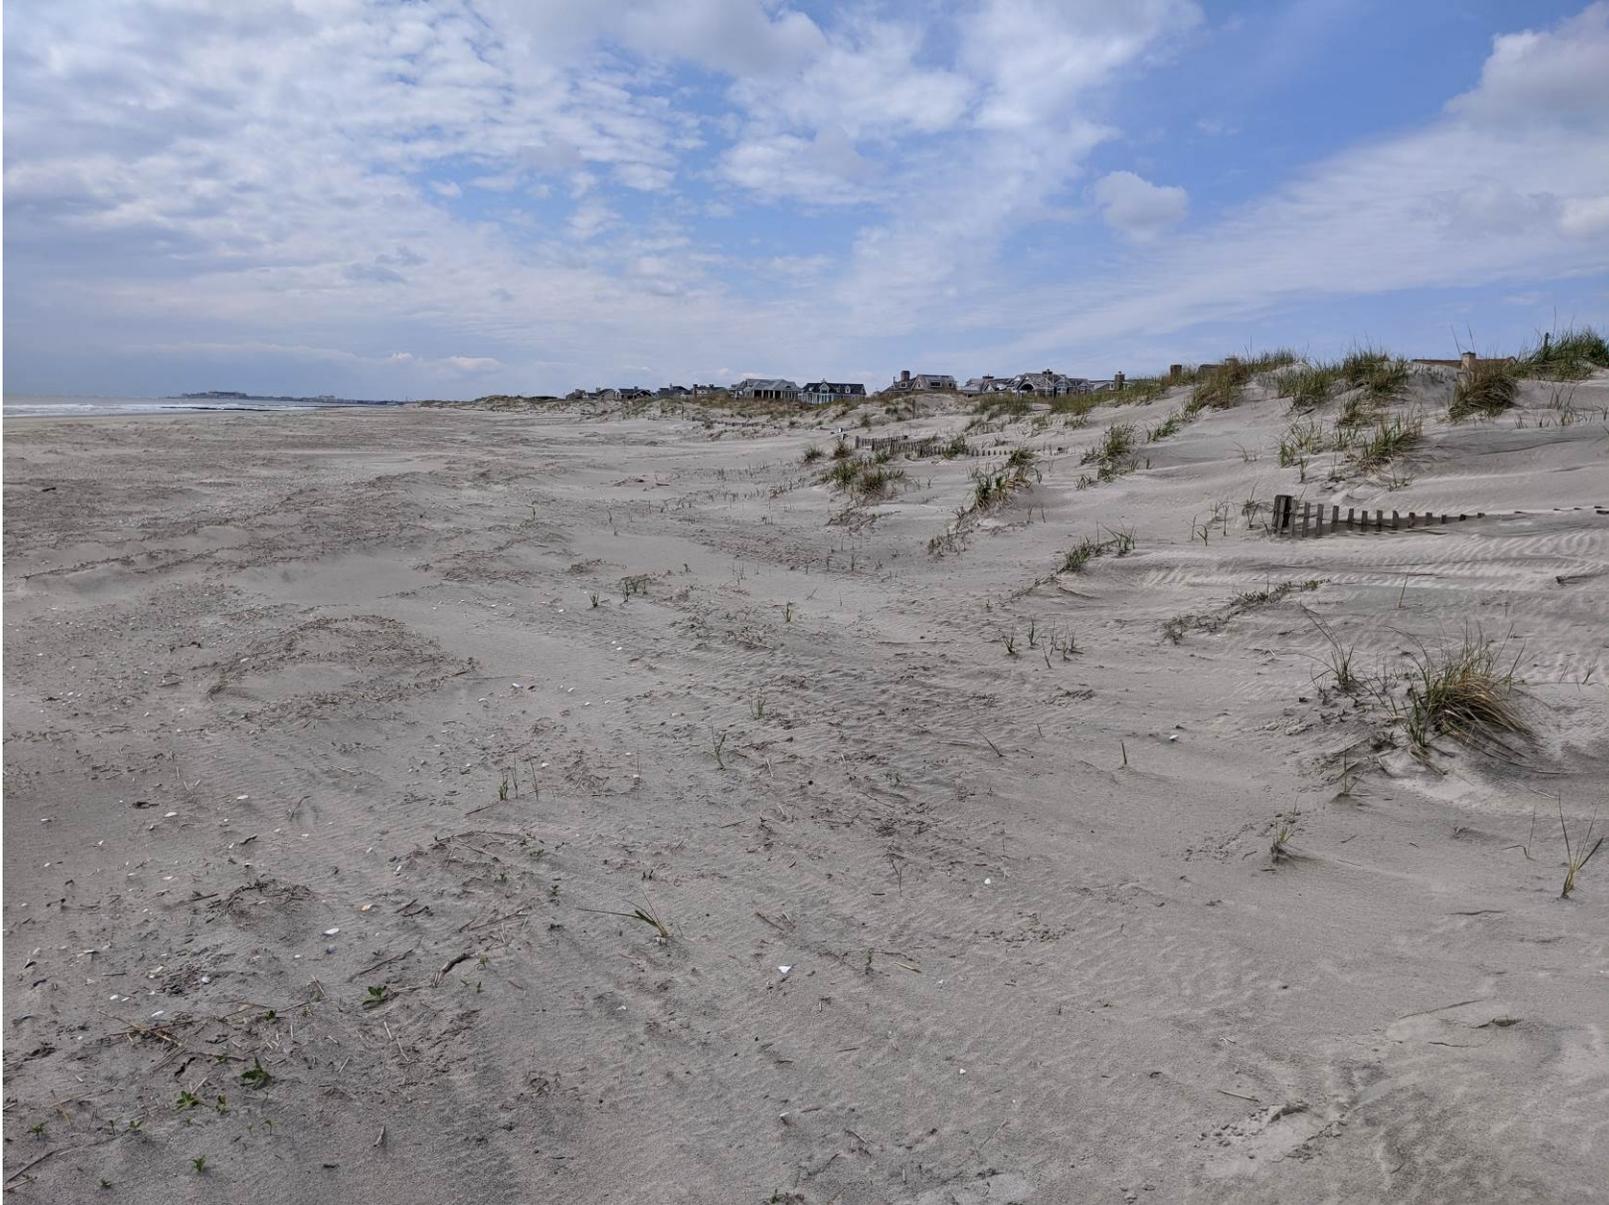
**SH-116**, This location has the widest dunes with foredunes advancing onto the USACE beach template. The 2017 fencing is buried and the beach width is extensive.

**Figure 7.** View to the south at 116<sup>th</sup> Street taken on April 15, 2020, showing extensive dune accumulation. The beach width allows the wind to scour the dry sand and move it into the dune field making this one of the best protected segments of the Stone Harbor oceanfront.

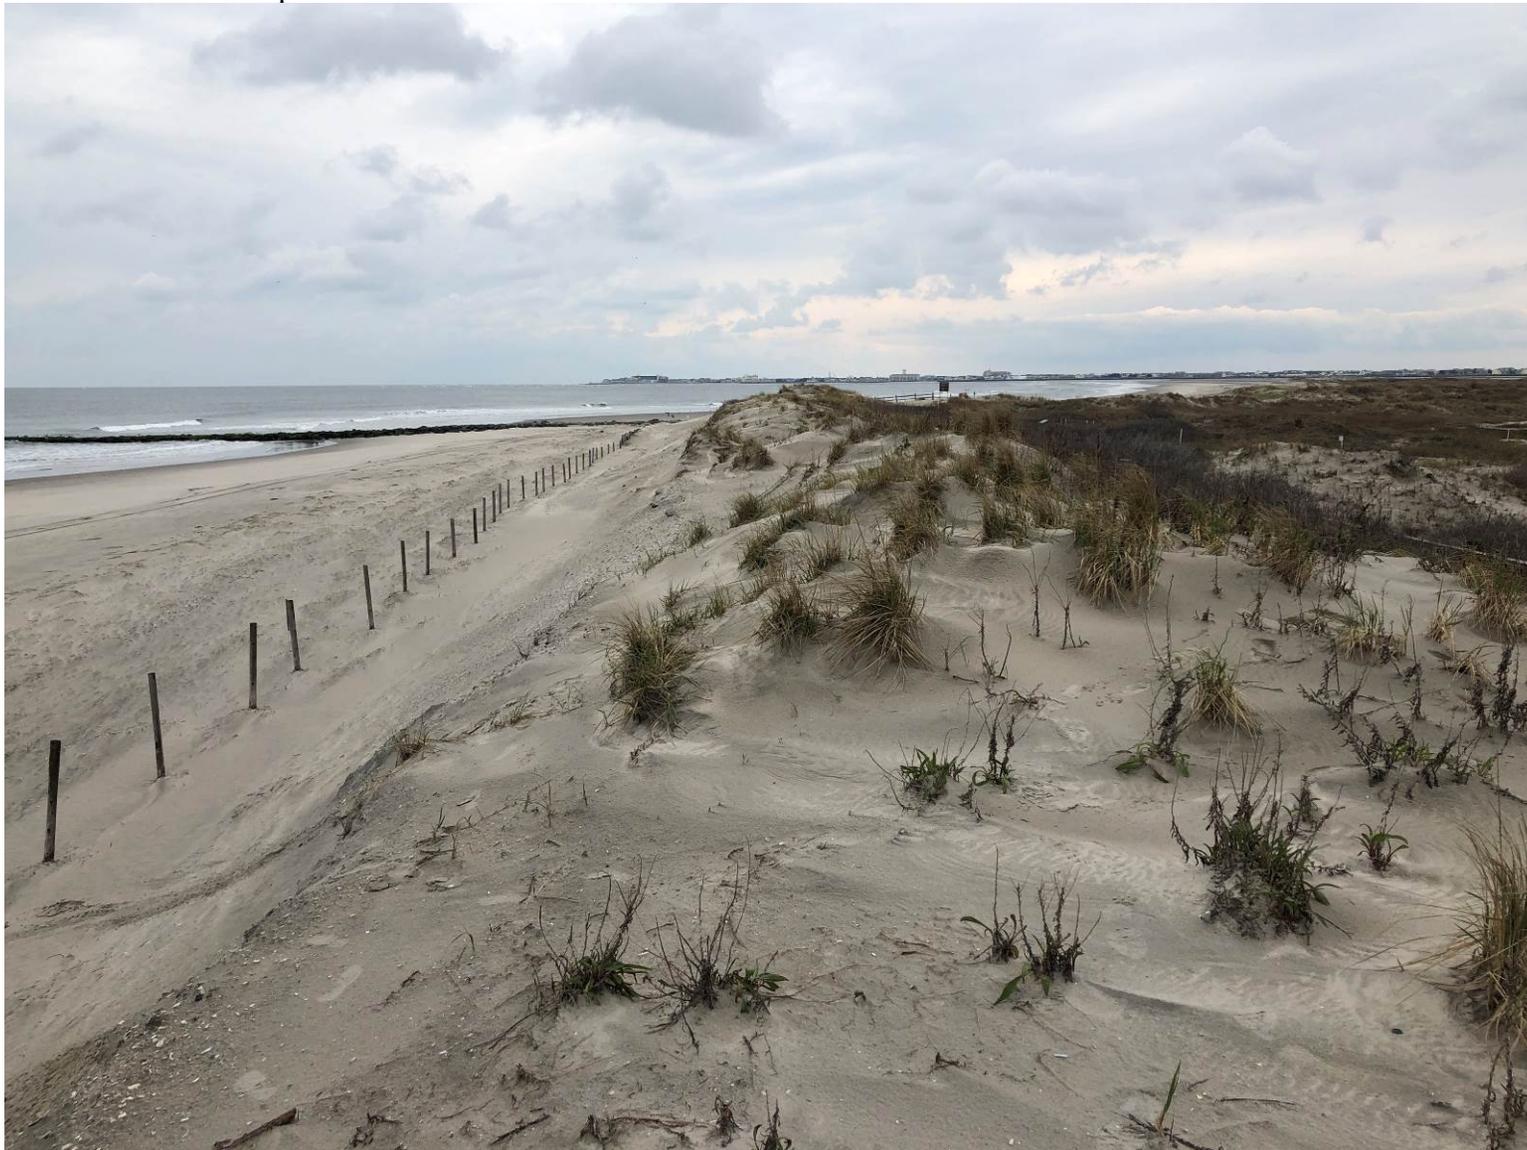
**SH-123**, site 123 is located just north of the terminal groin and the start of South Point. A new fence was installed last spring, but the fence itself was either removed or destroyed during the winter leaving only the posts. The low incidence of wave erosion is clear because this location did not suffer a new scarp into the seaward dune toe this winter.

**Figure 8.** View to the south taken on April 15, 2020, looking along the dune crest. The most recent row of sand fencing has been removed leaving the posts in place. This beach sees erosion under the least serious conditions and suffers dune loss almost every winter. The terminal groin in the distance captures some of the sand moving into this section, but the groin produces a severe offset in the shoreline further south by disrupting the uniform distribution of sand.

This winter season, the 123<sup>rd</sup> Street locality did see the largest sand volume gain of any site in the Borough. This is a fairly unusual situation due to the ease with which sand passes around or over the terminal rock groin to South Point.
