**2020 ANNUAL REPORT ON  
THE CONDITION OF THE MUNICIPAL BEACHES FOR  
THE BOROUGH OF STONE HARBOR, CAPE MAY COUNTY, NEW JERSEY**

**PREPARED FOR: THE BOROUGH OF STONE HARBOR  
9508 SECOND AVENUE  
STONE HARBOR, NJ 08247**

**PREPARED BY: THE STOCKTON UNIVERSITY COASTAL RESEARCH CENTER  
30 WILSON AVENUE  
PORT REPUBLIC, NEW JERSEY 08241**

**December 31, 2020**

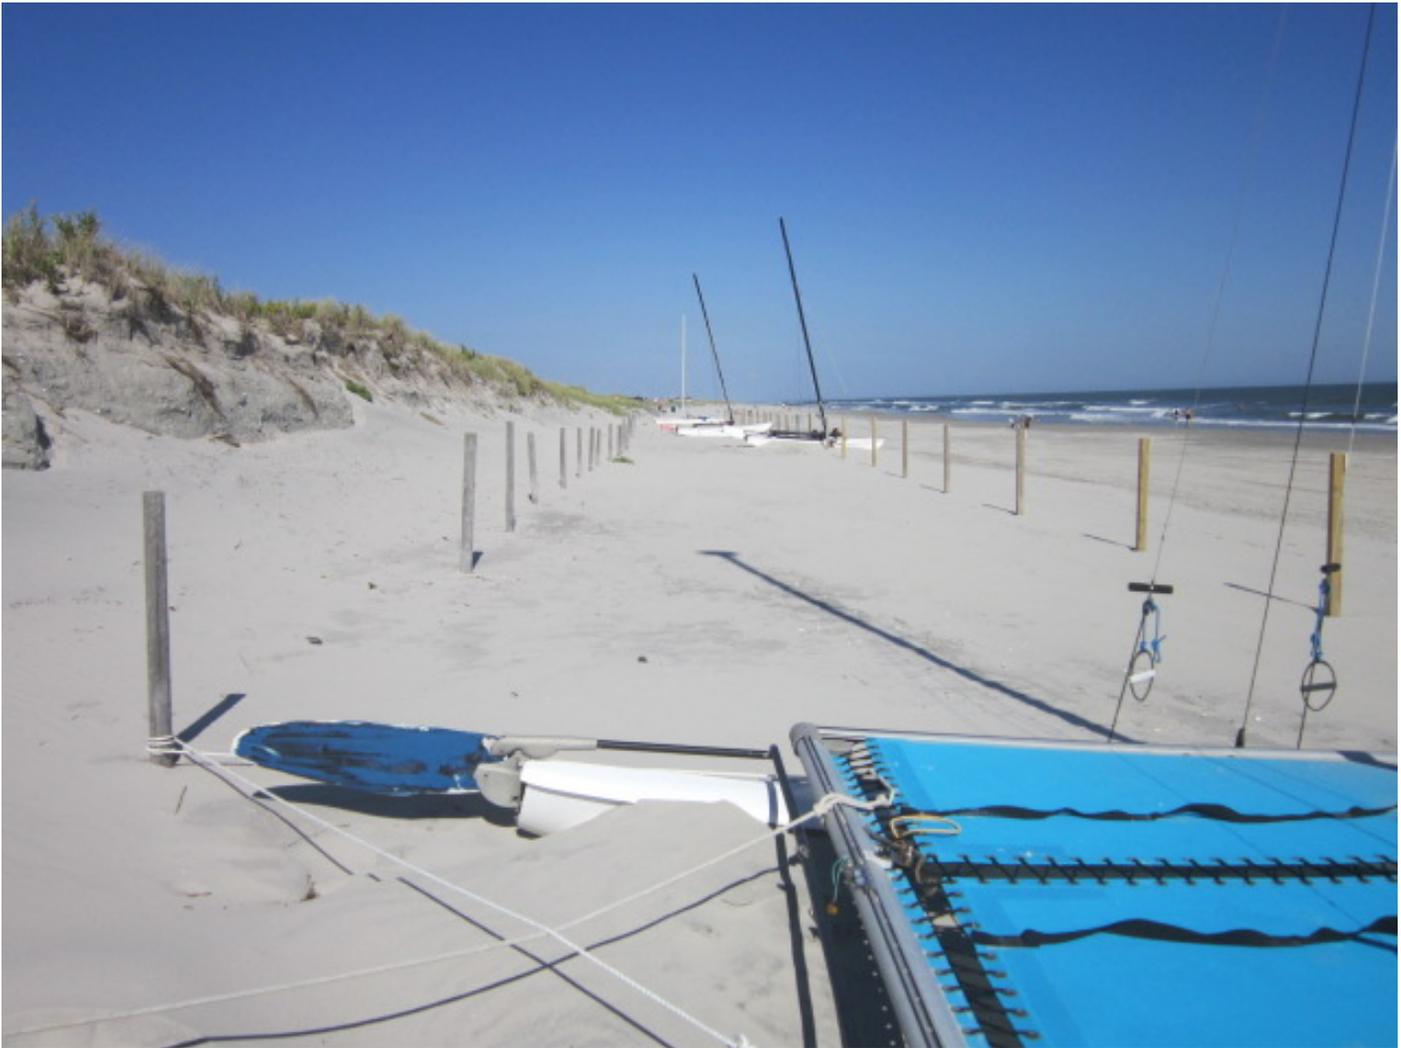
*This view to the north along the 123<sup>rd</sup> Street survey line as of October 4, 2020 a year after the view presented on the cover for the 2019 report. This view shows the best outcome for natural accumulation during a summer of mild wave action and wind transport. The scarp cut last fall is still present, but the wind has deposited a slope of dry sand about half way up the eroded bluff. The beach berm has added a narrow strip between the normal high tide line and the dune toe completing the typical summer beach “profile”. However, the most moderate of northeast storms will renew the erosion of the primary dune scarp going into the winter months.*

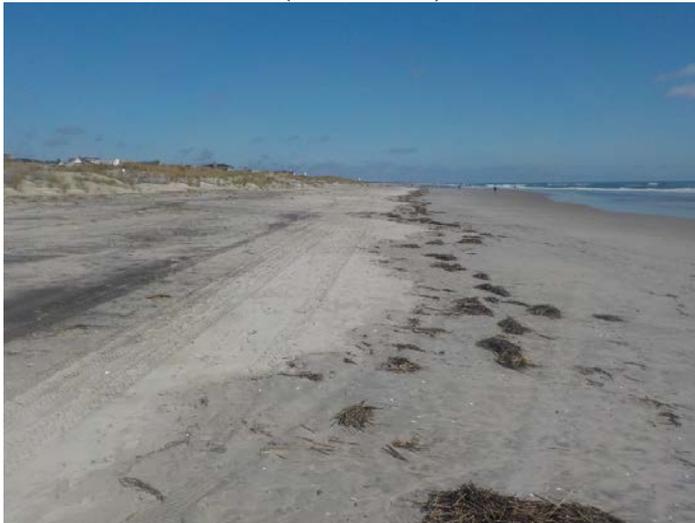
**Photo 1a – Photo taken October 14, 2019, the debris on the berm was left by early northeast waves.**

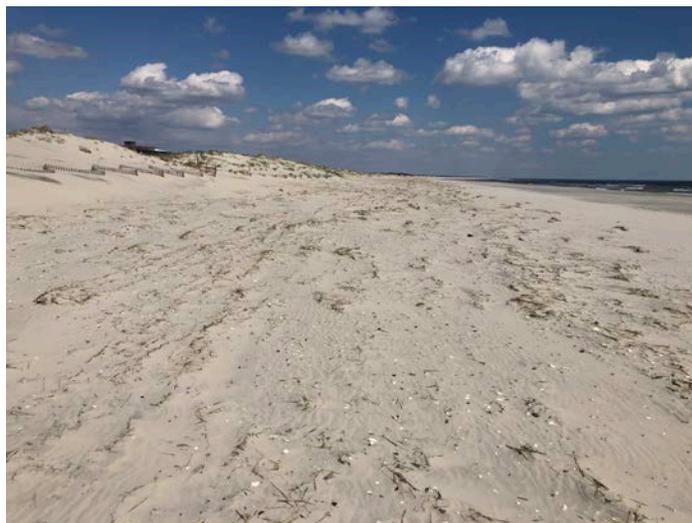
**Photo 1b - Photo taken April 16, 2020 showing a wide, dry beach and sand accumulation at the dune fencing.**

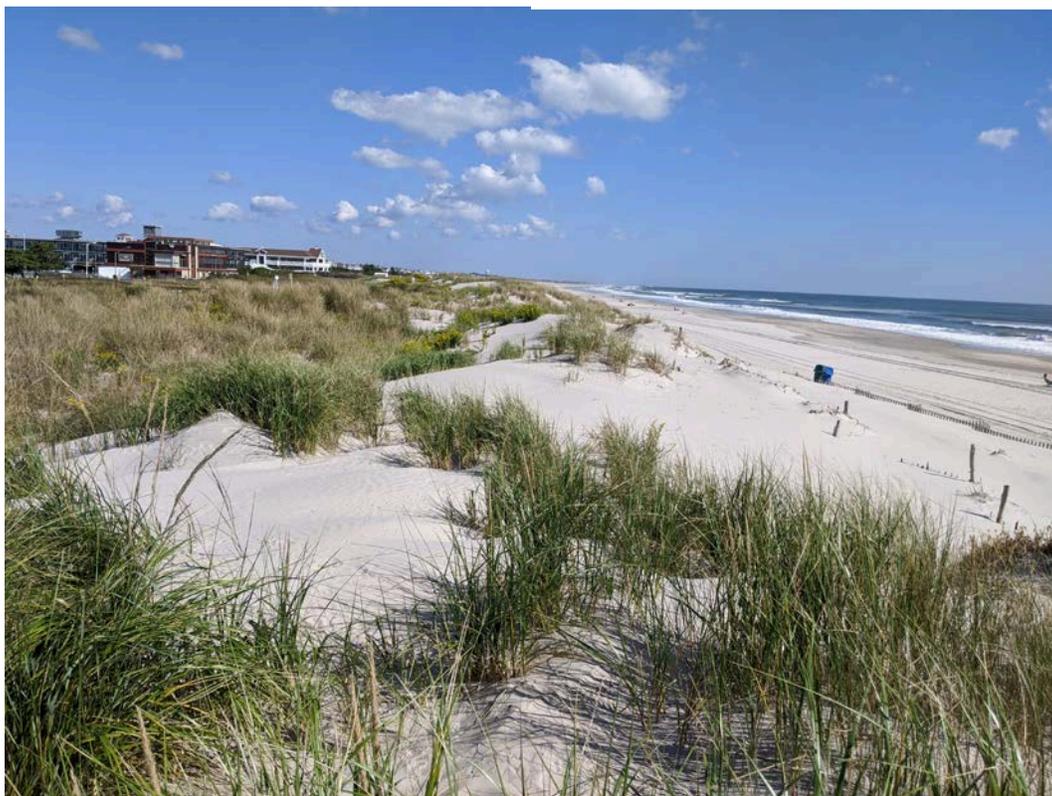
**Photo 1c – Photo taken on October 6, 2020, looking north along the dune crest where sand has been transported into the dunes and the sand fence is essentially buried by what could become a new foredune line.**

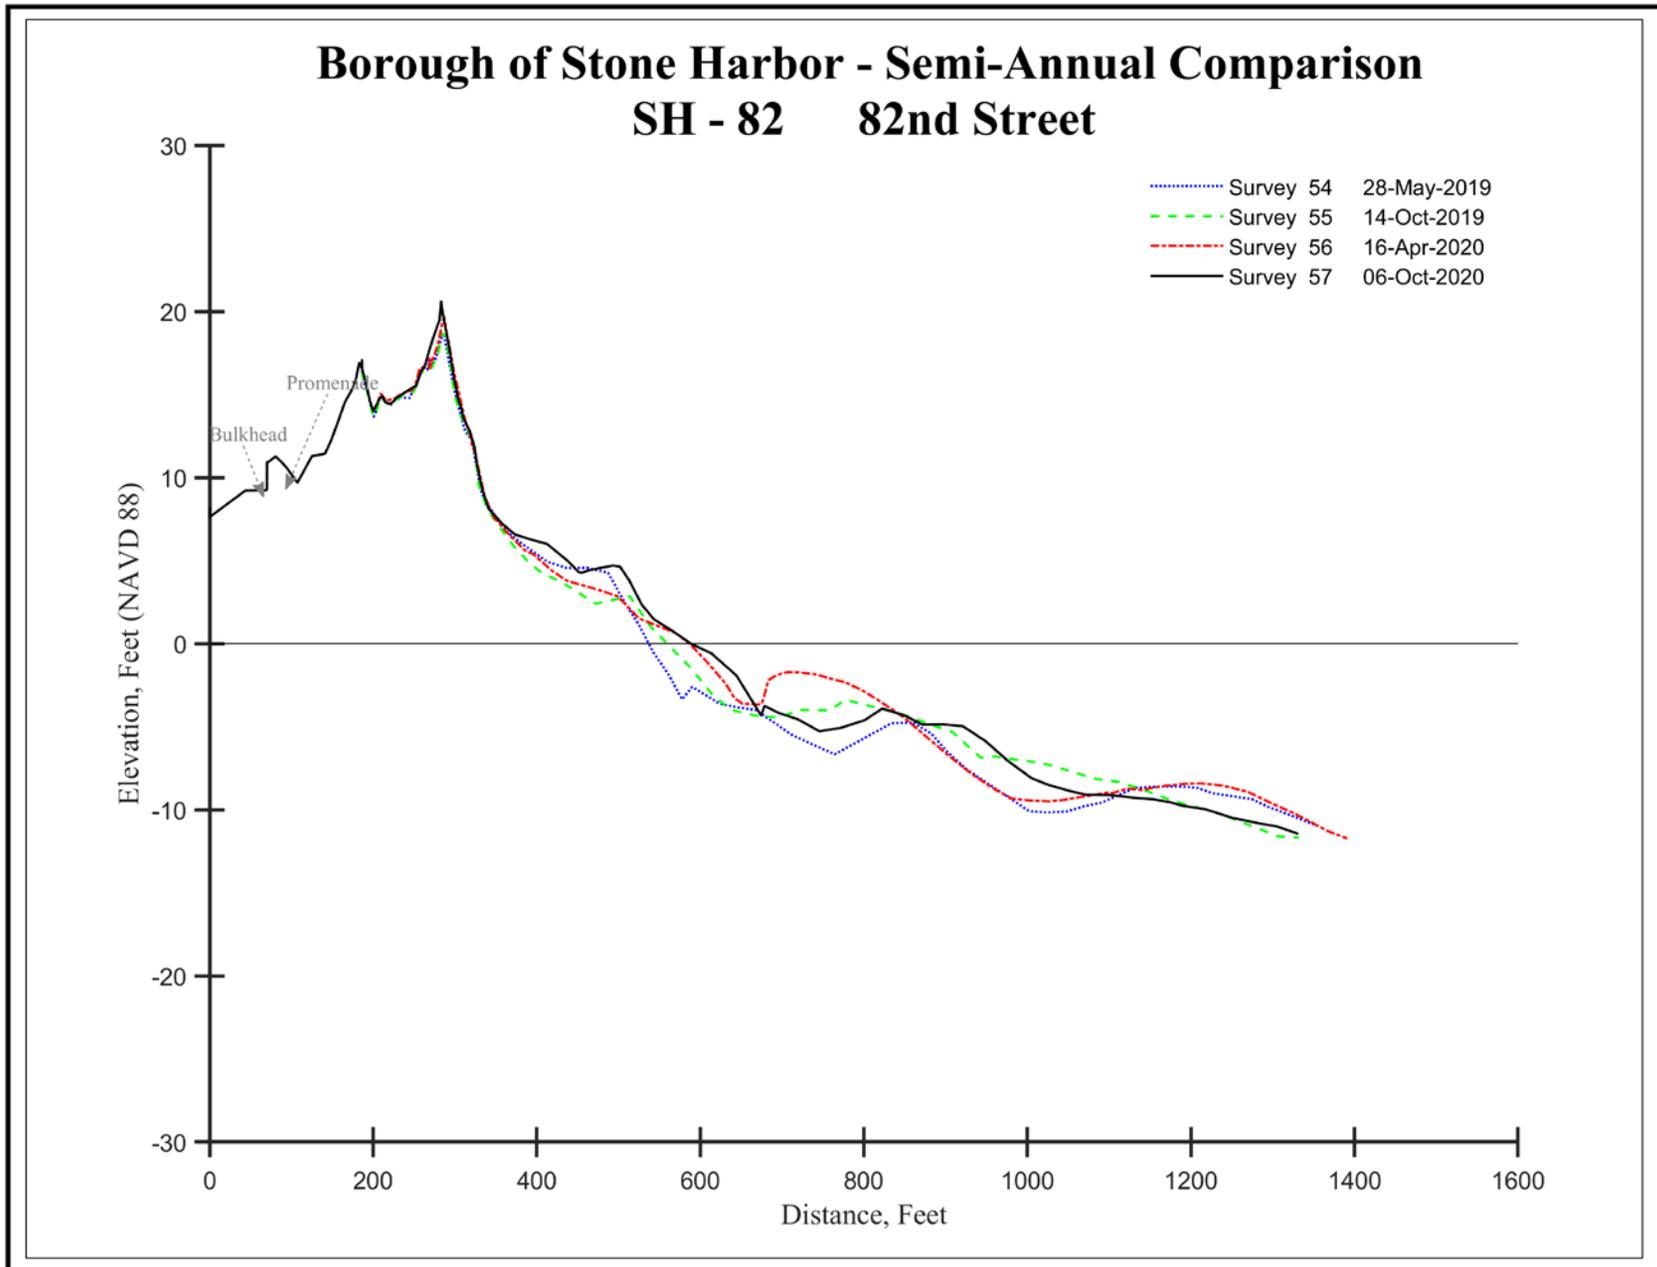
The dune remained stable, though with a steep seaward dune slope to the toe. A sizable beach berm developed during the summer of 2020 as seen in the early October 2020 survey. Offshore, the bar shown in the April 2020 survey appears to have provided the sand supply generating the berm and higher beach elevation seen in October 2020.

**Figure 1d.** The most interesting transition occurred between the presence of a nearby offshore bar as of April 2020 that moved onto the beach generating the higher berm and sand supply feeding into the dunes. This material addition was likely sourced from along the Avalon and Stone Harbor beaches to the north of the site.

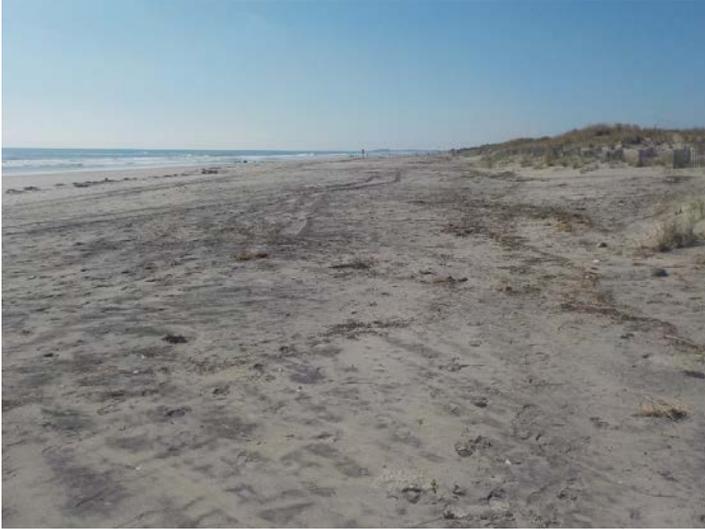
**Photo 2a – Photo taken October 14, 2019 shows dune growth, while wave action almost reaches the dune toe.**

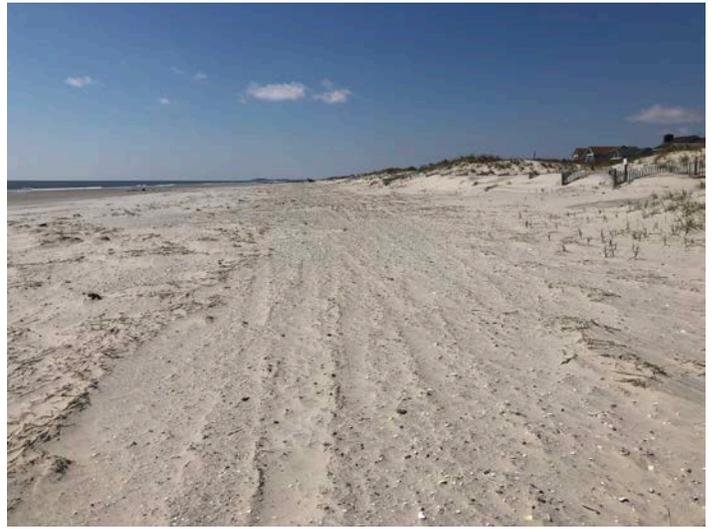
**Photo 2b - Photo taken April 16, 2020 showing a slight improvement in dry beach width as summer began.**

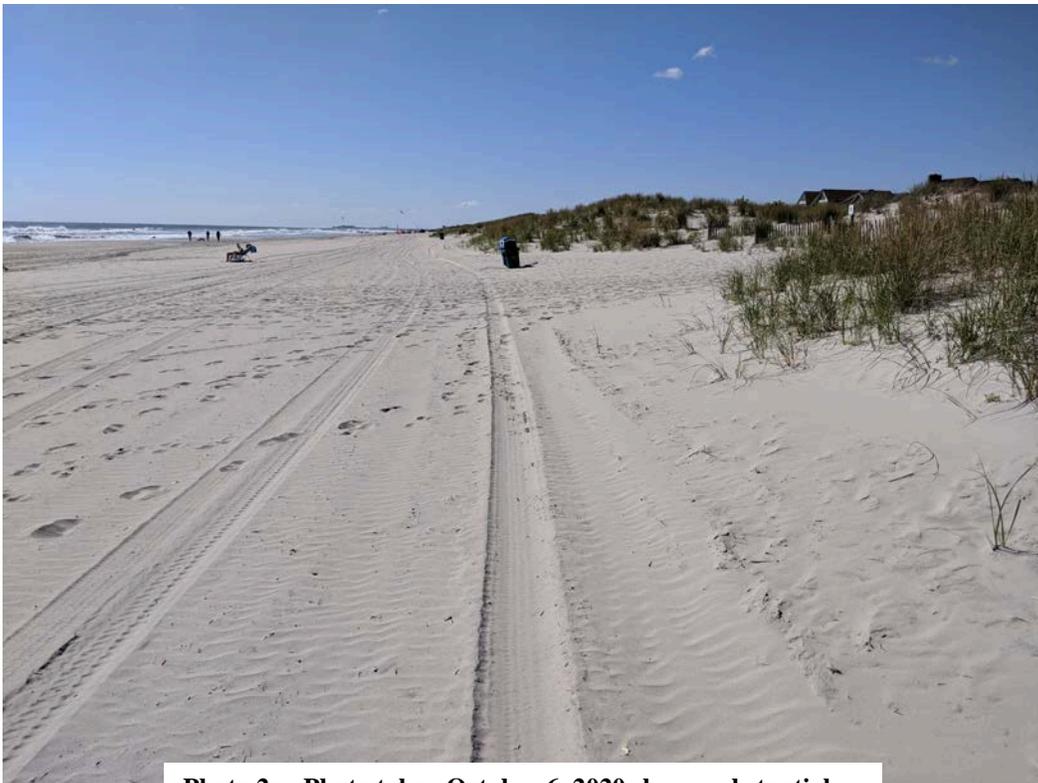
**Photo 2c - Photo taken October 6, 2020 shows substantial dune growth and the wider expanse of dry sand beach following the summer accumulation.**

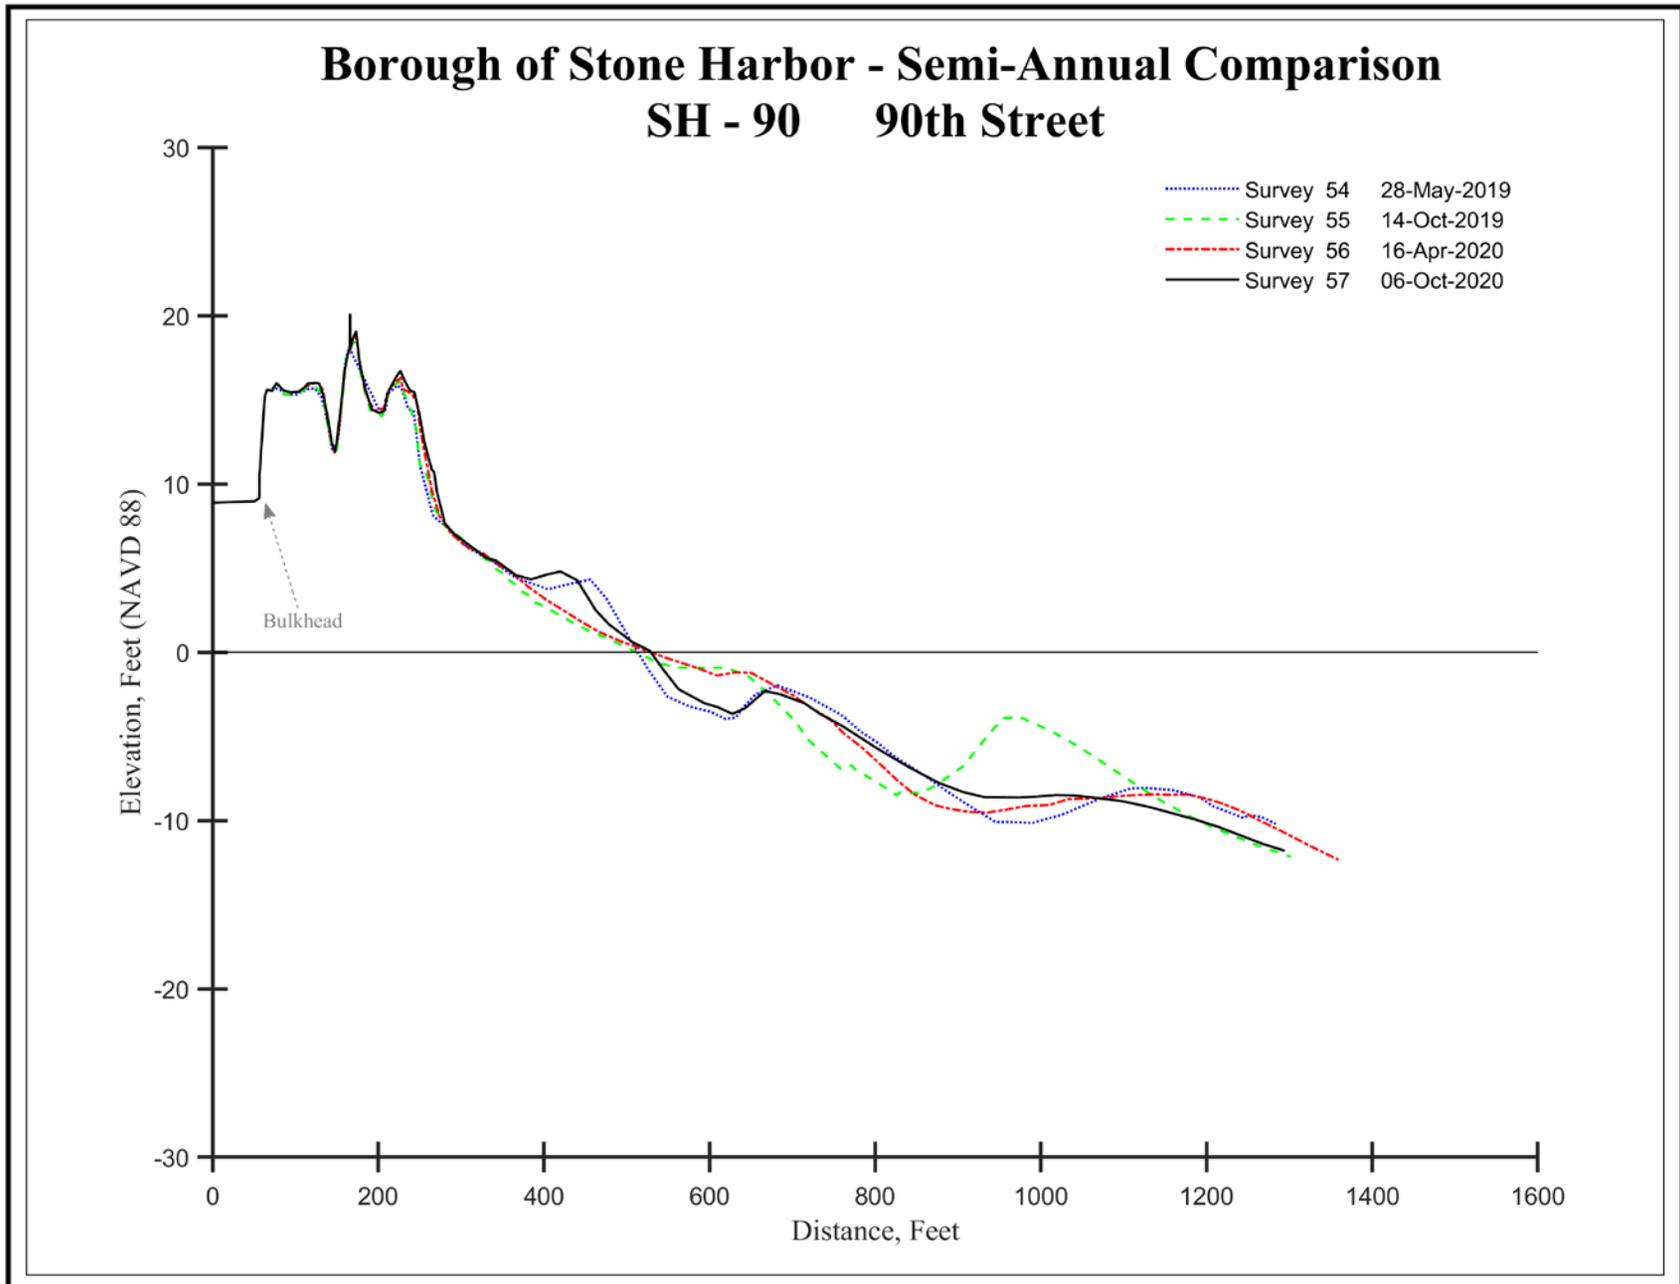
Sand appeared incrementally across the seaward dune slope and deposited as a berm on the beach by October 2020. Offshore sand transport to the beach was the probable method for accumulation.

Figure 2d. Sand was added to the dune's seaward slope and a substantial berm was generated by October 2020 derived from offshore bar migration toward the shoreline. As of the Oct. 2020 survey another ridge of sand was migrating toward the beachface.

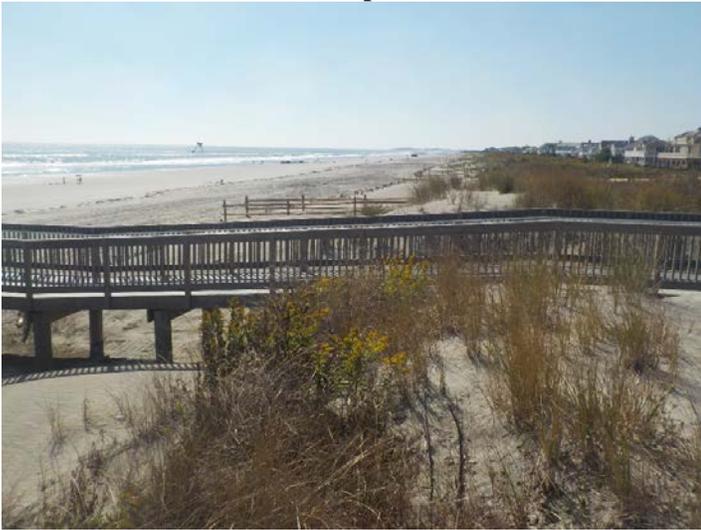
**Photo 3a - Photo taken October 14, 2019 shows a height over the access walkway that includes the dune and the beach to the south.**

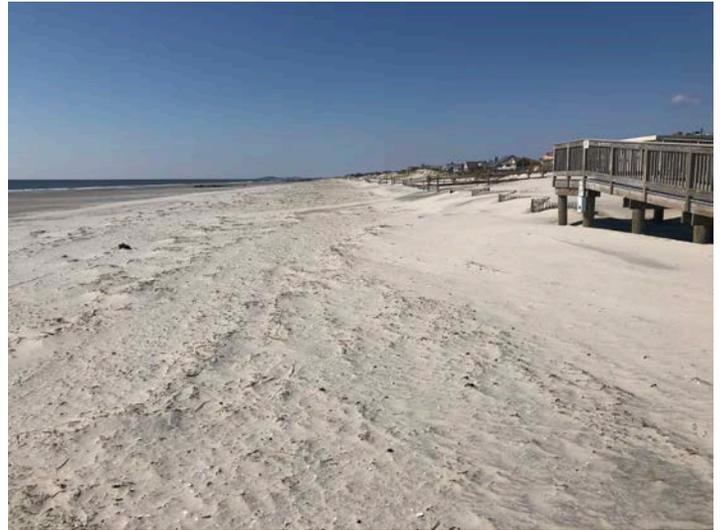
**Photo 3b – The April 16, 2020 photo presents a wider dry beach with sand added to the nearly buried sand fencing at the toe of the seaward dune slope.**

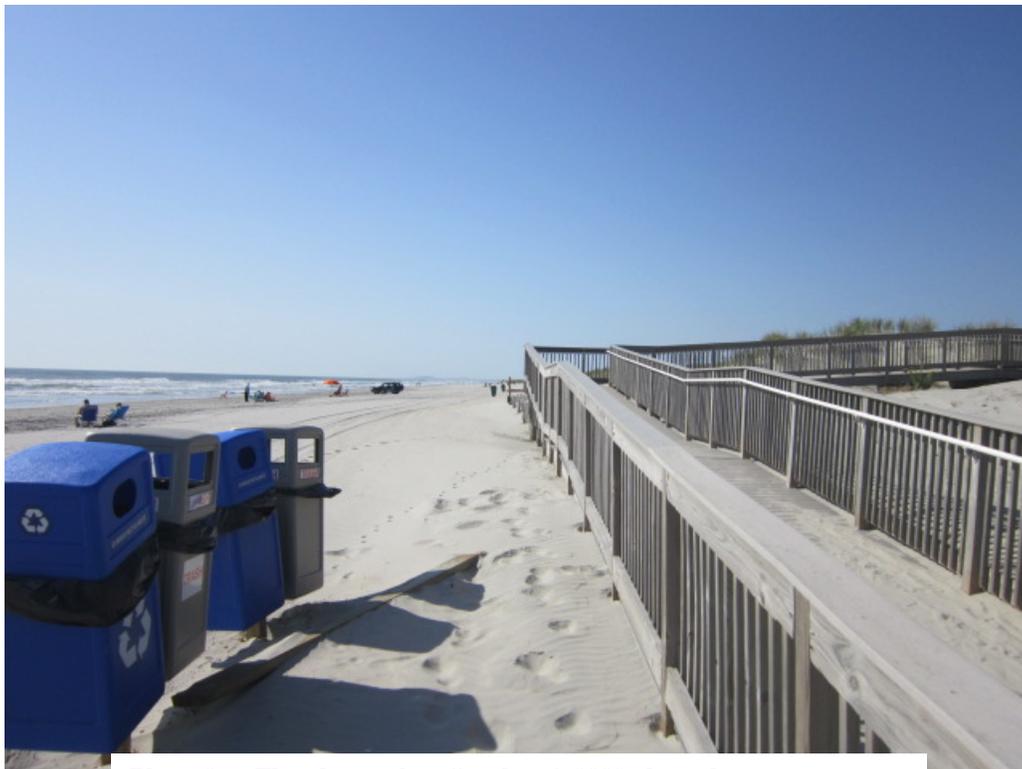
**Photo 3c – The photo taken October 6, 2020 along the access pathway. The beach continued to accumulate sand at the dune toe.**

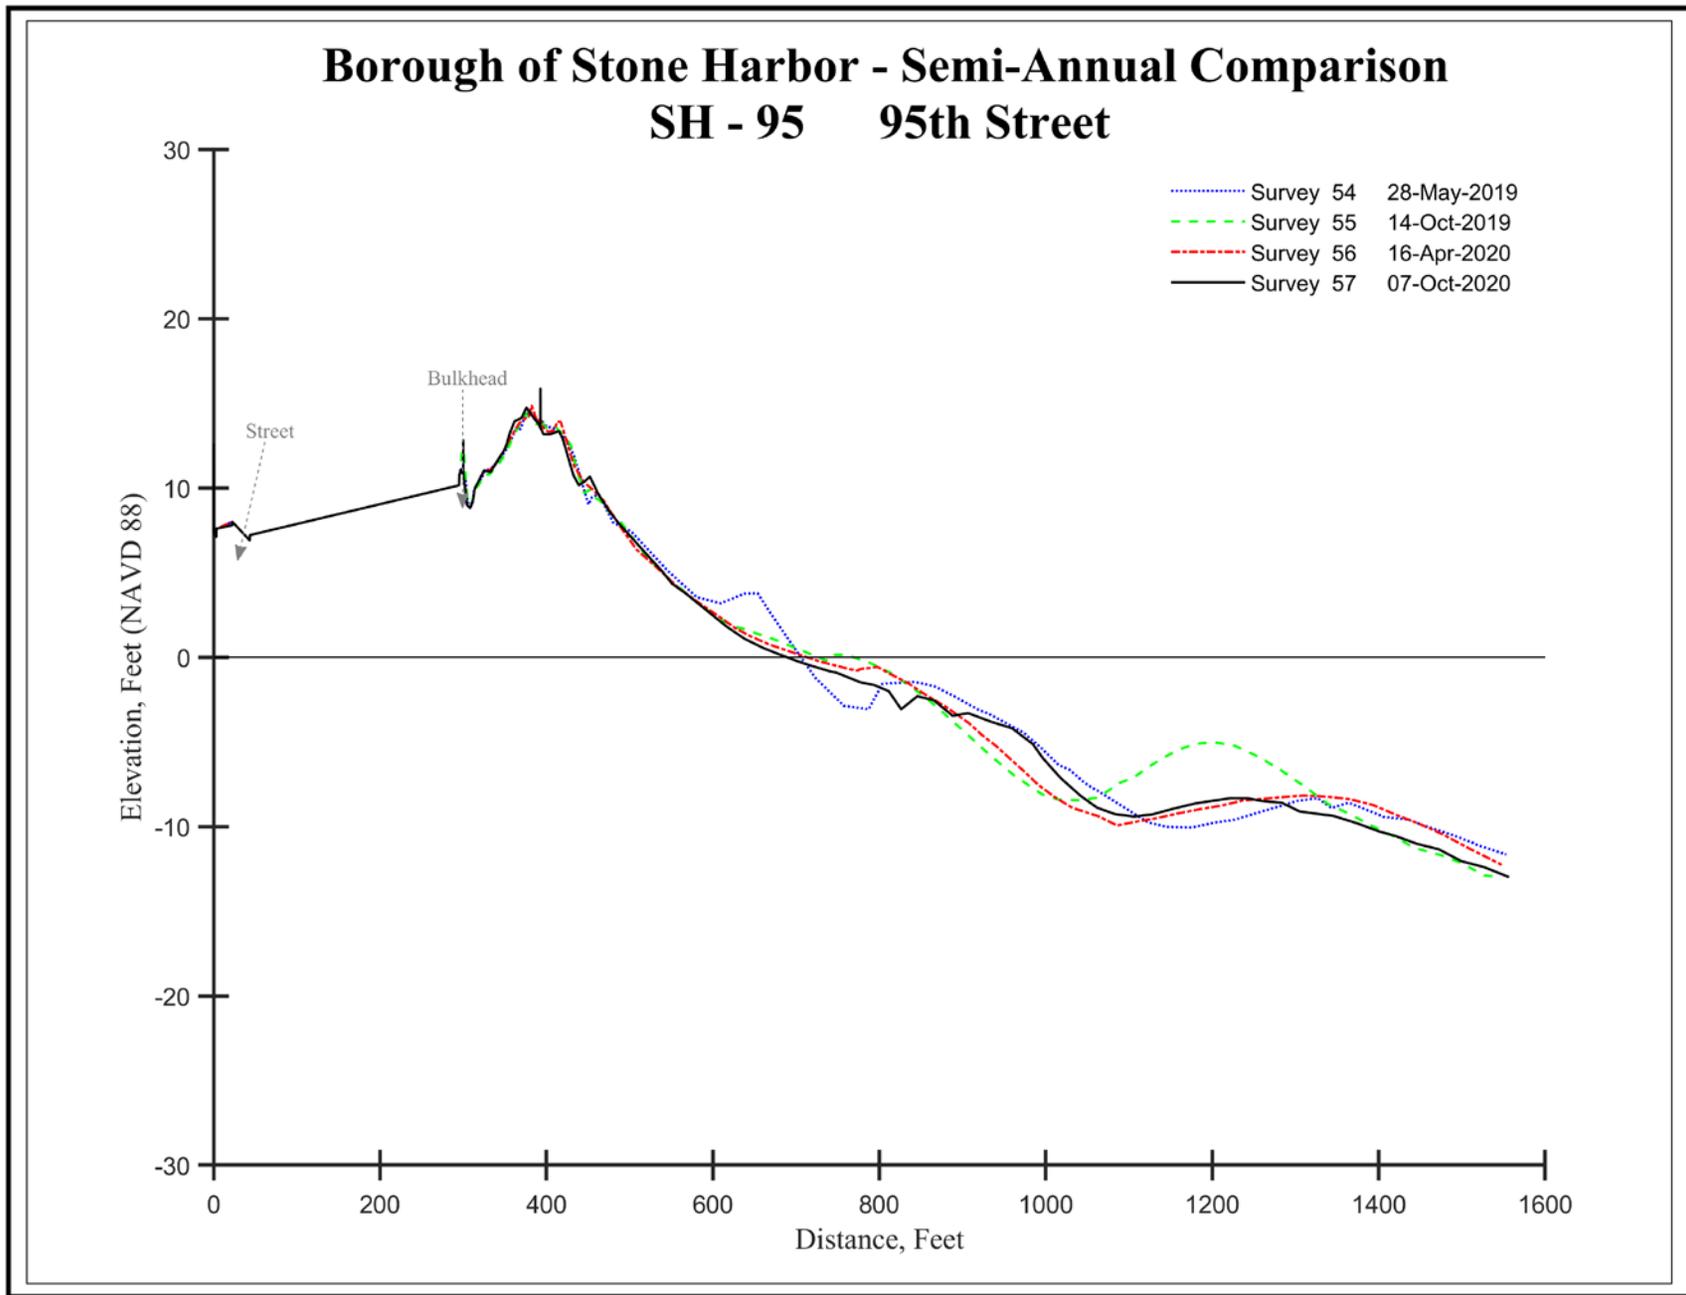
Sand moved beyond the dune crest this year adding to the bulk, but not on the seaward slope. The beach remained at the initial position and configuration seen as of May 2019, but without the enhanced berm crest. Offshore sand was redistributed leading to a small loss across the profile.

Figure 3d. Sand was added to the landward dune slope by Oct. 2020 and the small foredune at the fencing line increased in size. The beach remained at the same configuration as May 2019, but without an enhanced berm crest. Offshore the large bar, seen in October 2019 had moved landward as a series of ridges.

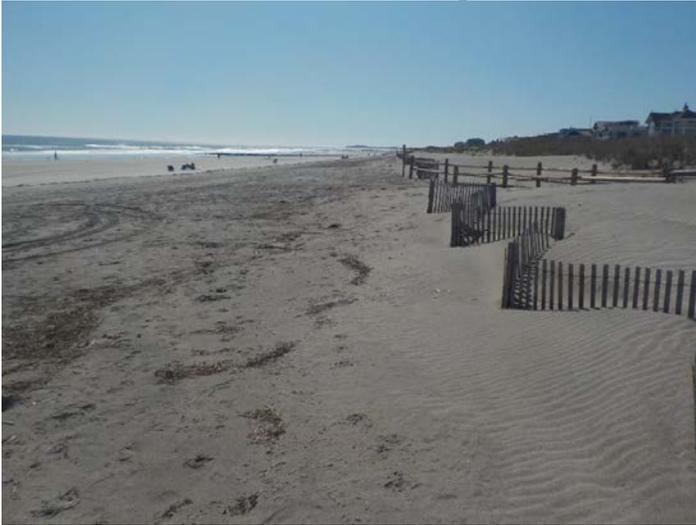
**Photoplate 4a - Photo taken October 14, 2019 showing sand continuing to fill the 4-foot high snow fencing creating a new foredune. The beach width was sufficient to provide the supply.**

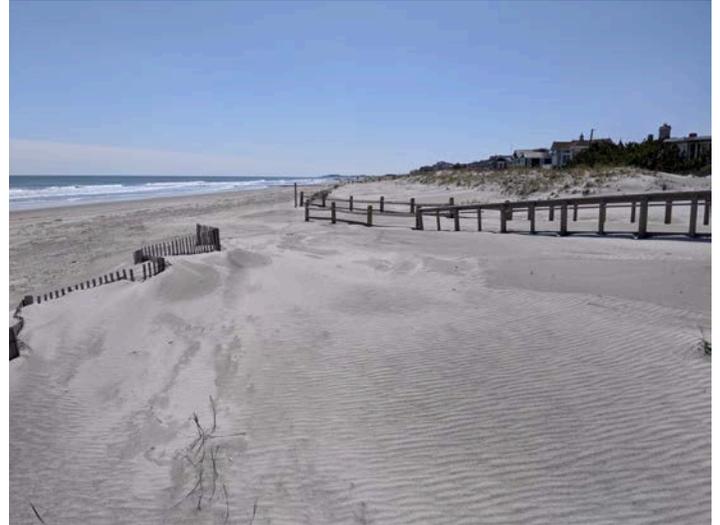
**Photoplate 4b - Photo taken April 15, 2020 shows sand filling in the lower section of the access pathway burying the fencing.**

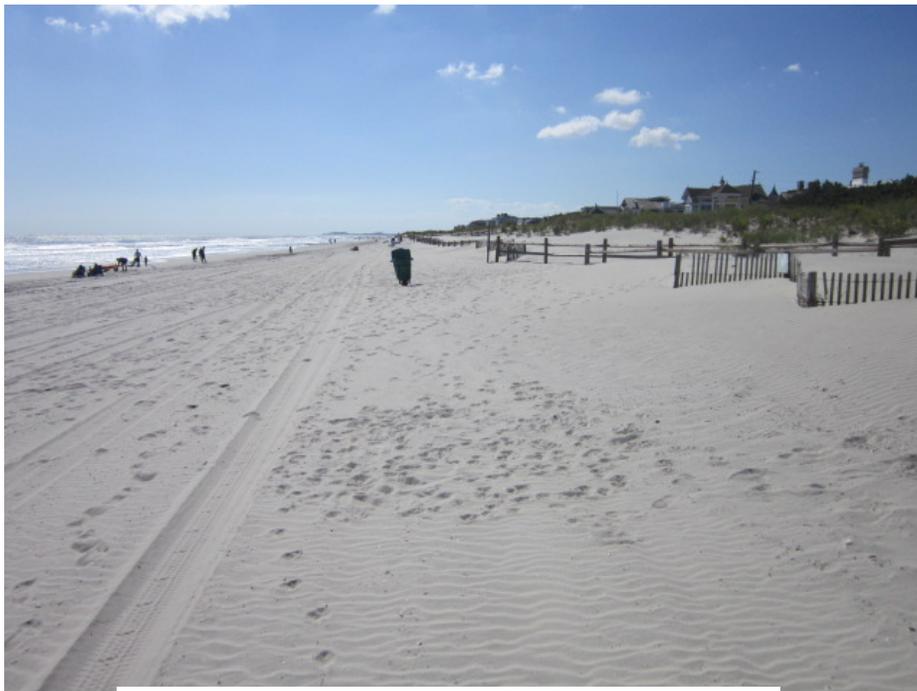
**Photoplate 4c – Photo taken October 6, 2020 on the beach just seaward of the dune’s seaward slope that included the new foredune development.**

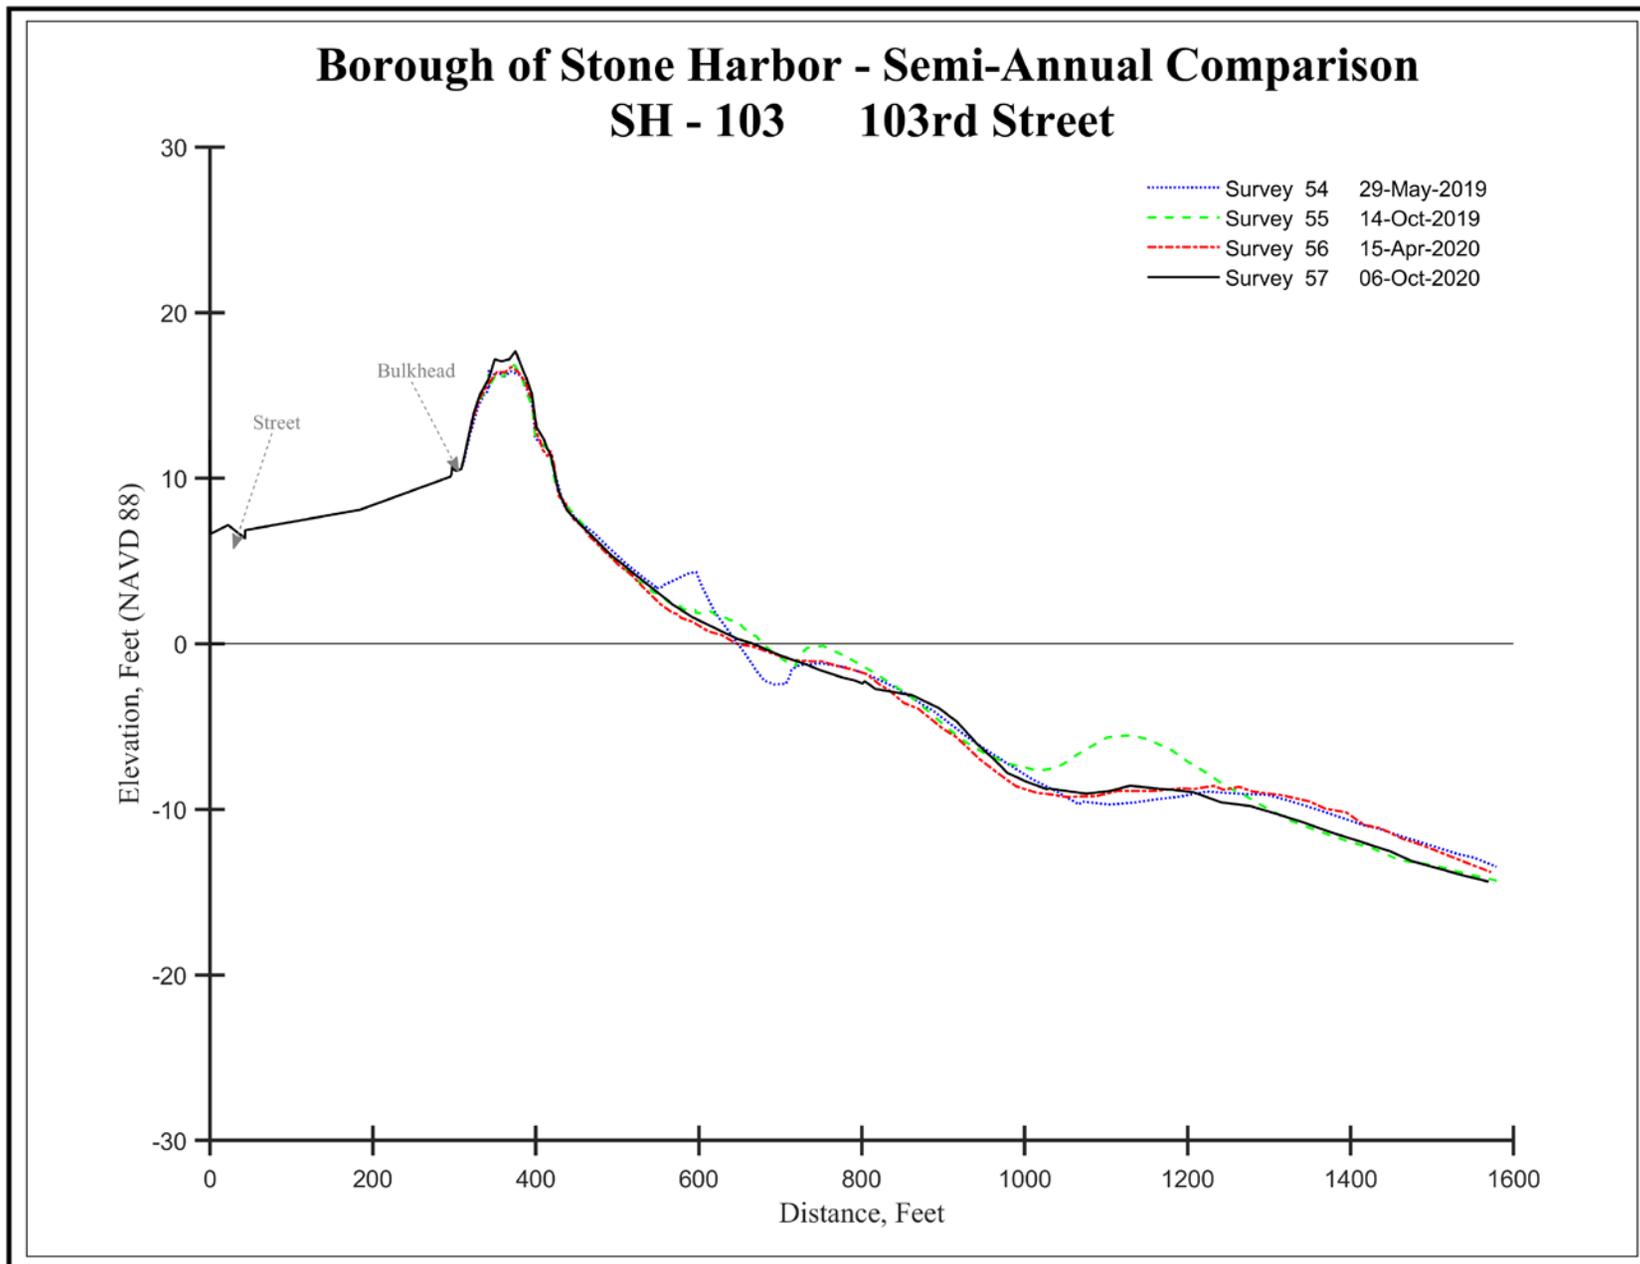
Behaving in similar fashion to SH-95, the beach configuration changed little except for no summer berm like that present in May 2019 present on the profile by October 2020. Some of the October 2019 offshore bar sand appears to have migrated onto the beachface slope by October 2020.

Figure 4d. The cross sections at 103<sup>rd</sup> Street show a similar pattern to that seen at 95<sup>th</sup> Street where the May 2019 berm was not reproduced by late summer 2020. Sand did migrate onto the beach in minor quantities adding to the dunes, but not to the beach itself.

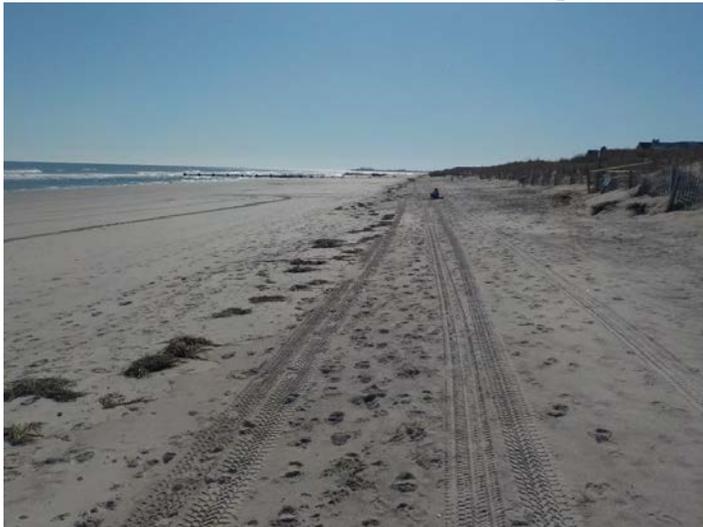
**Photoplate 5a – The October 14, 2019 photo shows the proximity of the high tide to the dunes on a narrow beach.**

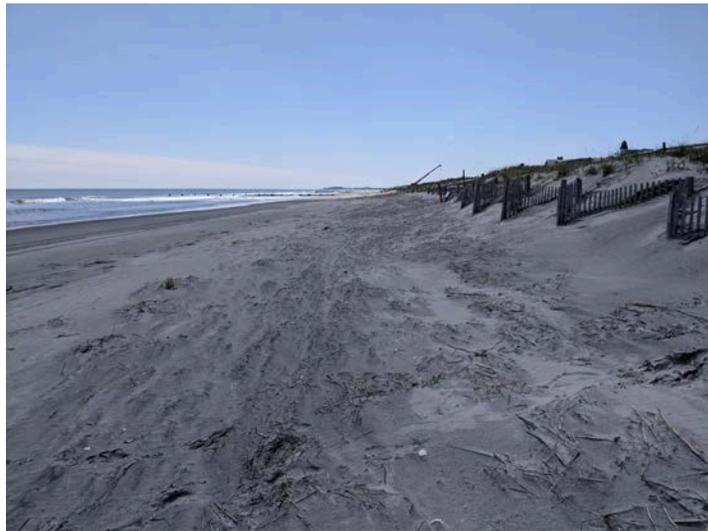
**Photoplate 5b – The photo taken April 15, 2020 shows minor additions of sand near the dune toe, but a similar width beach to the water line.**

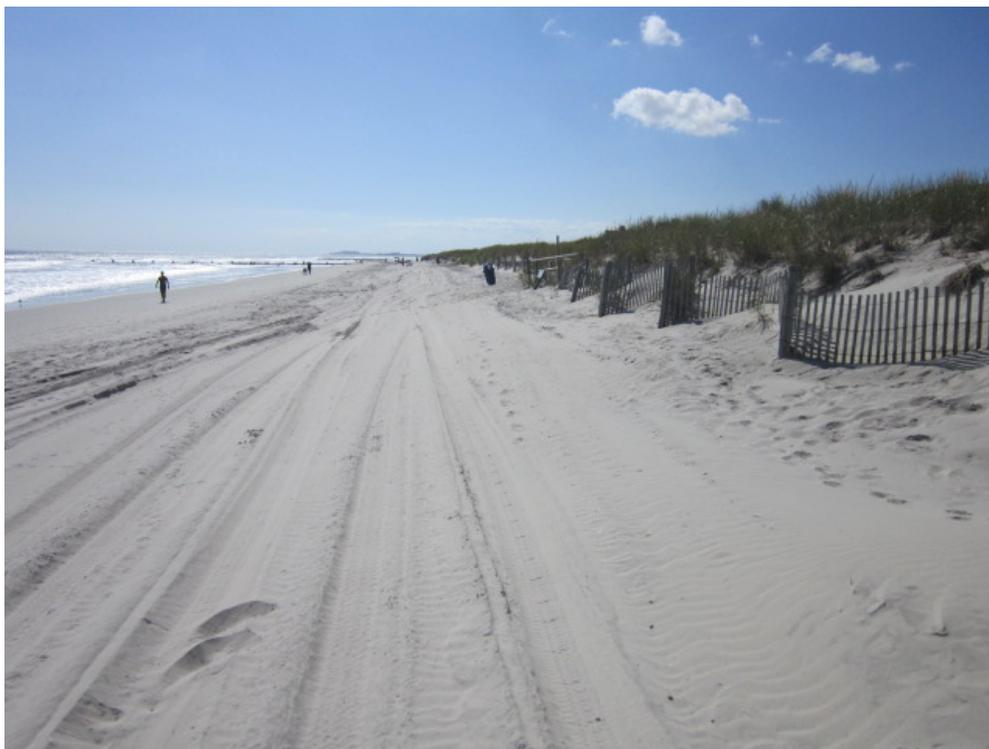
**Photoplate 5c – Photo taken October 6, 2020 shows improvement in beach width as sand was added to the upper part of the dry beach.**

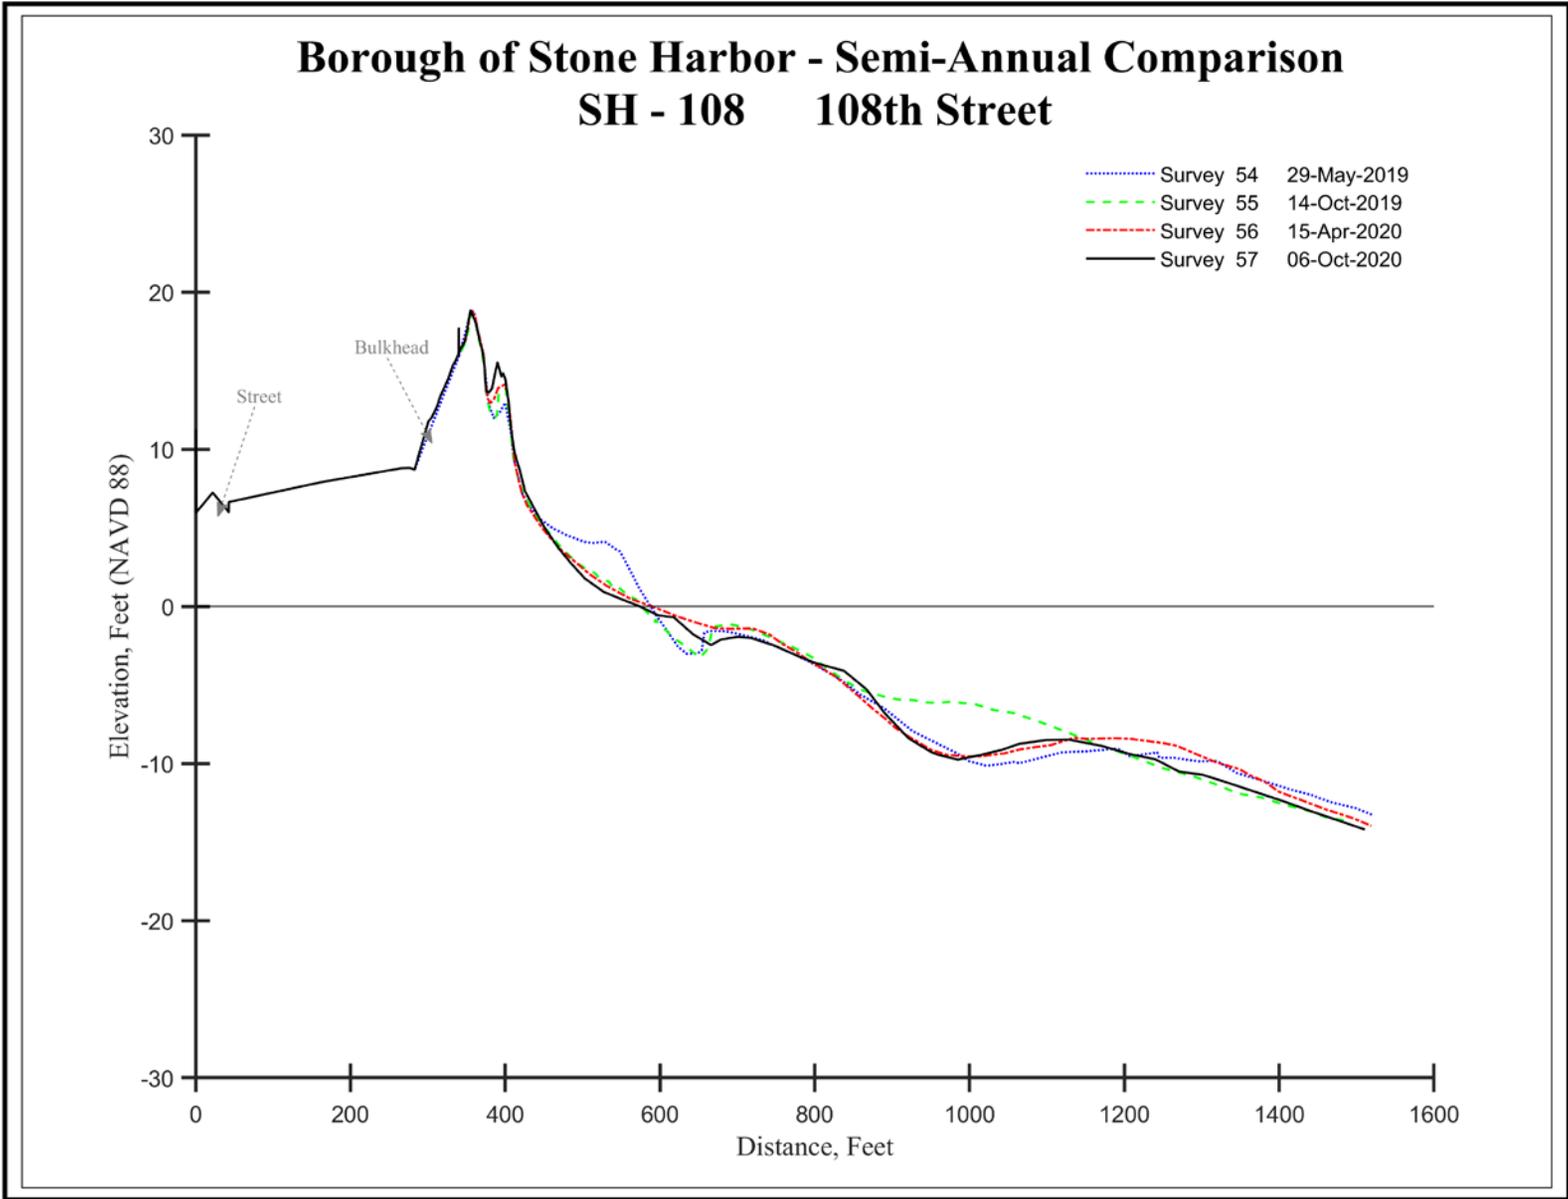
Considerable sand volume was added to the dunes while the beach remained at the May 2019 configuration minus the berm crest seen in the May cross section. The offshore region provided the sand supply to the beach from the October 2019 bar arrangement seen.

Figure 5d. Dune growth was substantial at the foredune location as all four surveys documented additional height and width to the feature. The generous berm present in May 2019 was not replicated subsequently, but the offshore bar ridge in October 2019 appears to have moved onto the beach as small ridges of sand.

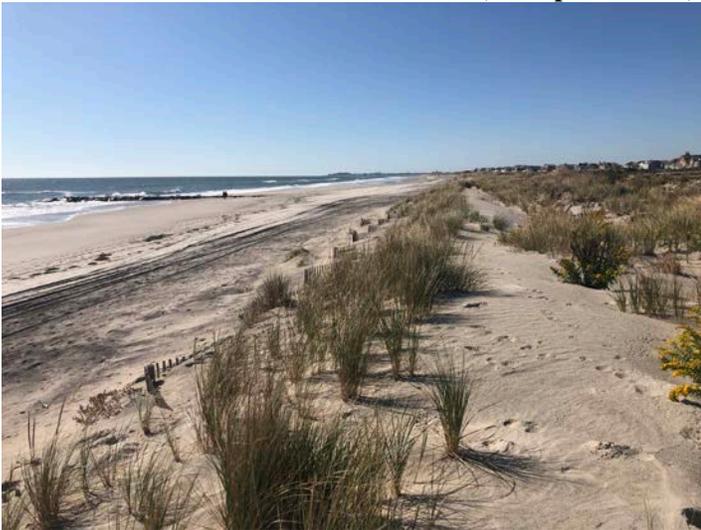
**Photoplate 6a – The October 15, 2019 overlooking the accreting foredune encroaching onto the planted project dune slope. The fencing is buried with new sand from the beach that is colonized quite densely.**

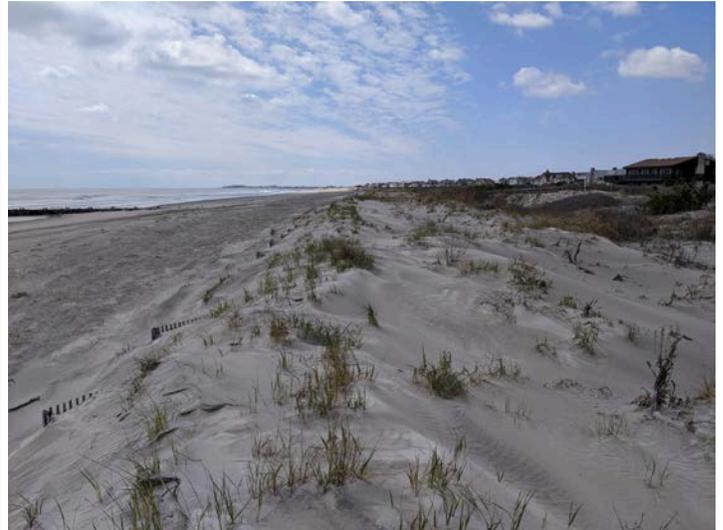
**Photoplate 6b - Photo taken April 15, 2020 and shows large amounts of wind deposition around the existing plants.**

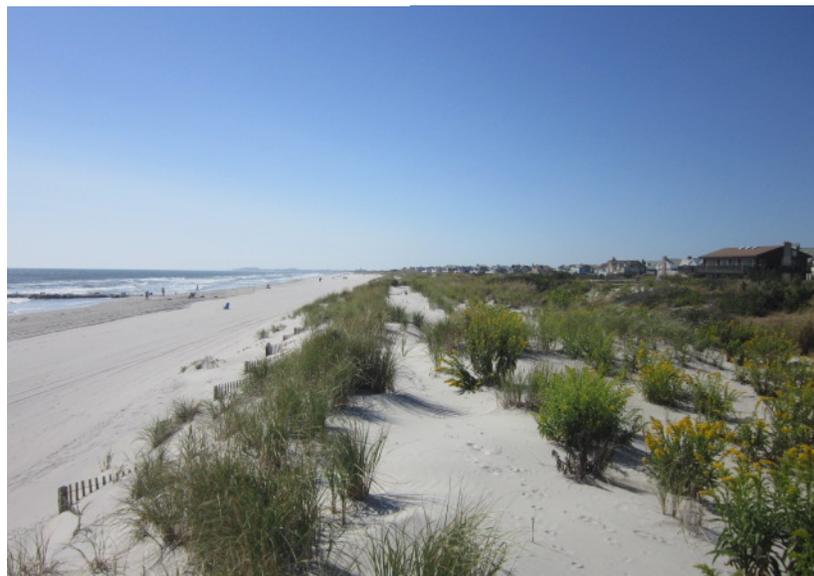
**Photoplate 6c – Photo taken October 7, 2020 where the seasonal plant growth has taken hold on the new sediment supplied by the wind.**
