**2020 ANNUAL REPORT ON  
THE CONDITION OF THE MUNICIPAL BEACHES FOR  
THE BOROUGH OF STONE HARBOR, CAPE MAY COUNTY, NEW JERSEY**

**PREPARED FOR: THE BOROUGH OF STONE HARBOR  
9508 SECOND AVENUE  
STONE HARBOR, NJ 08247**

**PREPARED BY: THE STOCKTON UNIVERSITY COASTAL RESEARCH CENTER  
30 WILSON AVENUE  
PORT REPUBLIC, NEW JERSEY 08241**

**December 31, 2020**

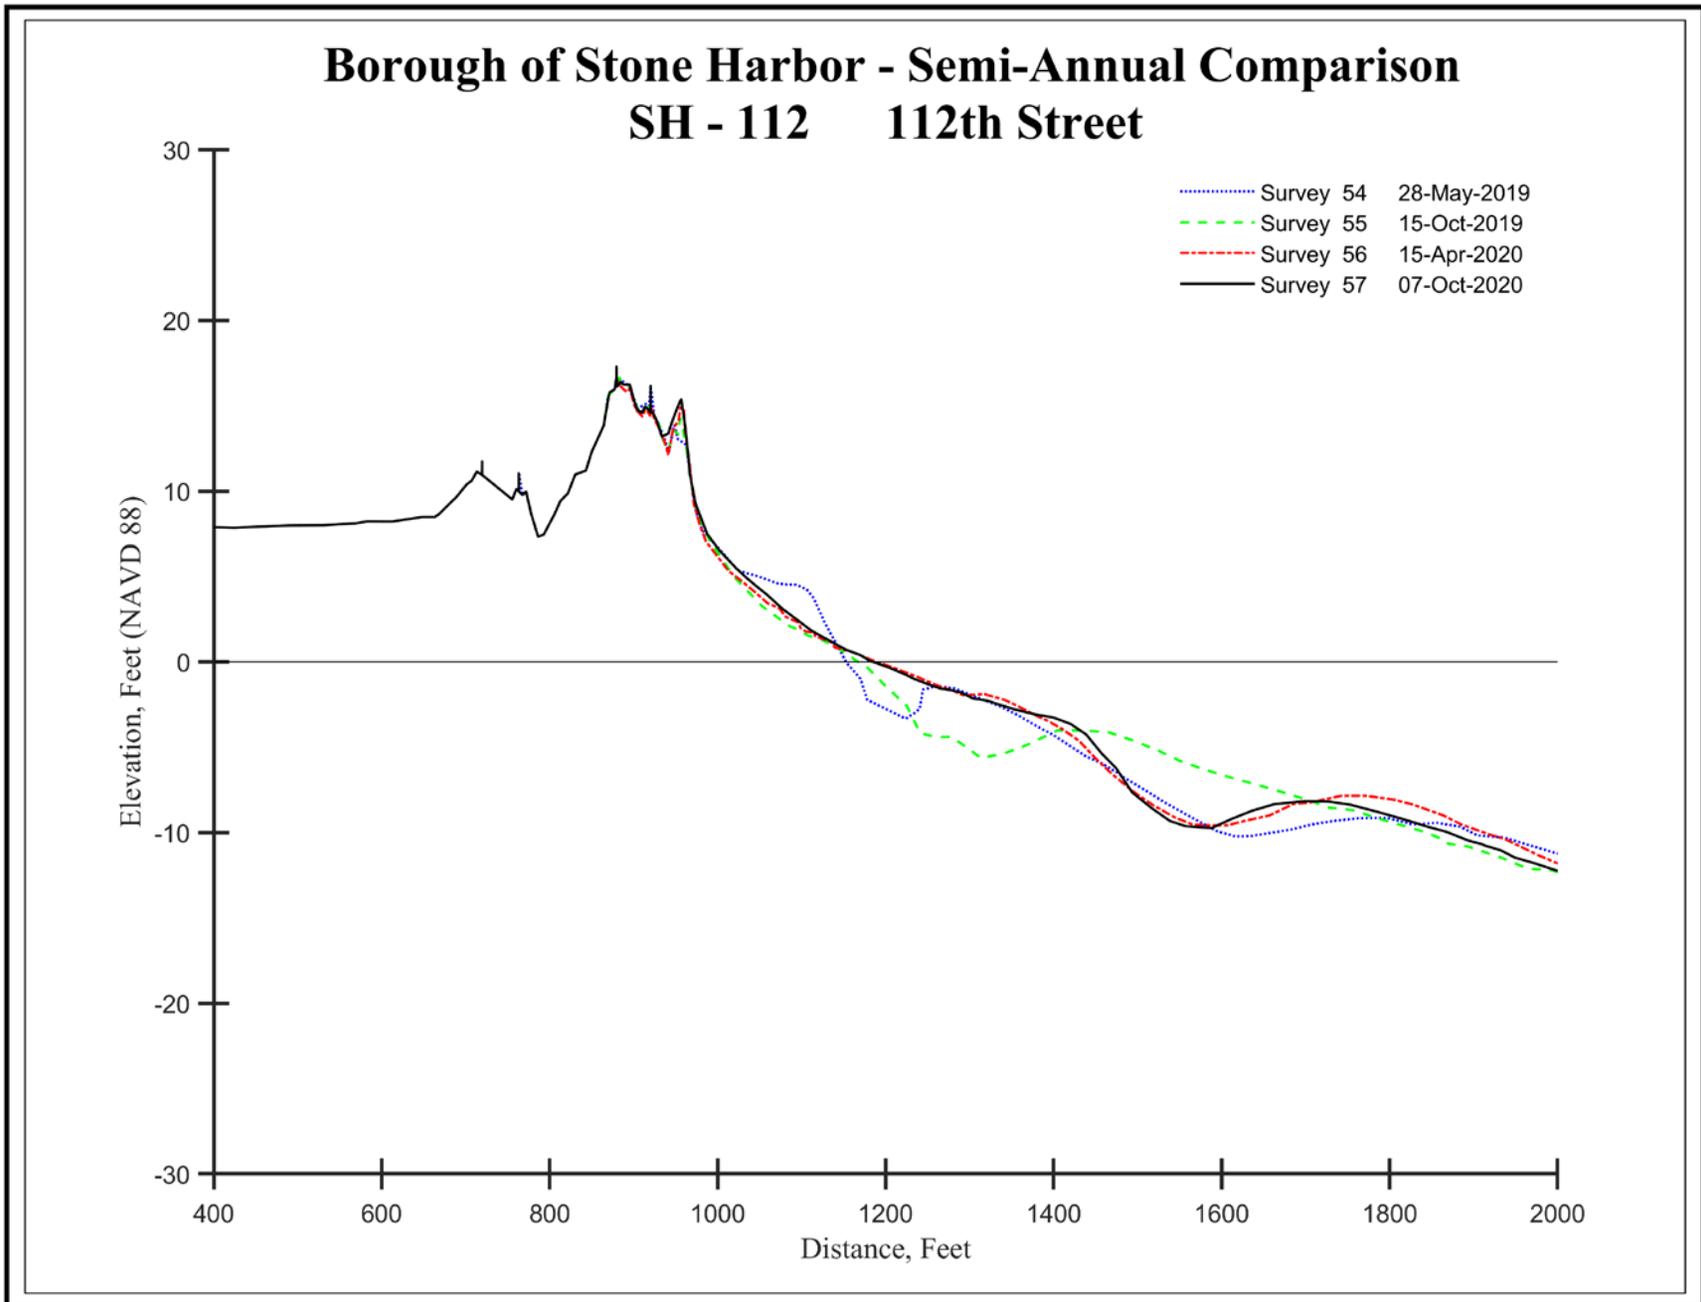
A berm crest on the beach together with a close-to-the-beach sand ridge offshore appears to have provided a stable beach profile between the dunes and the water's edge. The offshore region shifted by October 2019 to a more distant, low elevation bar system.

Figure 6d. The profiles at 112<sup>th</sup> Street continued the pattern where the beach slope and position maintained the same configuration following the addition of a berm from offshore sand supplies in May 2019. Continued cross-shore migration continued after October 2019 as the entire system stabilized with few changes in 2020.

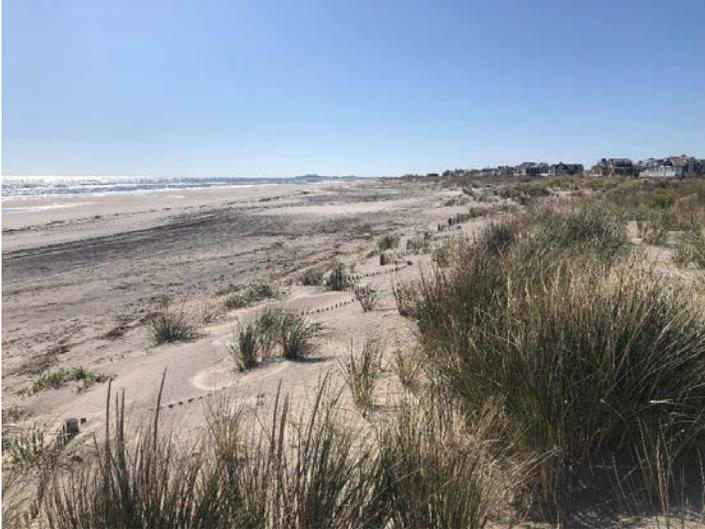
**Photoplate 7a - Photo taken October 15, 2019 finds the fencing placed in 2017 buried and luxuriant dune grass growing across the feature created since the fence was built.**

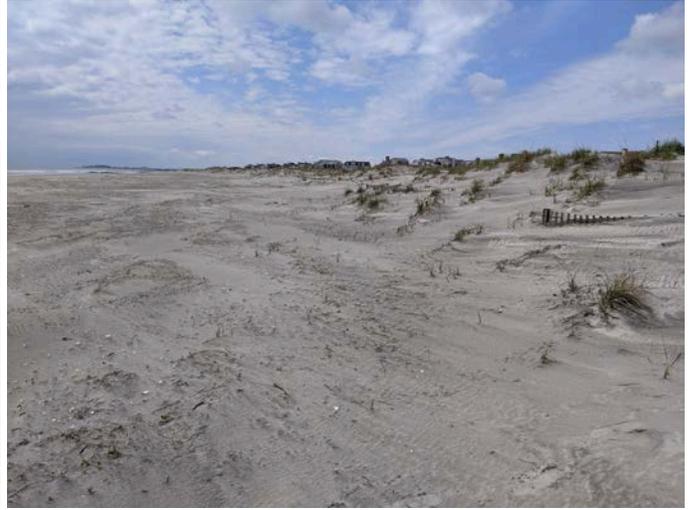
**Photoplate 7b – Photo taken April 15, 2020 showing continued sand deposition around fencing locations and a wide beach seaward .**

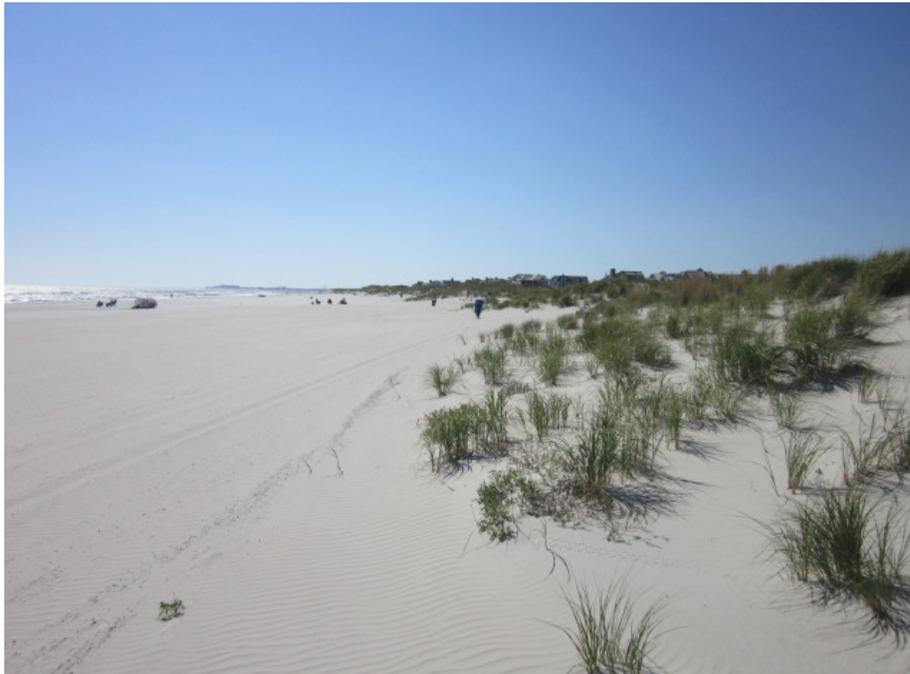
**Photoplate 7c – Photo taken October 7, 2020 provides a view of the wide dry beach and sand deposited among the dune plants at 116<sup>th</sup> Street.**

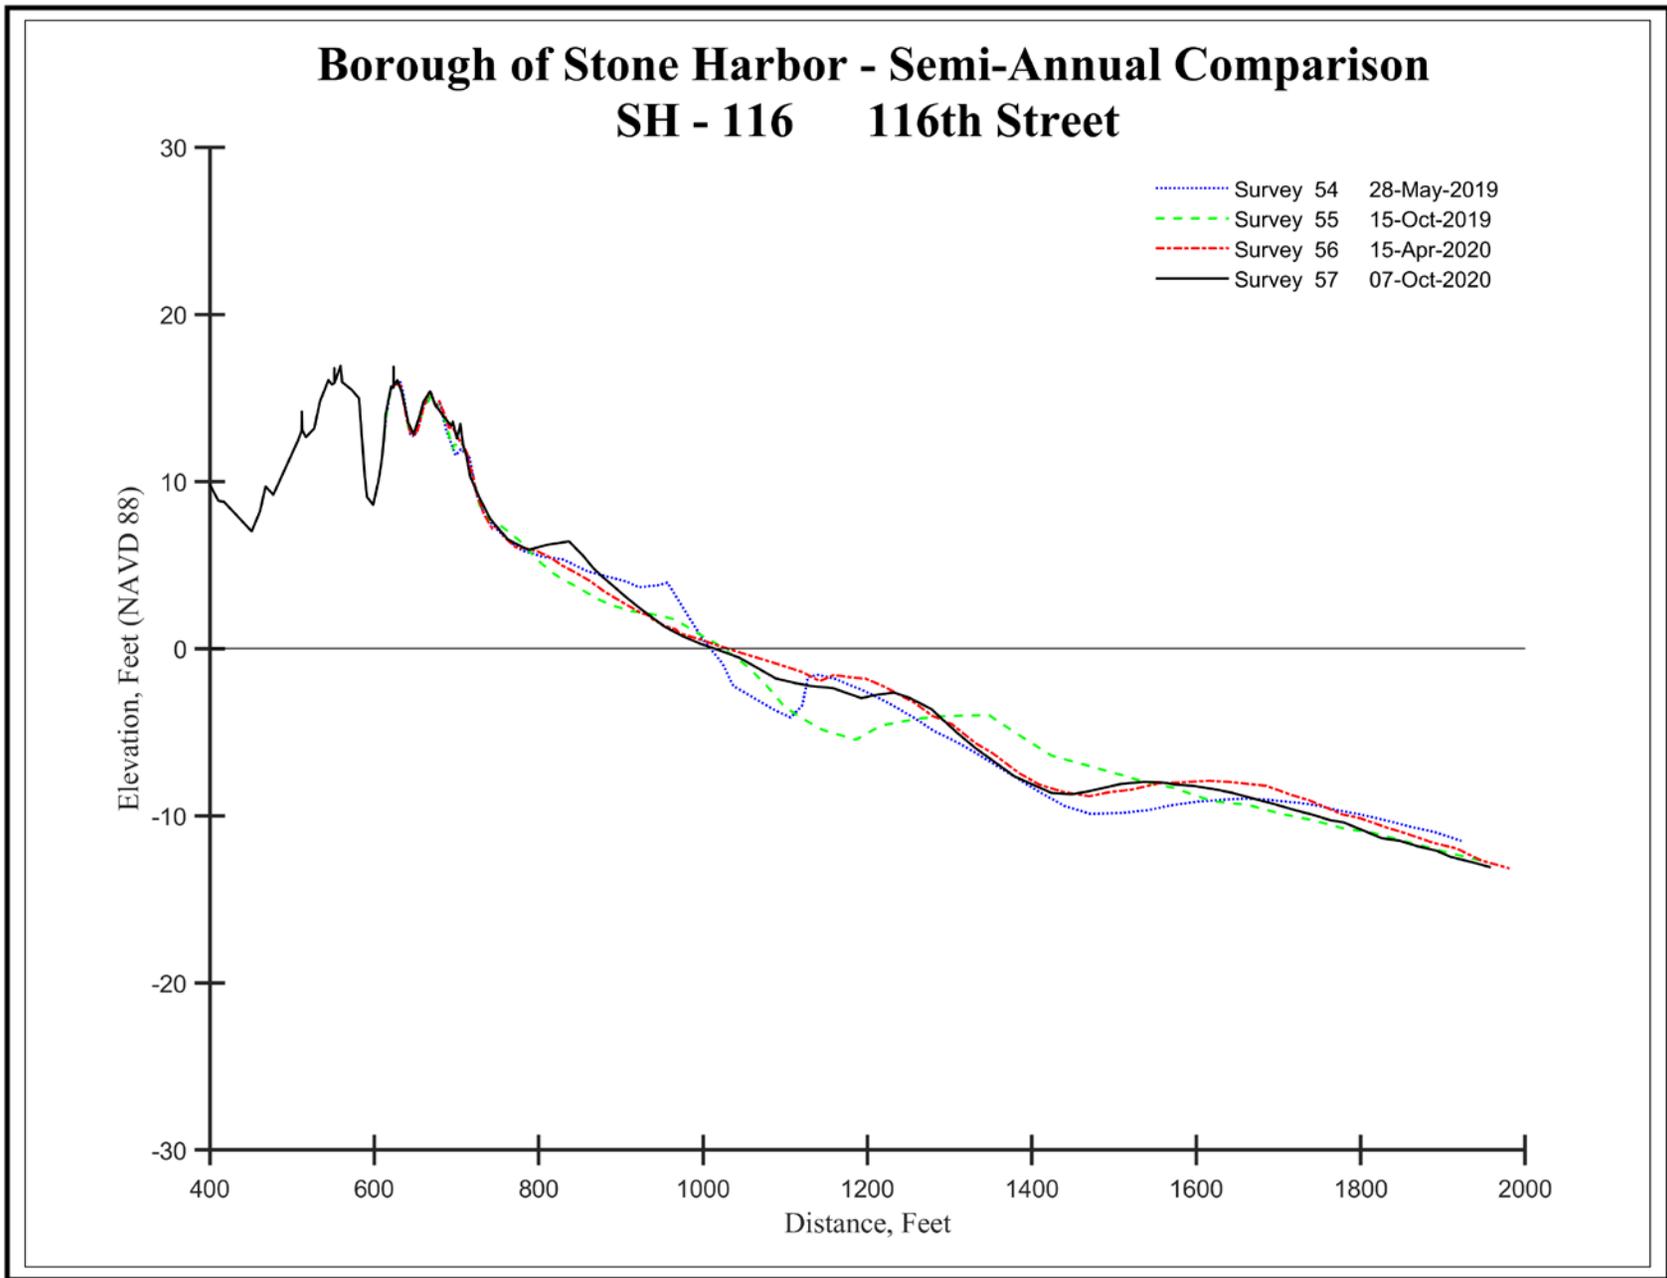
The site was unique in the generation of a late summer 2020 berm crest to pair with that found on the May 2019 survey. The dunes accumulated sand similar to other sites while the offshore region stabilized around small offshore bars as considerable distance from the water's edge.

Figure 7d. The 116<sup>th</sup> Street location includes a double dune system that continues to capture wind transported material mostly on the seaward slopes. This site developed a prominent berm crest ridge in 2020 duplicating the one present in May 2019, but further landward. Offshore bar material provided the supply of sand.

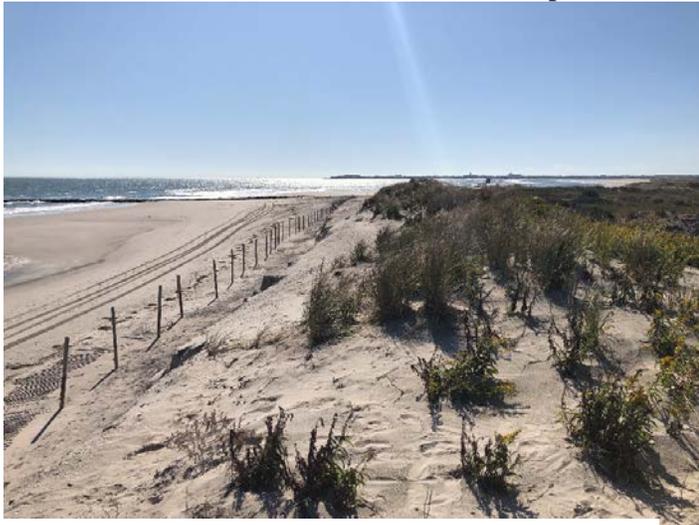
**Photoplate 8a - Photo October 15, 2019 following another episode of dune toe erosion generating a 4-foot scarp in the toe. The sand supply is not sufficient to maintain even a minor storm proof dune.**

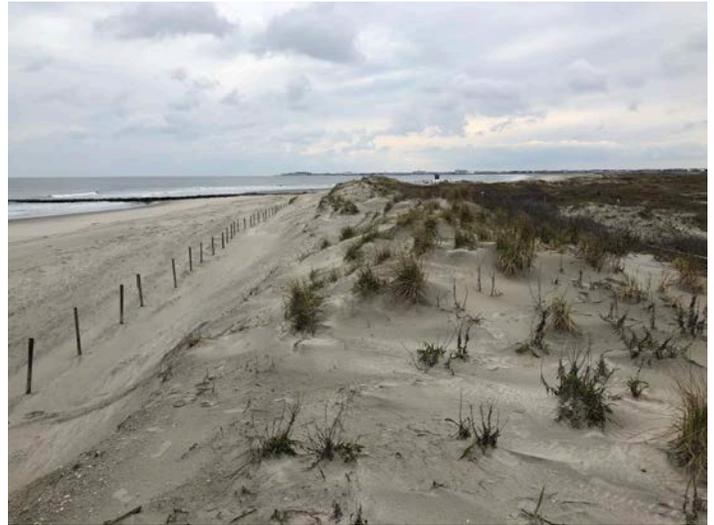
**Photoplate 8b – Photo taken April 15, 2020 following a long interval of quite waves and wind transport placing sand at the scarp. Crest slumping also added sand to the slope.**

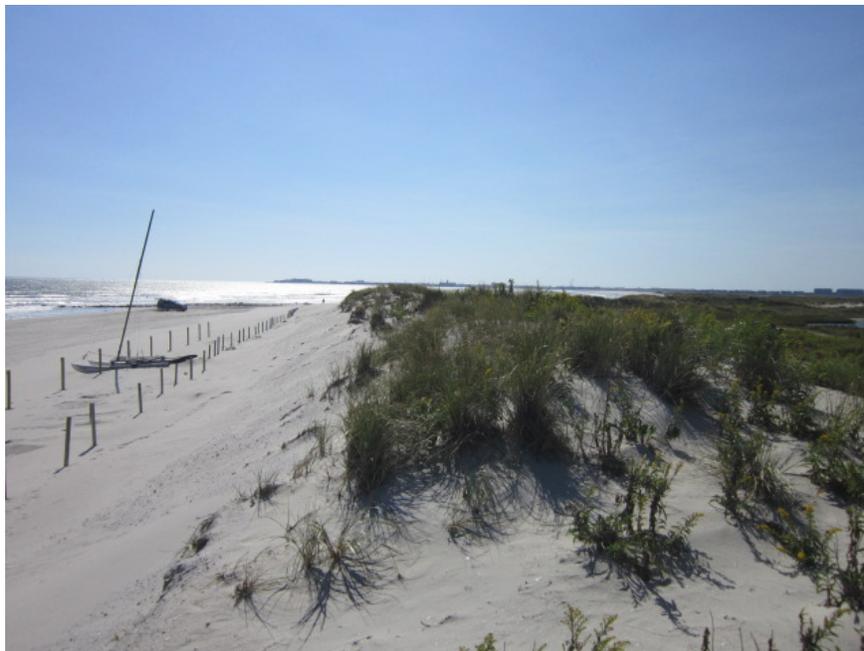
**Photoplate 8c – The photo taken October 7, 2020 illustrates the maximum impact natural wind deposition can have in restoration of dune erosion damage. The beach is wider at the close of the 2020 summer season.**

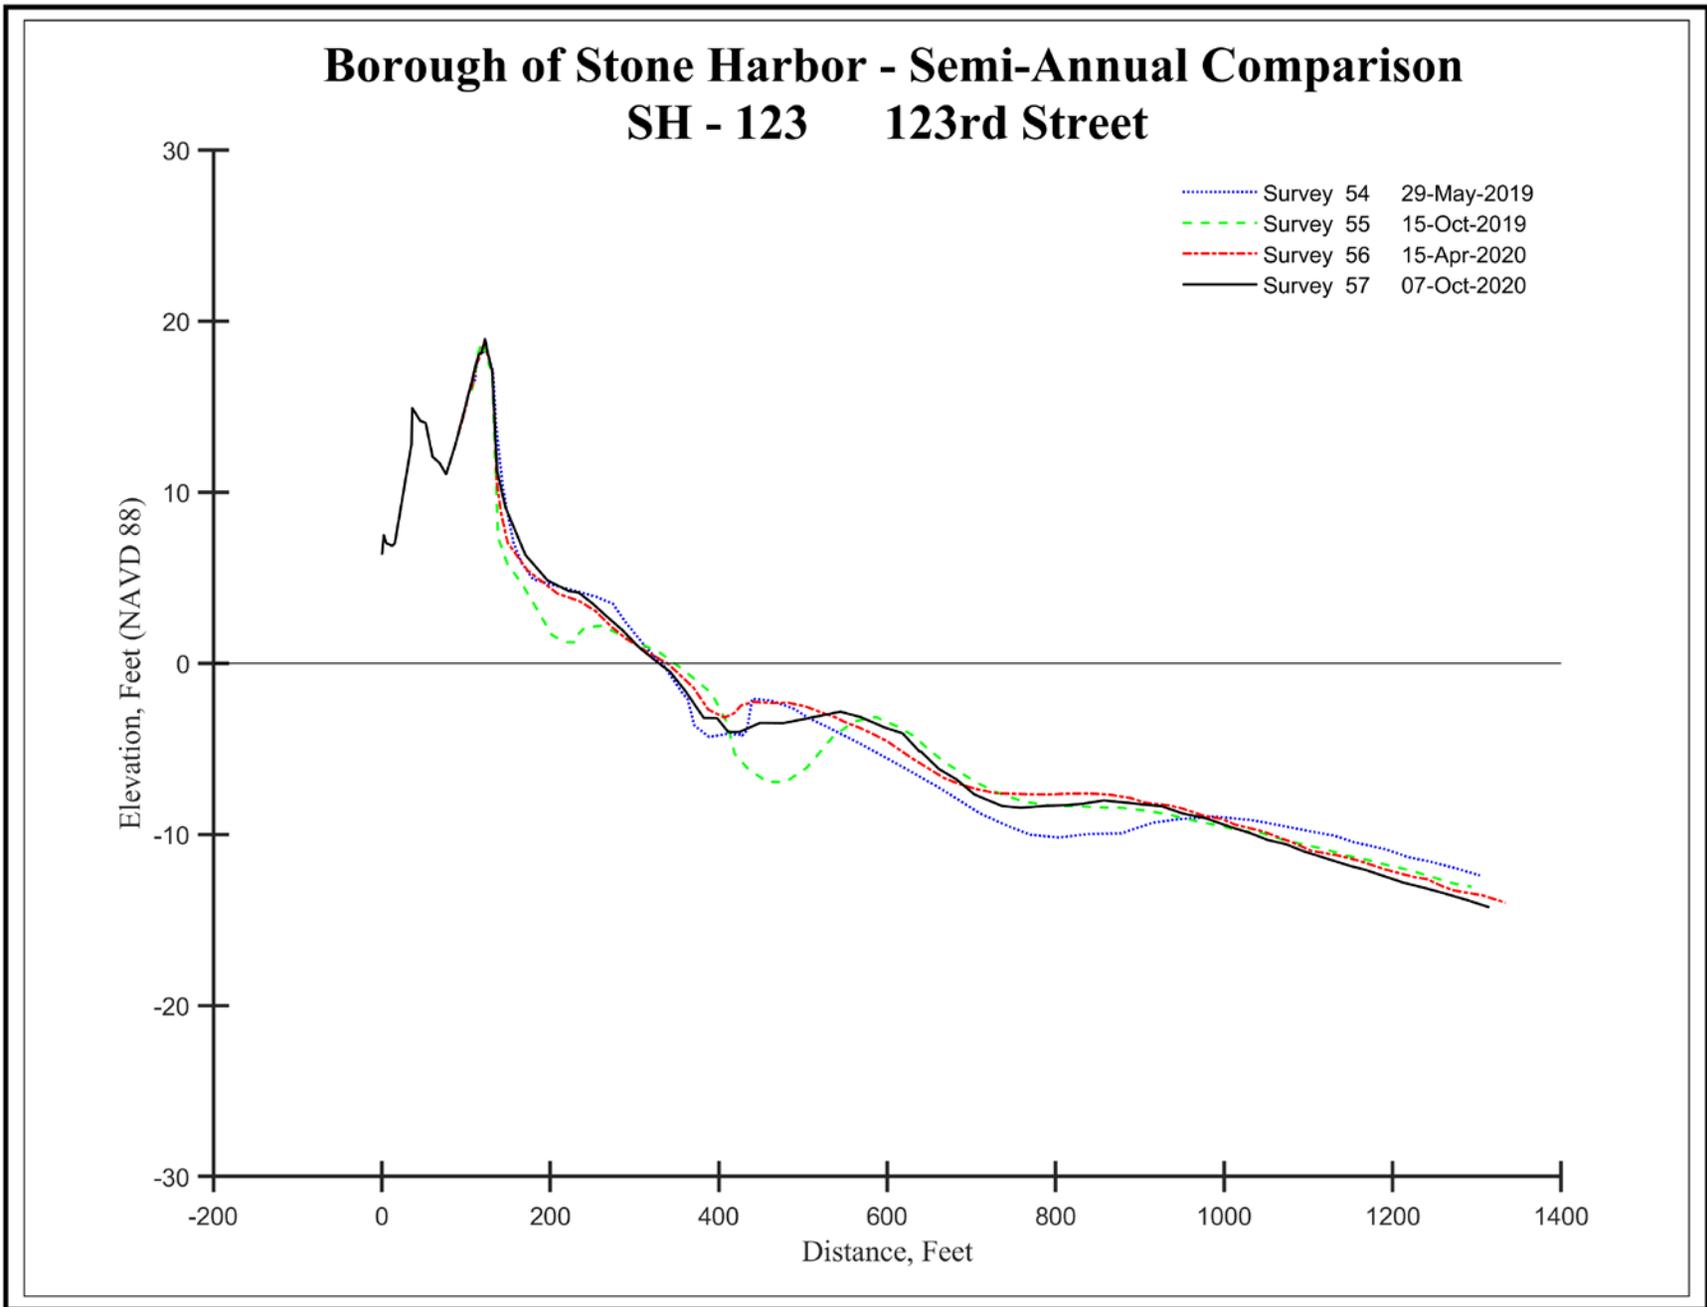
The abrupt scarp cut into the dunes last fall was partially covered by a slope of dry sand that was wind transported to conceal about two-thirds of the eroded face of the dunes. Accumulation of sand on the beach above high tide also widened the profile. Offshore bar migration provided the necessary sand supply during both summer seasons.

Figure 8d. 123<sup>rd</sup> Street site was eroded at the dune toe slope in May 2019 when sand commenced migrating onto the beach from offshore sources moderating the scarp and adding a dry sand slope toward the dune crest by October 2020. The bar sequence offshore was more variable than other sites, but still was adding sand to the beach.
