The Coastal Research Center

The Stockton University Coastal Research Center (CRC) completed the first of two scheduled seasonal surveys for 2021. The spring 2021 municipal oceanfront beach survey was completed on April 14th and 15th at the eight established sites in Stone Harbor. Semi-annual shoreline and sand volume changes were calculated between survey #57 (conducted in October 2020) and survey #58 to determine changes over the 2020 to 2021 winter season and review changes to the Borough beaches. This spring has presented significant beach berm losses seen between the Avalon boundary and the 95th Street profile site. From 95th Street south to the last profile at 123rd Street change has been considerably less with gains on the beach appearing at 112th to 123rd Streets. Storm activity commenced with two northeasters in mid- to late-December, followed by two minor events in January and the worst event February 1st and 2nd that produced berm erosion to the seaward toe of the dunes. Since the February 2021 event, storm activity declined with low pressure systems moving west of the Jersey shore to the northeast not setting up in the Atlantic Ocean off the coast between North Carolina

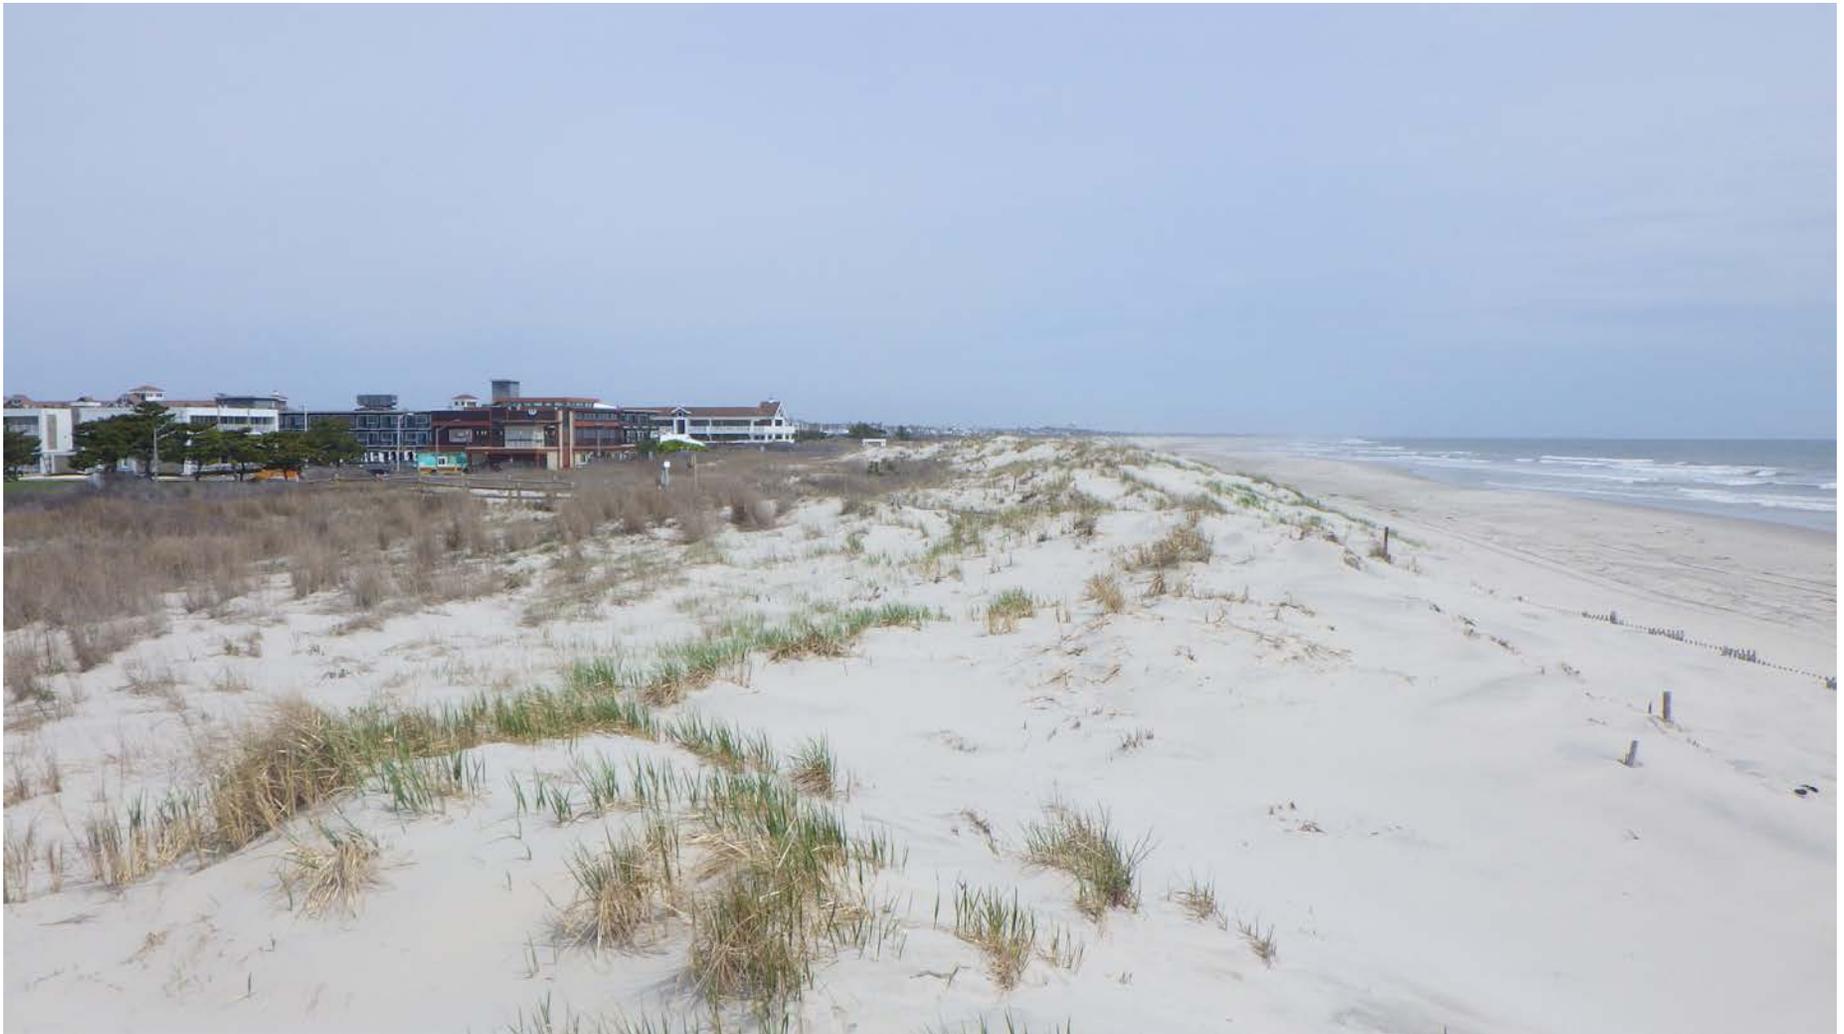
SH-82, located at 82nd Street, this beach received sand later in 2017 derived from Townsend's Inlet. This April 16, 2020 view shows the sand accumulated at the dune fencing over the past 2 winters and a wide beach looking north towards Avalon.

Figure 1. View to the north at 82nd Street. The photo was taken on April 14, 2021. This view duplicates the perspective from last spring with a little more sand deposited on the seaward dune slope at the nearly buried fencing. The beach is narrower with storm debris almost to the seaward dune toe.

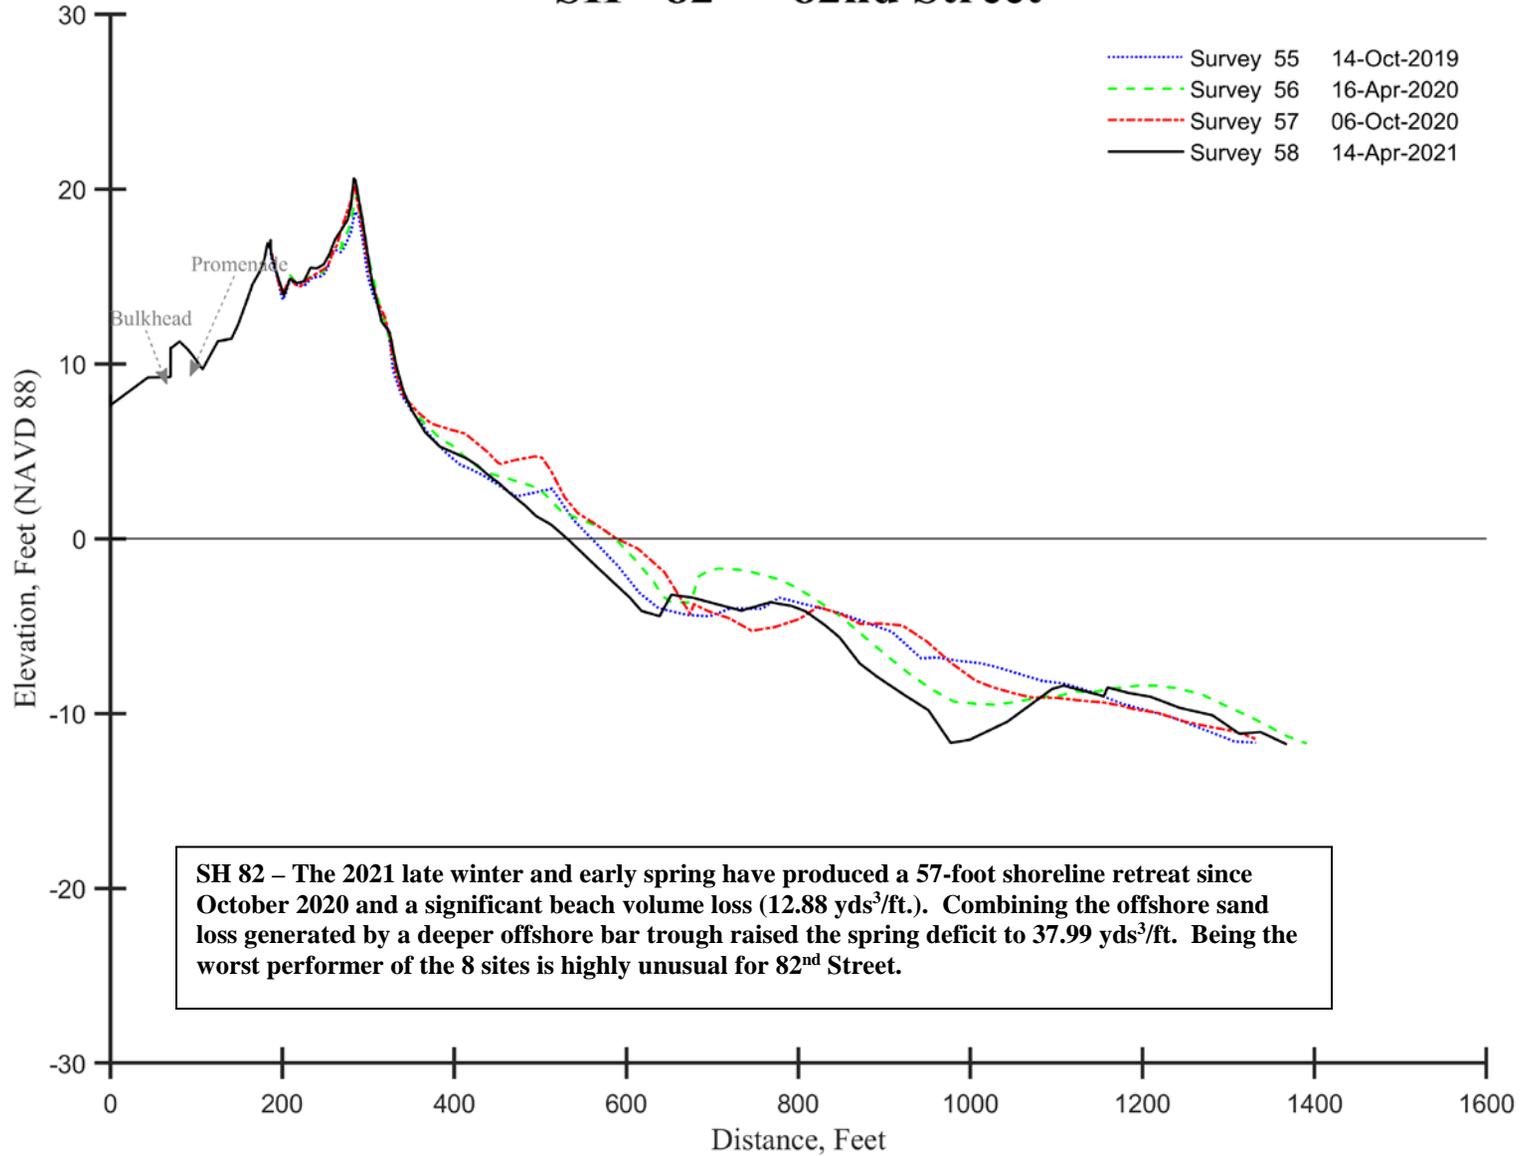
Borough of Stone Harbor - Semi-Annual Comparison SH - 82 82nd Street

The winter of 2020 – 2021 saw extensive sand volume loss along the northern Stone Harbor shoreline particularly at the 82nd Street location. The 90th Street site had substantial shoreline retreat, but without the

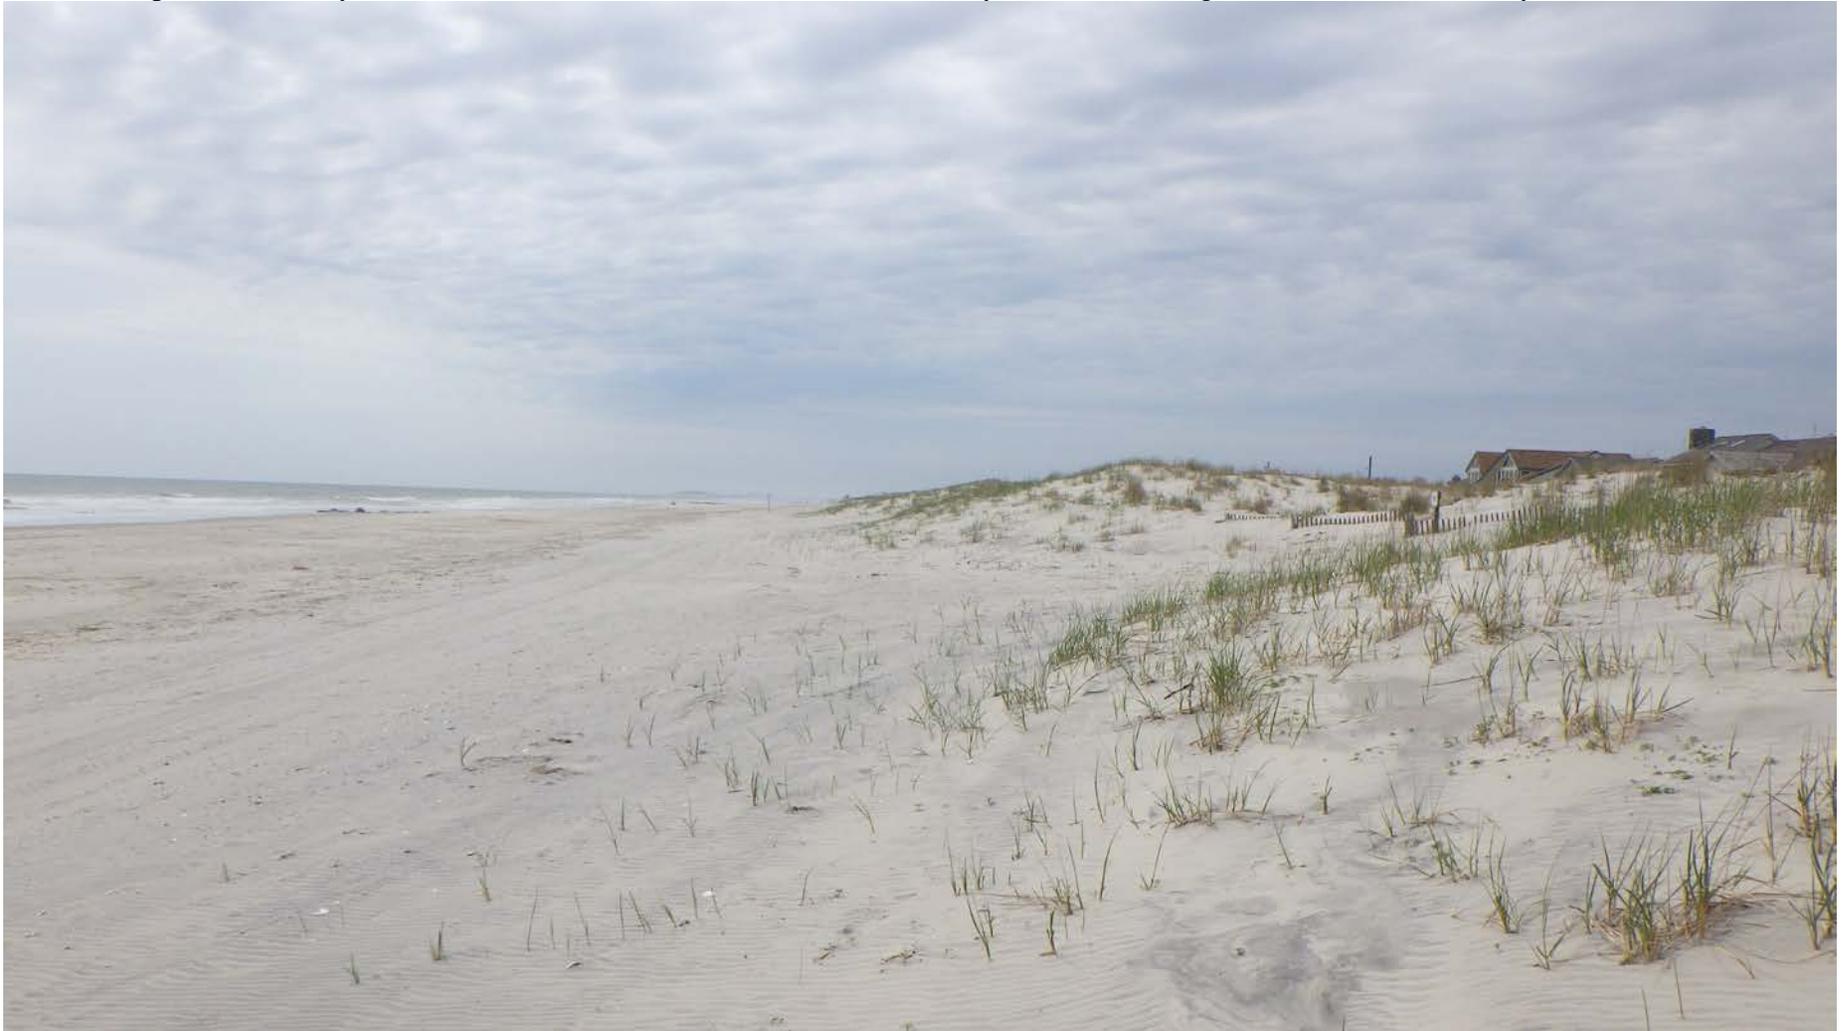
SH-90, located at 90th Street this beach also received sand during spring of 2017 adding 44.63 yds³/ft. The beach width sustained the dune's seaward slopes without any erosion. Storm debris does cover much of the dry beach indicating the winter storm activity.

Figure 2. View to the south taken from the foredune toe on April 14, 2021. The dune remains unscathed by storm damage with the debris line 20 or so feet seaward of the seaward dune toe. The beach width is less, but not substantially so.

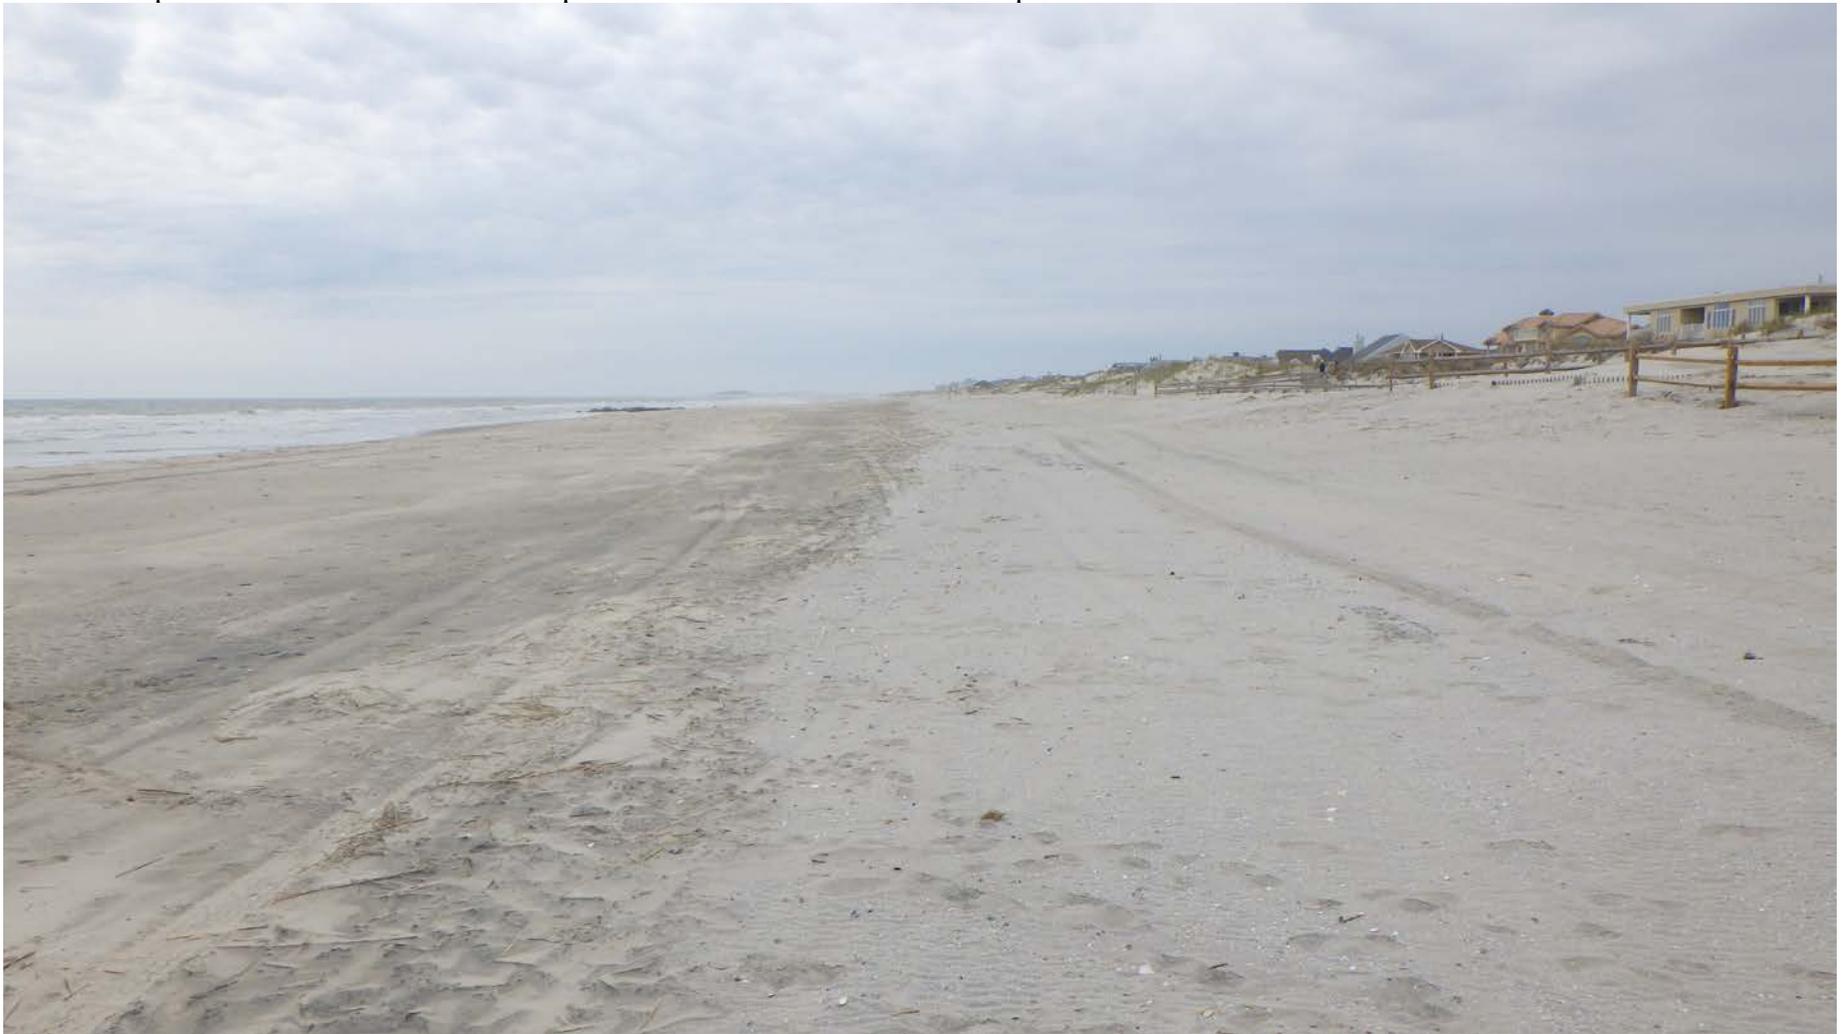
SH-95, located at 95th Street this site received sand by June 12, 2017, providing a 99-foot wider beach as 53.73 yds³/ft. were placed above the zero elevation. The beach remains in decent shape with sand deposited by the wind in the dunes in substantial quantities over the past 3 years. Wave run-up did remove the earlier sand deposited on the seaward dune toe slope to the fence line.

Figure 3. This view to the south along the recent wrack line taken April 14, 2021 shows the beach and dunes just south of the handicapped access ramp.

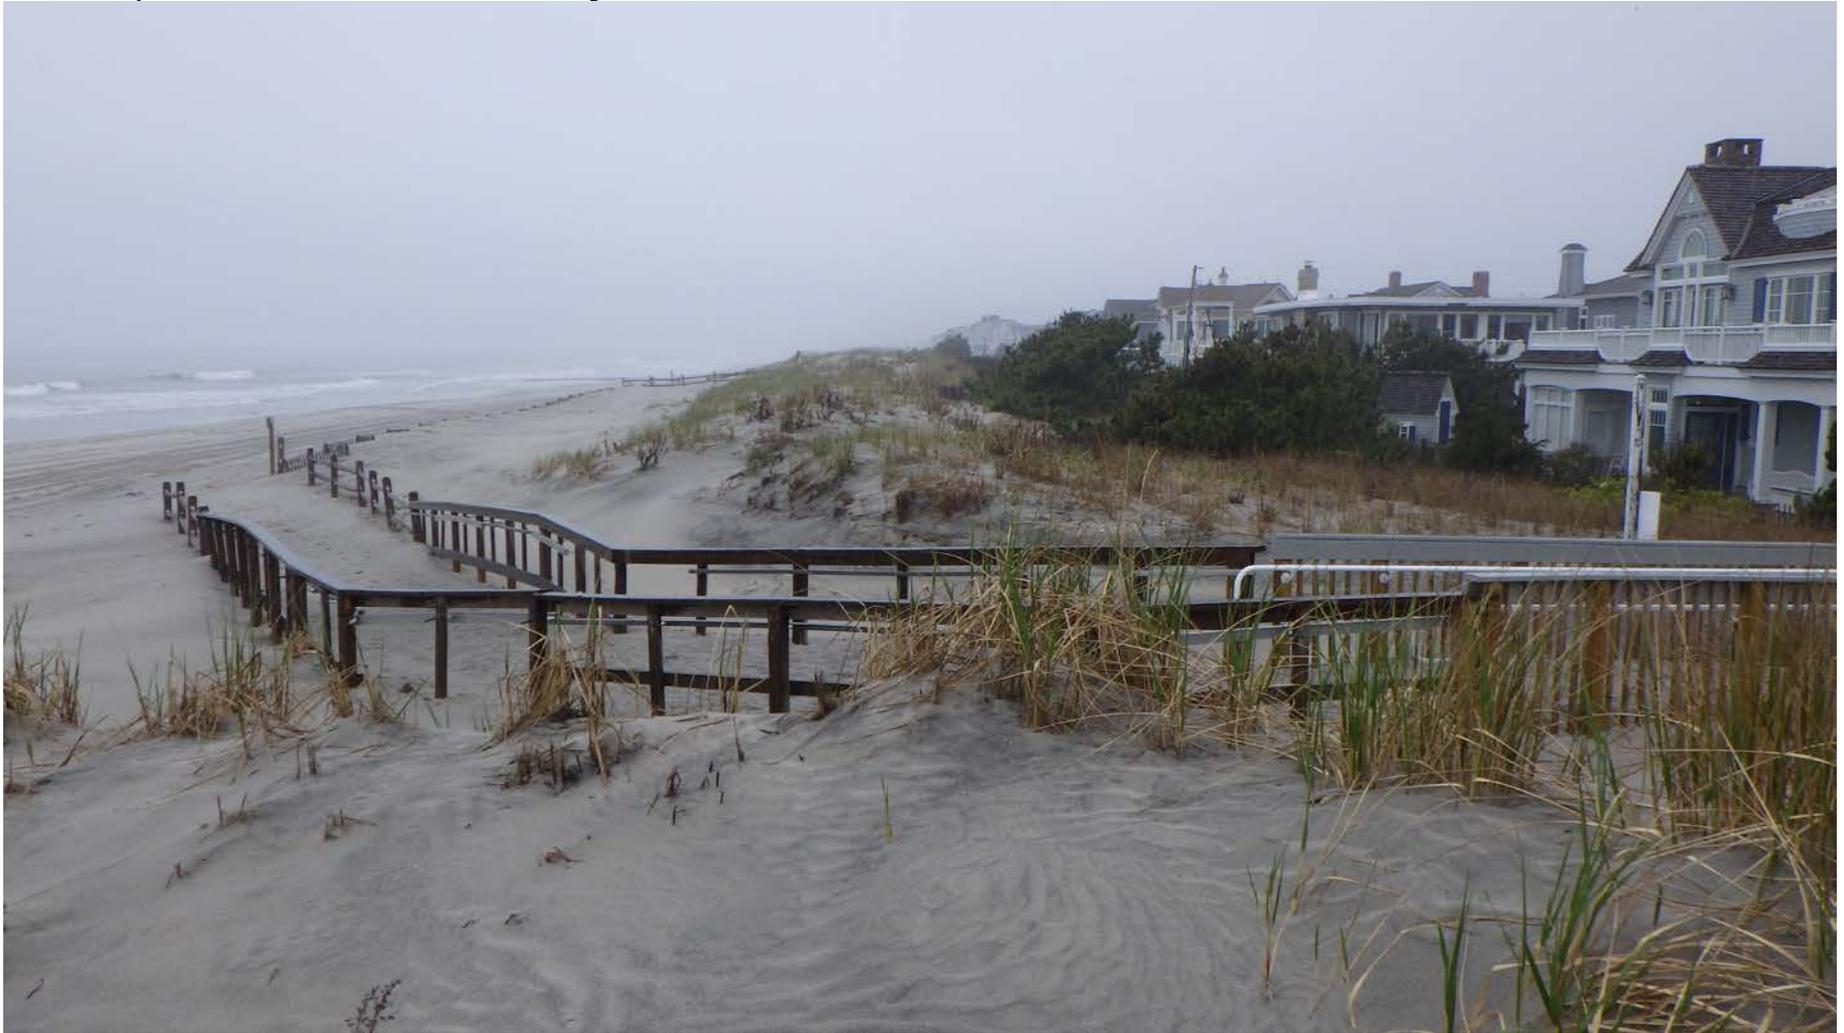
SH-103, the 103rd Street beach gained sand at the dune fencing burying the most recently placed row of fencing (2017). The beach width declined by 30 feet but remained sufficient to protect the dunes from erosion.

Figure 4. View to the south at 103rd Street taken April 15, 2021. There has been extensive sand deposition around the 2017 fence installation that has buried the fence. The site suffered a minor loss in beach width, but no dune damage this past winter.

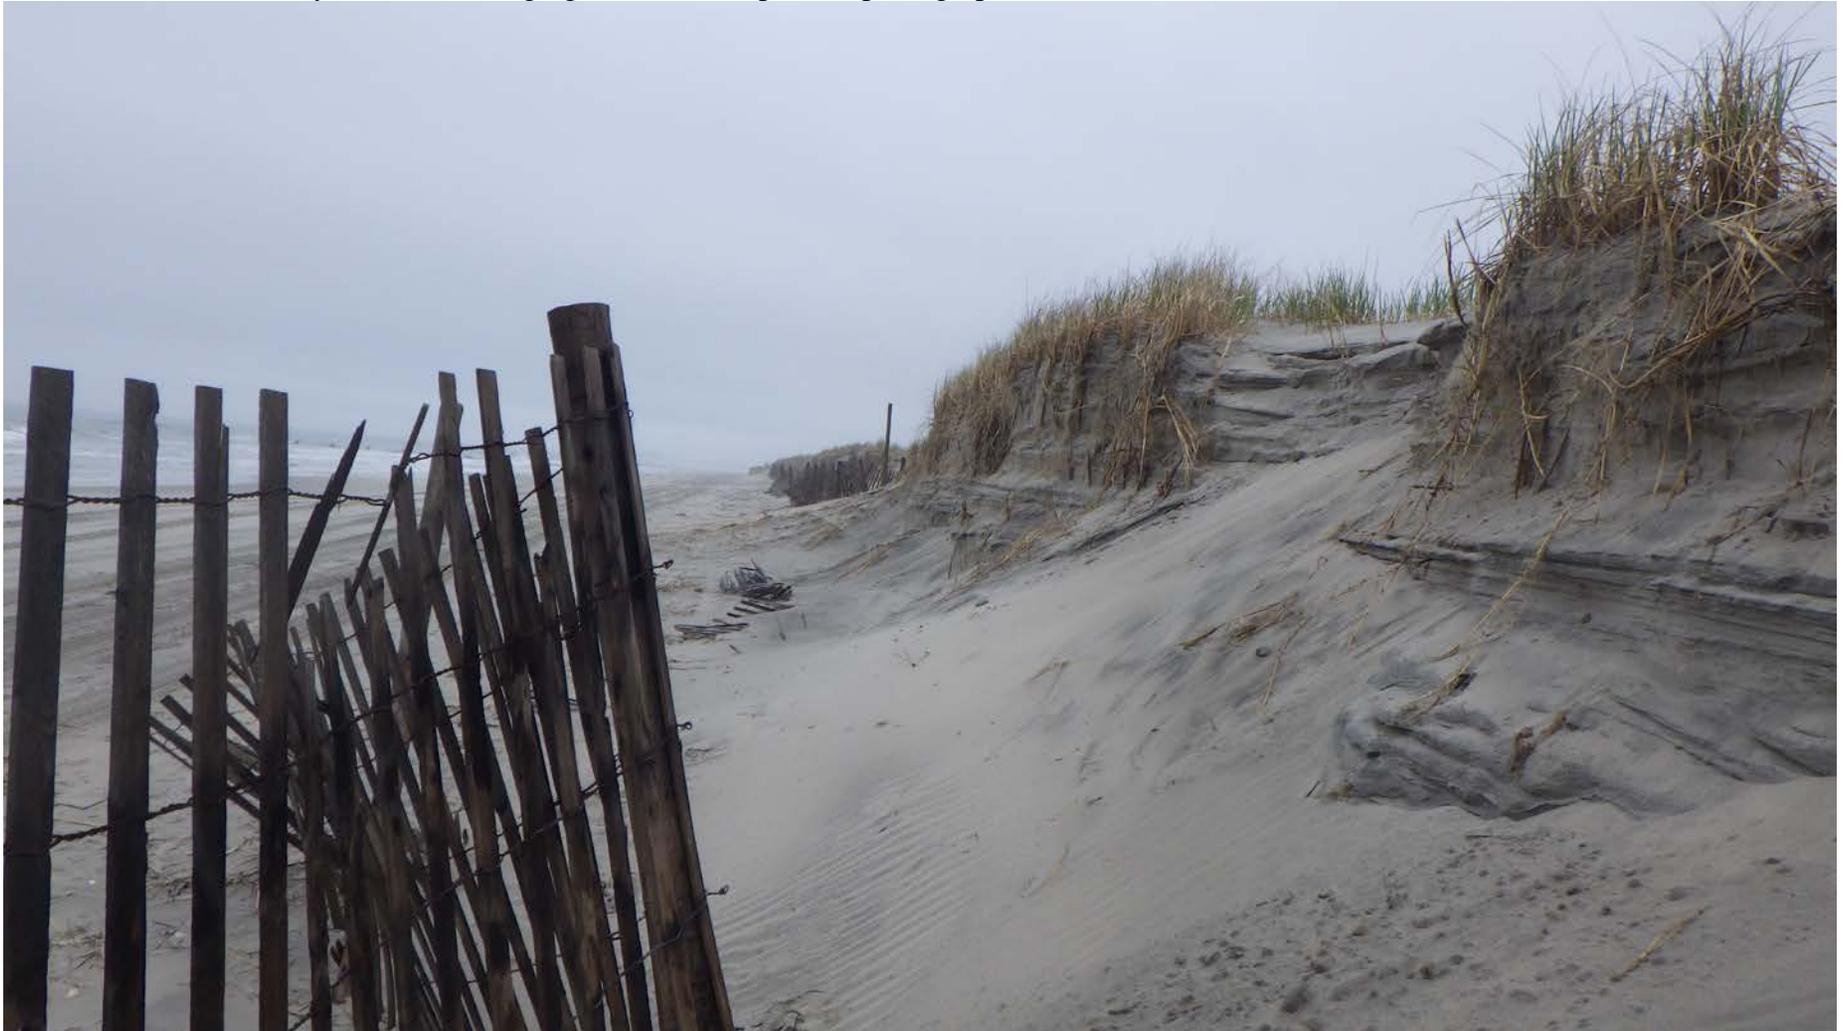
SH-108, the project beach at 108th Street was restored by March 27, 2017. Since the project, the dunes have been brushed by wave erosion, with this winter's activity the most damaging. The cut scarp in the photograph is hard evidence of modest dune erosion.

Figure 5. View to the south taken on April 15, 2021. At this site, most likely the February 1, 2nd northeast storm cut into the seaward dune slope generating the scarp in this picture and destroyed the 2017-installed fencing in the immediate vicinity of the profile transect. The shoreline retreated 28 feet leaving a narrow beach that waves continue to run up to the dune toe.

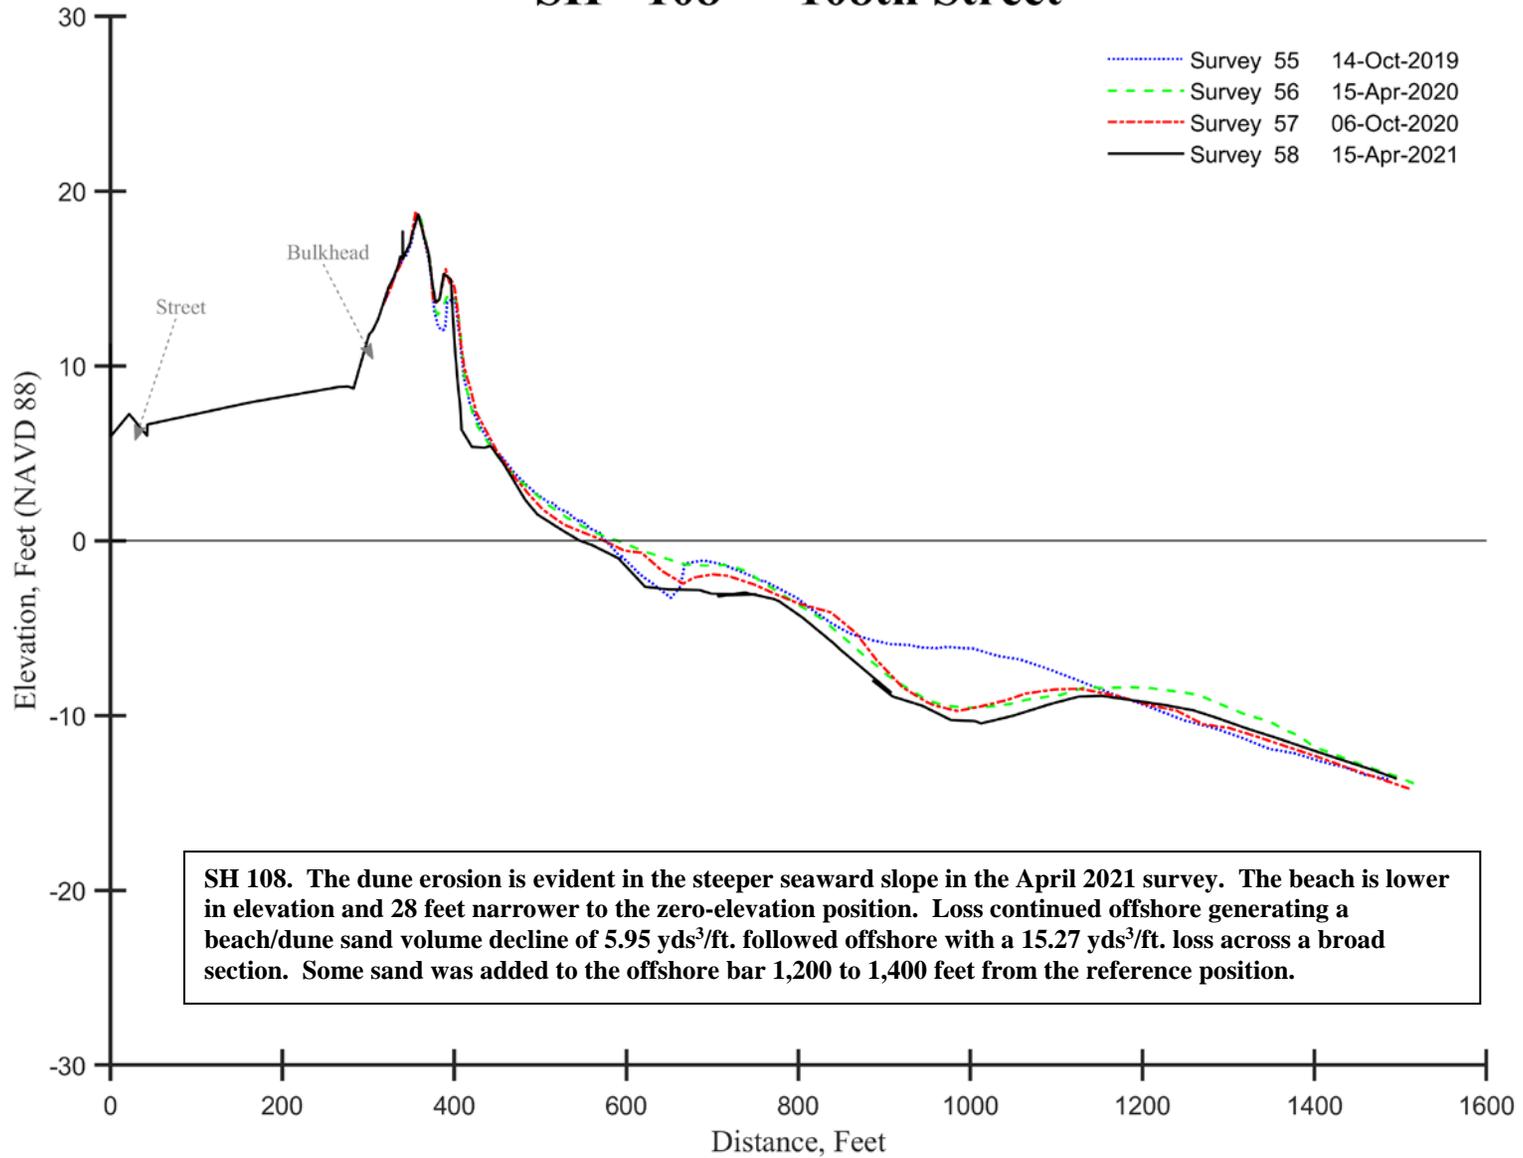
Borough of Stone Harbor - Semi-Annual Comparison SH - 108 108th Street

This winter season, the 123rd Street locality did see the smallest overall sand volume loss of any site in the Borough. This has been a fairly unusual situation due to the ease with which sand passes around or over the terminal rock groin to South Point. The narrowest beach which did see minor dune erosion was 108th Street where the dry beach width is about 140 feet from the dune toe to the mean high-water line.

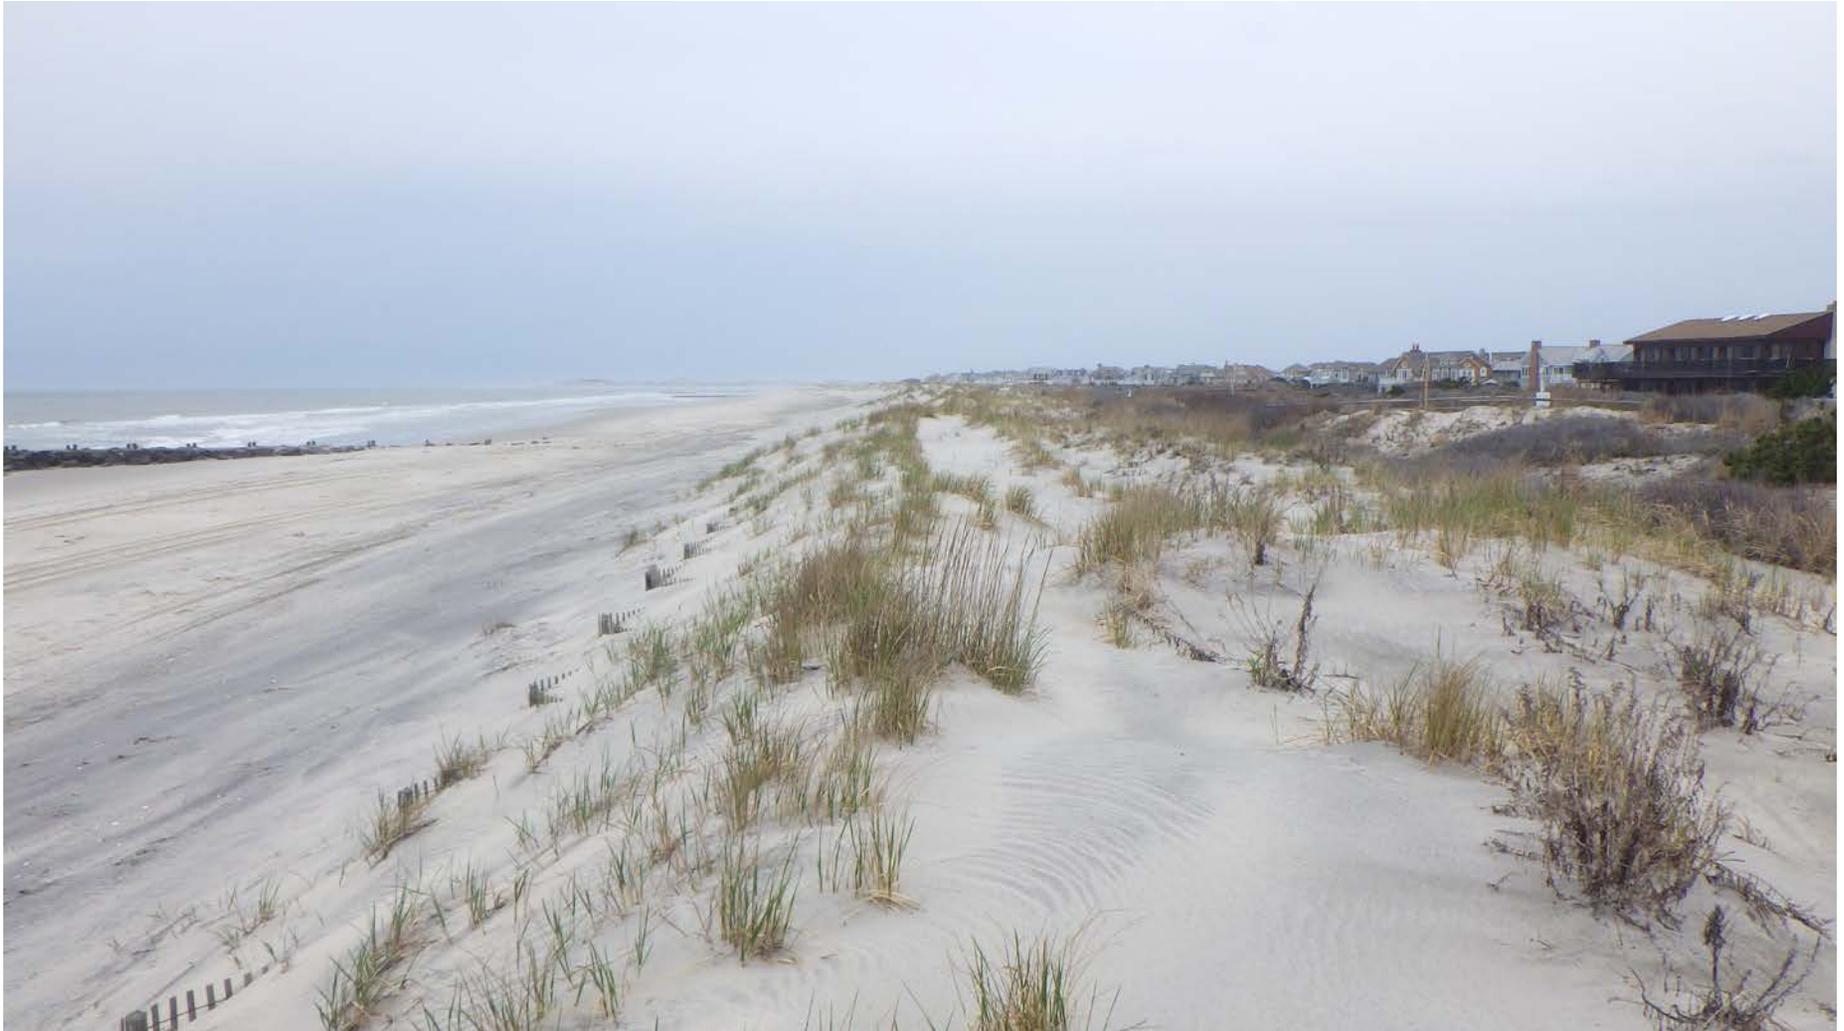
SH-112. The 112th Street beach re-nourishment was completed by March 27, 2017. The new fencing is all but buried by April 2021 and the beach width remains excellent.

Figure 6. View to the south taken April 15, 2021 along the foredune crest. Wind deposition is universally present where the 2017 fence installation is almost buried and lobes of sand deposited by the wind extend from almost every plant cluster. The 112th Street beach is wider at this location.

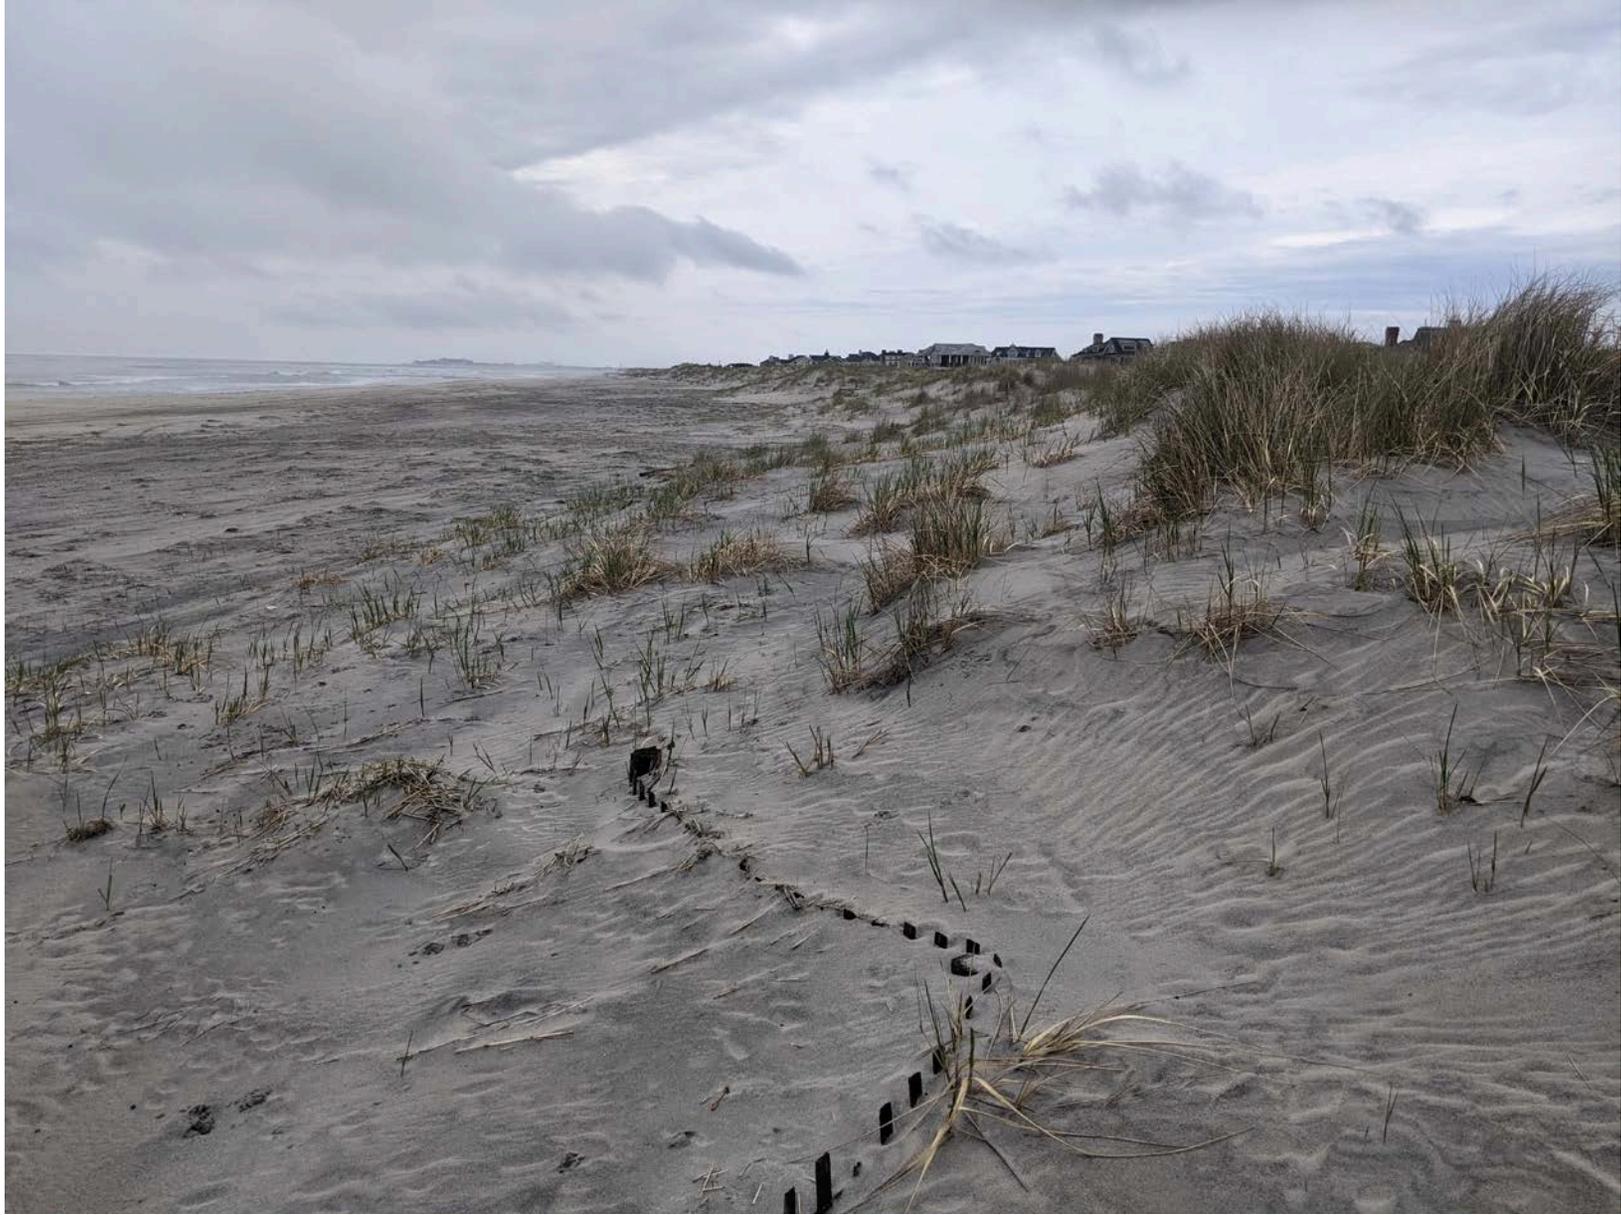
SH-116, This location has the widest dunes with foredunes advancing onto the USACE beach template. The 2017 fencing is buried, and the beach width is extensive.

Figure 7. View to the south at 116th Street taken on April 15, 2021, showing extensive dune accretion at the newest fence line with dune plants advancing onto the beach beyond the fence. The beach is the widest in Stone Harbor and allows the wind to scour the dry sand and move it into the dune field.

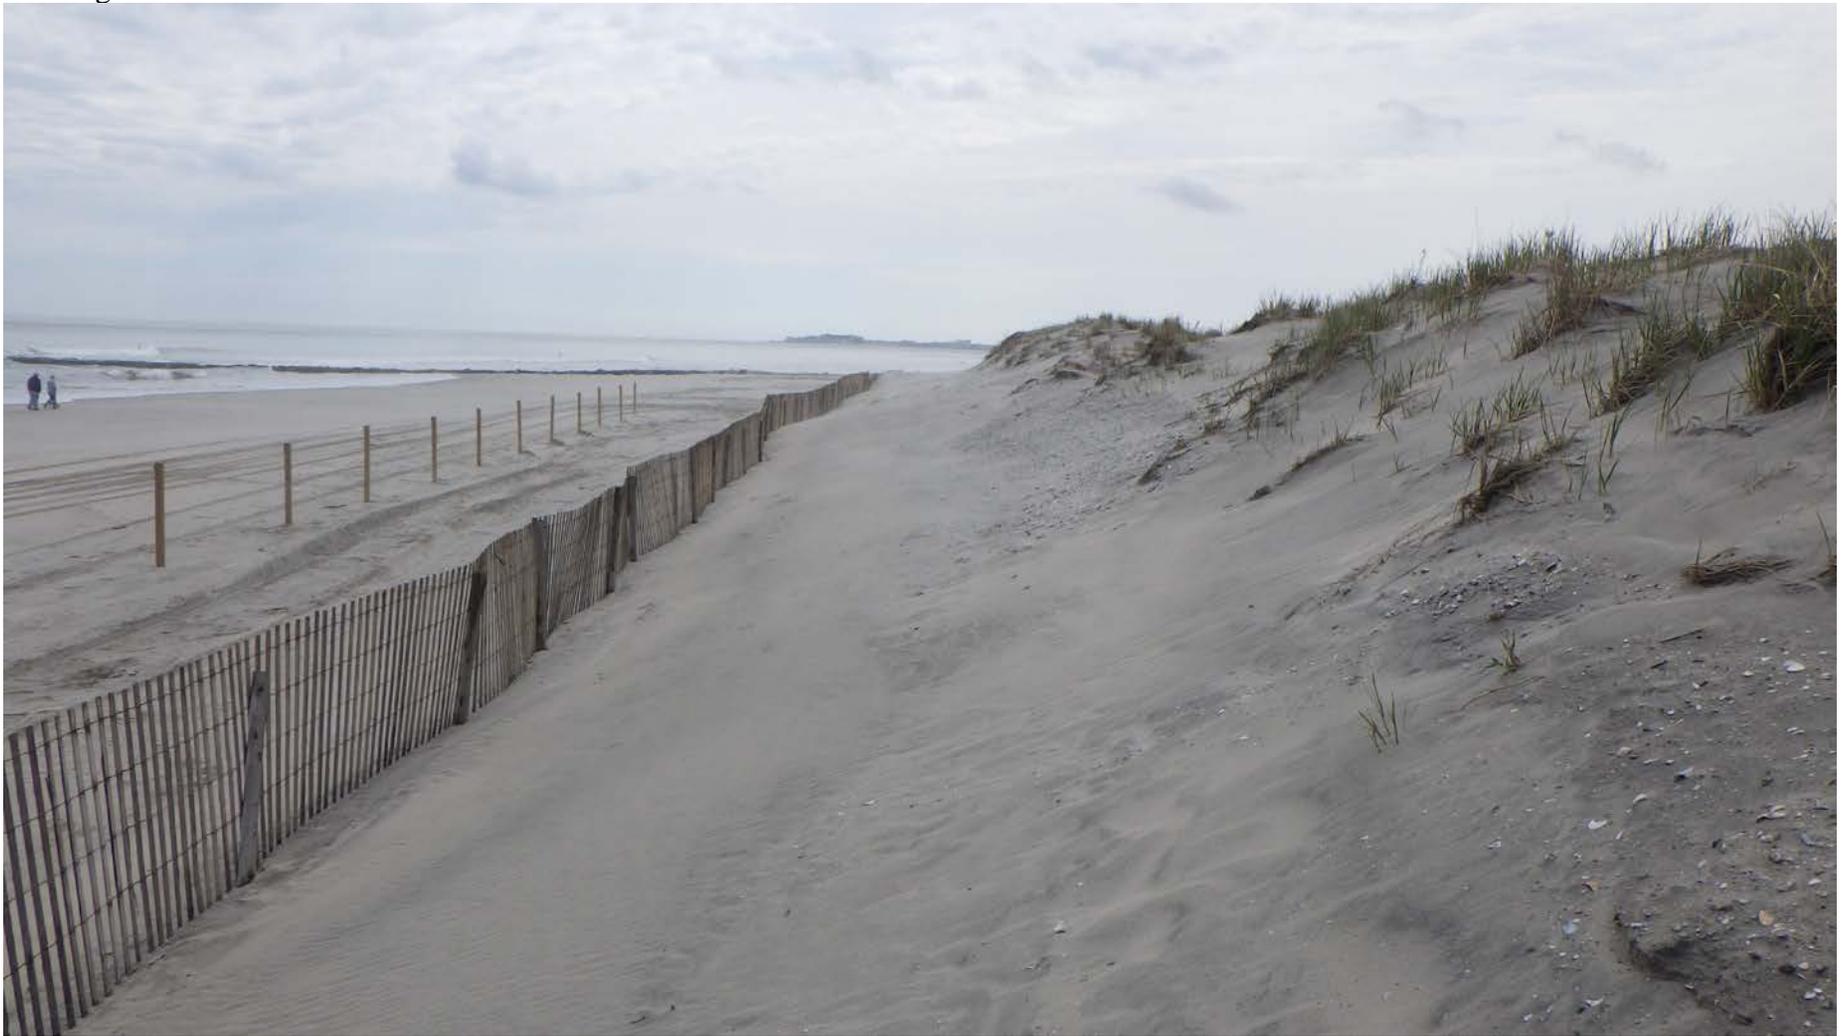
SH-123, site 123 is located just north of the terminal groin and the start of South Point. A new fence was installed since October 2020. The beach is narrow, but the winter storms do not appear to have eroded into the dune's seaward toe. The outer row of posts are for sea kayak moorings.

Figure 8. View to the south taken on April 15, 2021, looking toward the terminal rock groin. A new row of sand fence is in place with the winter damage to this dune less extensive than seen most winters. The wave run-up reaches just past the fence line.
